Inspection Photos

Operator: VERDAD RESOURCES LLC - 10651

Location ID: 436809

Inspection Doc. Number: 682504465

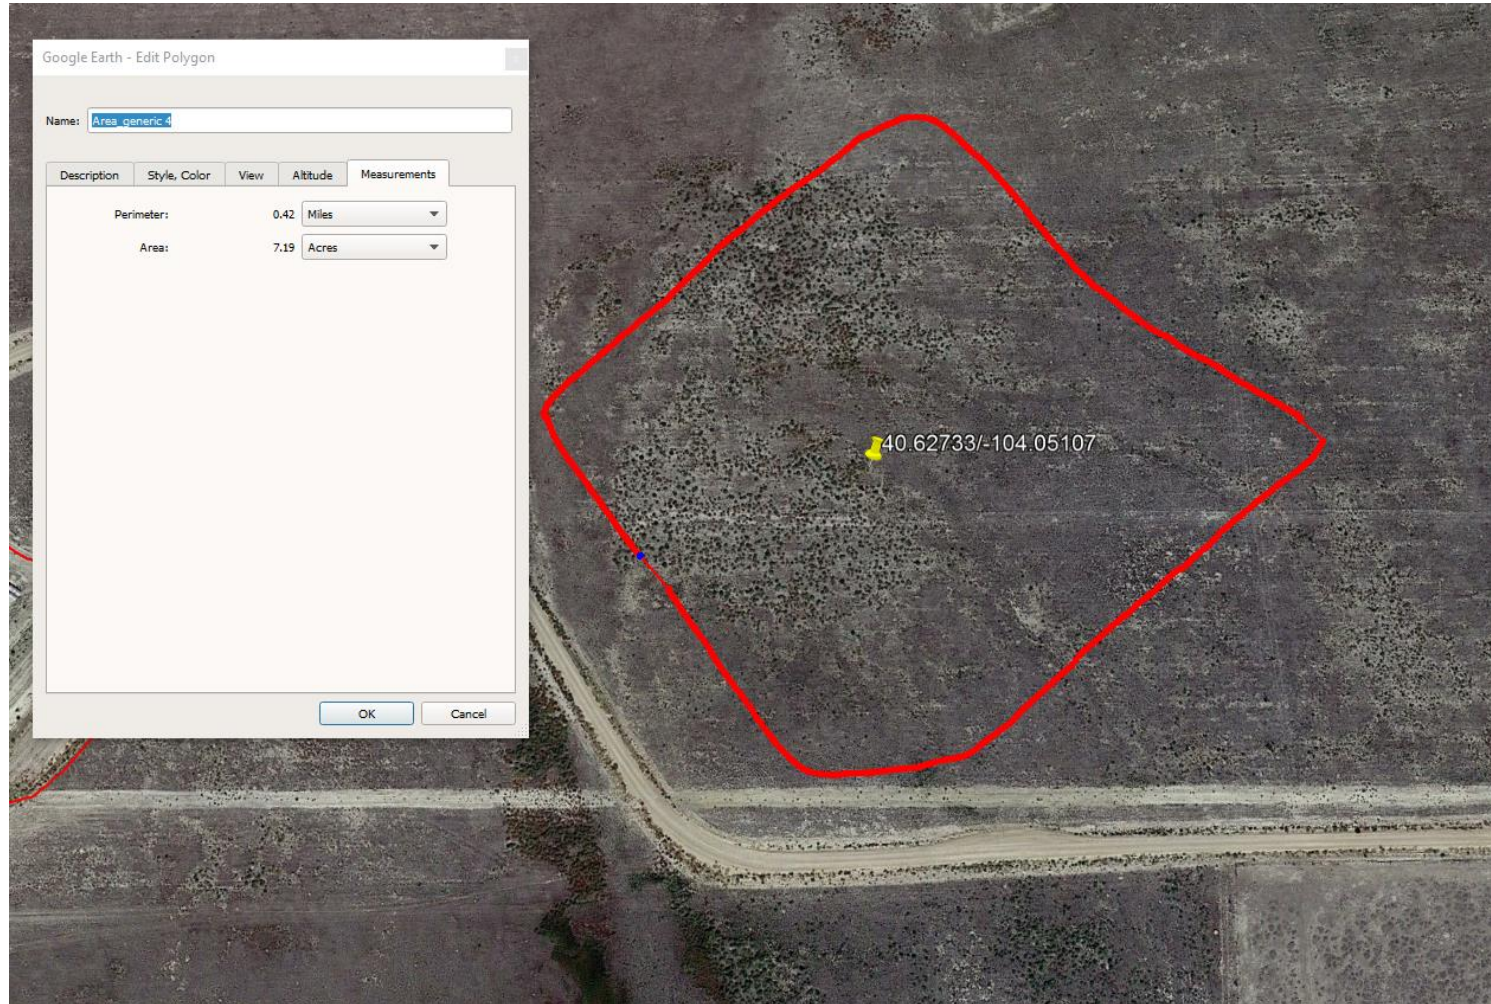
Photo 1: 2013 Google earth aerial imagery. Photo shows disturbance area for the location. A disturbance area of 7.19 acres was measured using a Trimble Juno 3B handheld device. This exceeds the permitted disturbance area of 6.8 acres.

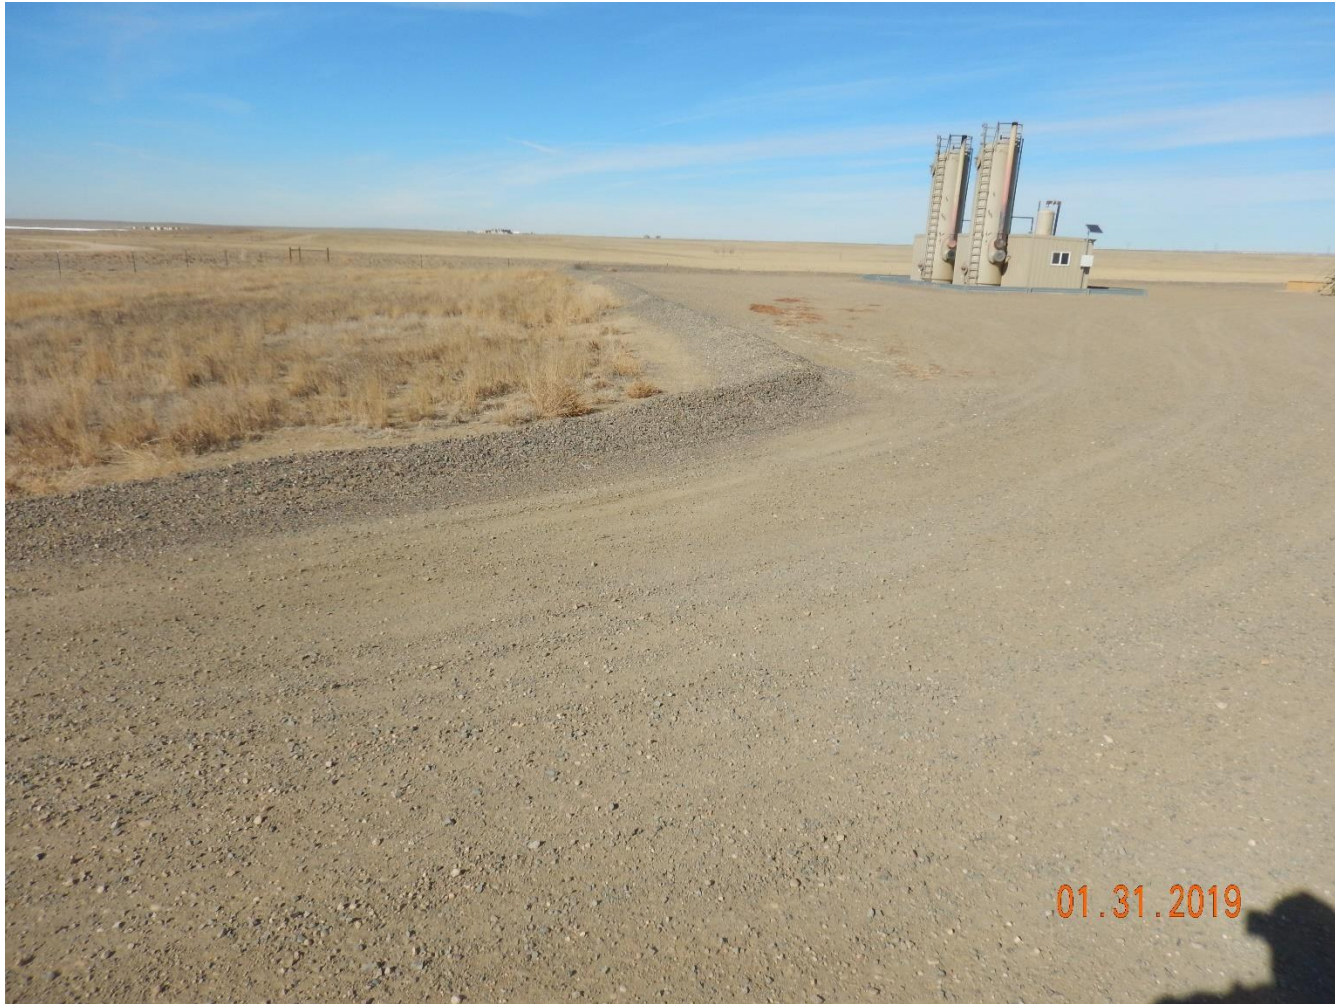
Photo 2: Photo taken from the south end of the location, facing west. Photos 2- 5 provide and overview of the location from west, northwest, northeast to east. Photos also show interim reclamation has not been conducted in accordance with COGCC rule 1003.

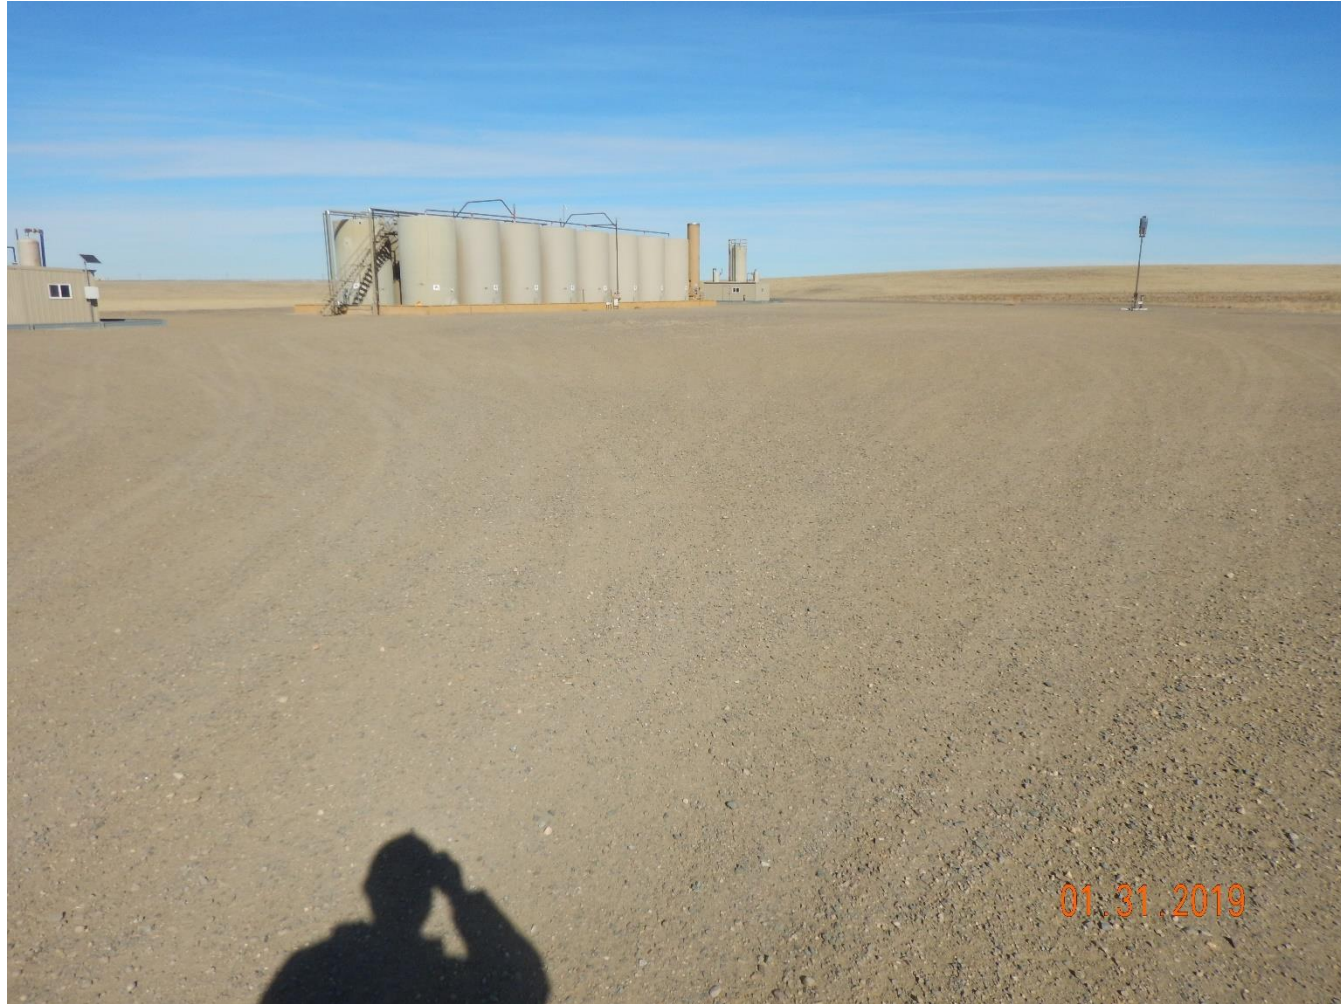
Photo 3: See comments under photo 2.

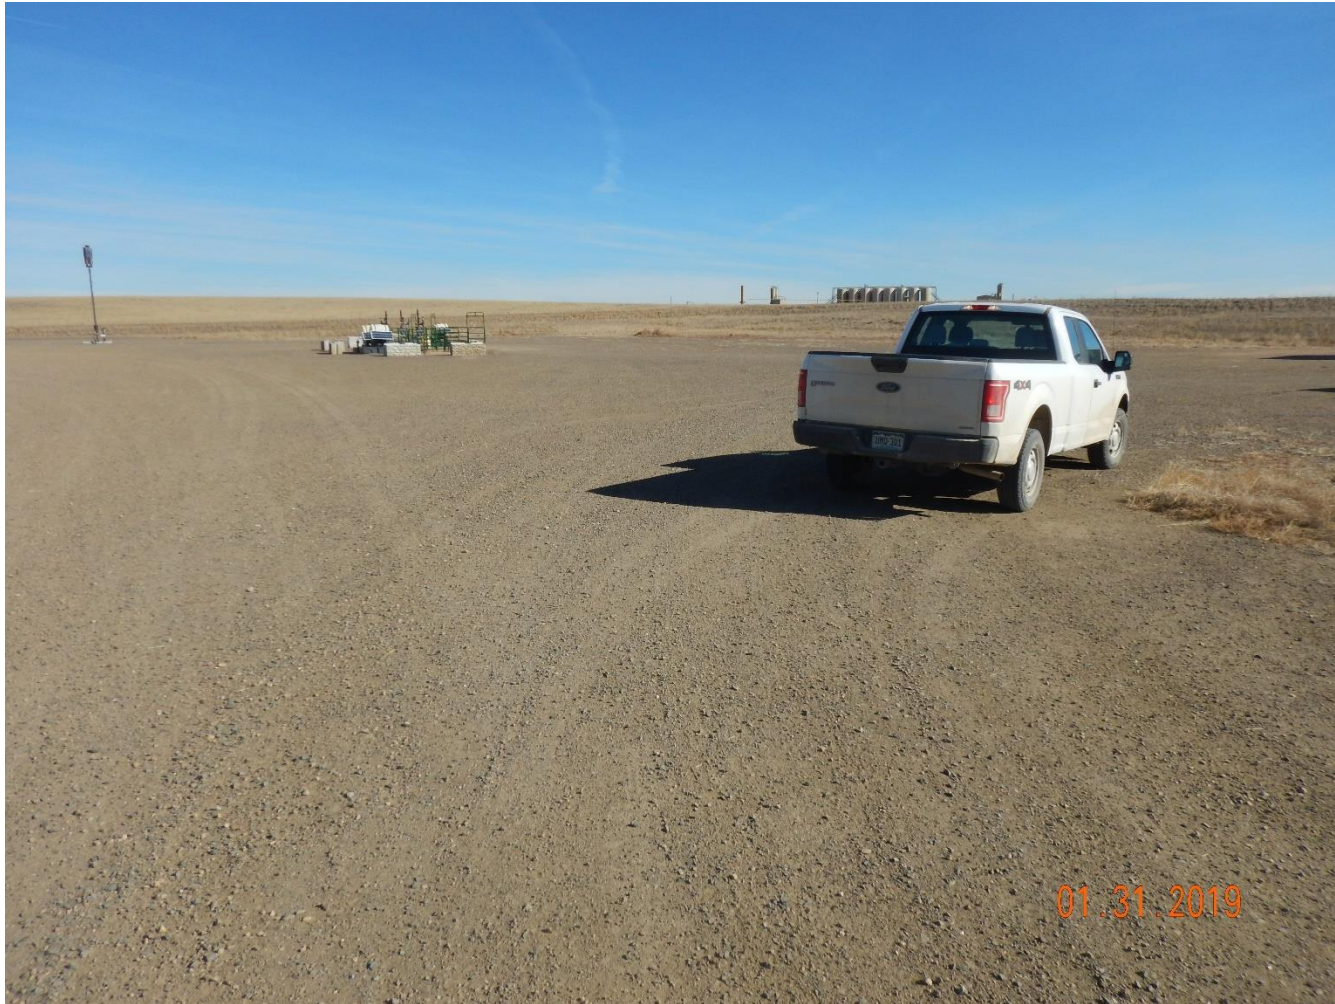
Photo 4: See comments under photo 2.

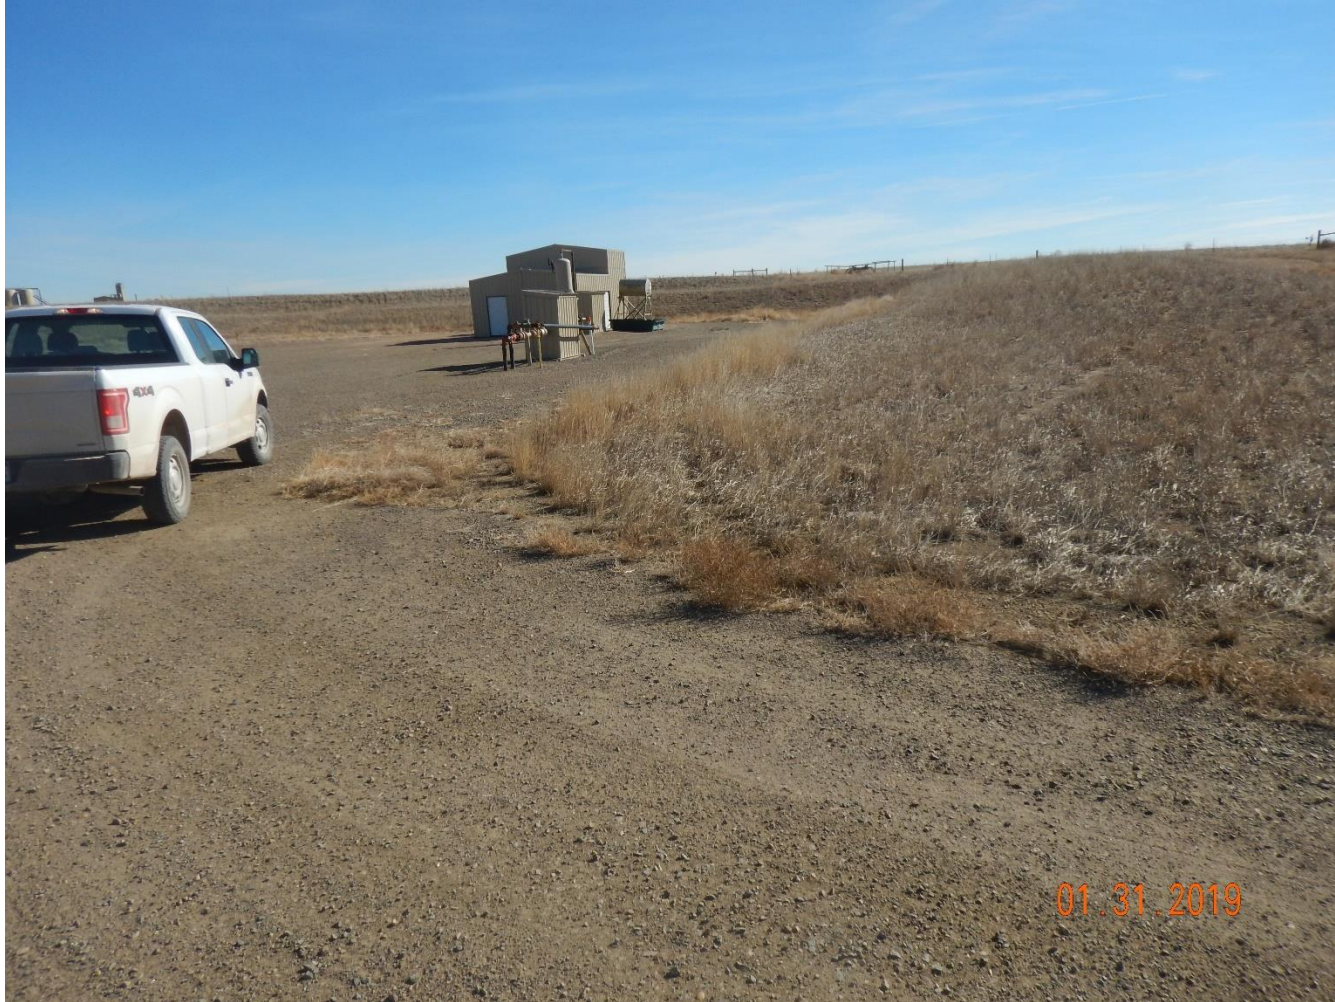
Photo 5: See comments under photo 2.

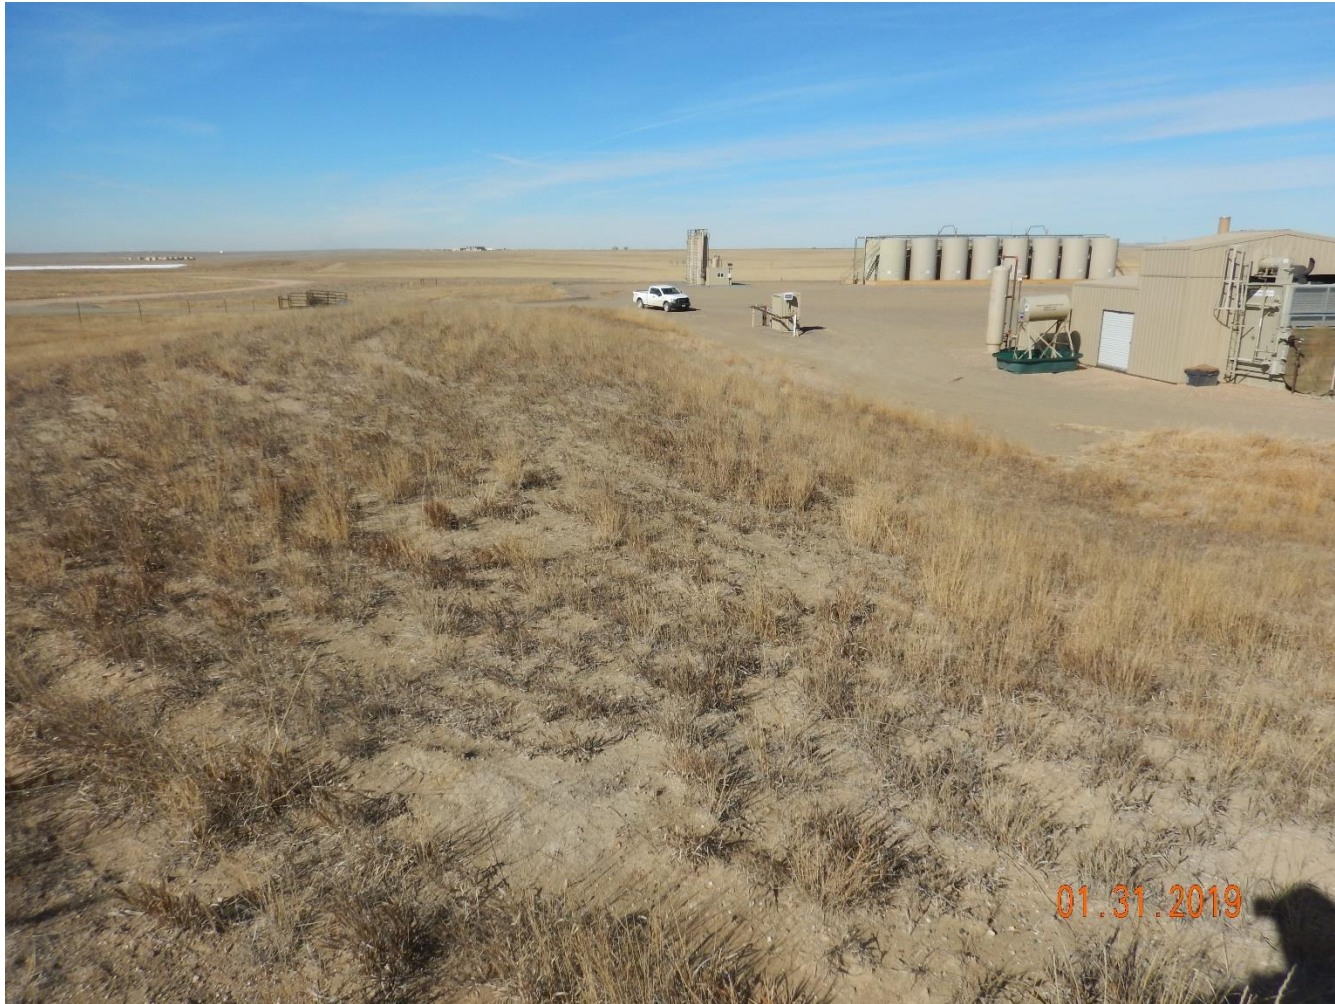
Photo 6: Photo taken from the southeast corner of the location, facing northwest. Photo shows interim reclamation has not been conducted in accordance with COGCC rule 1003

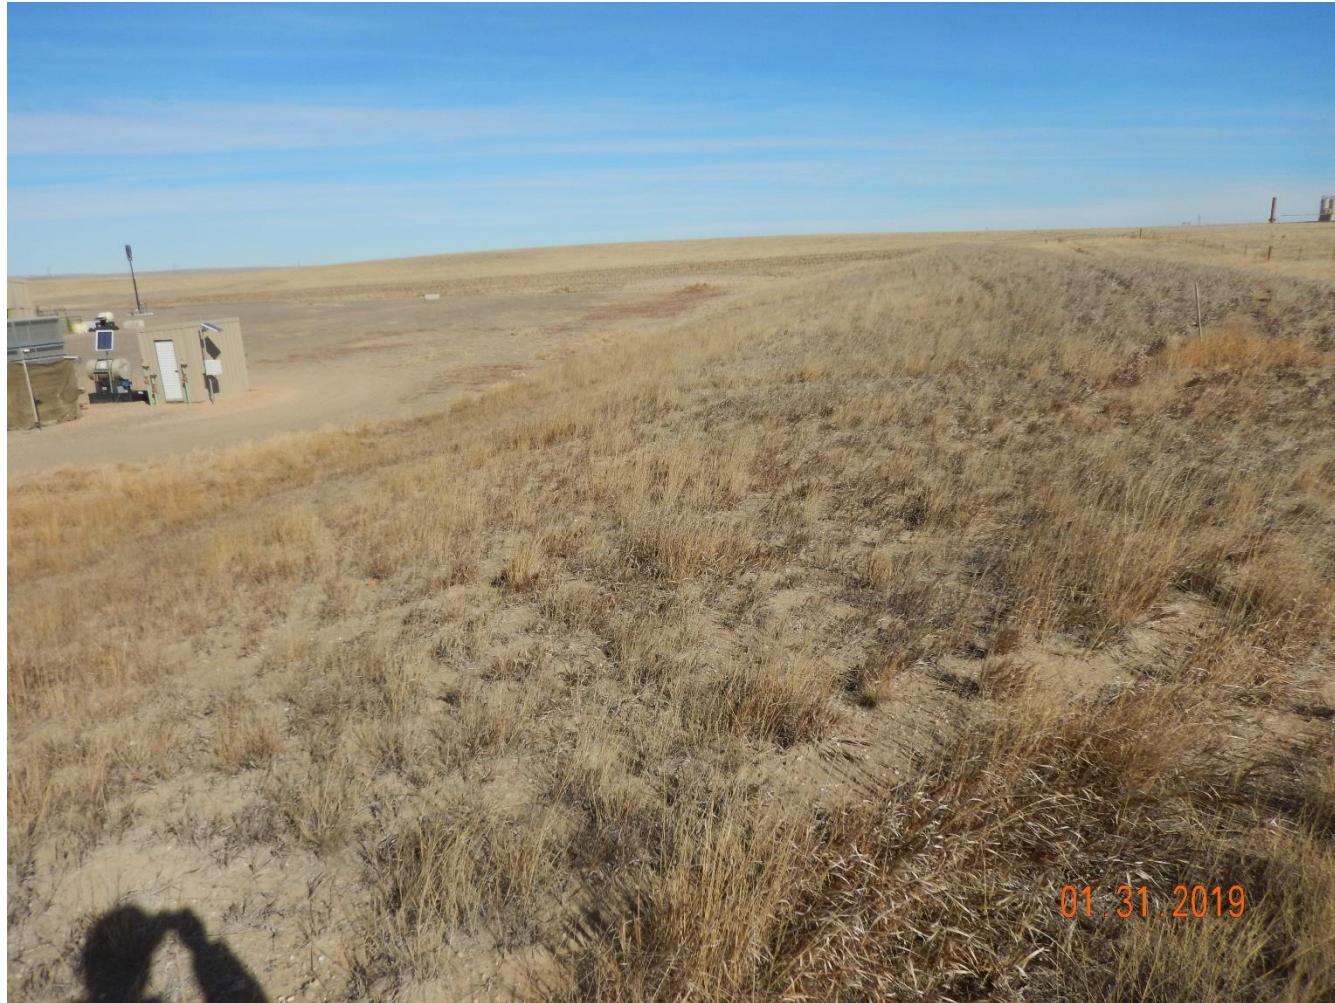
Photo 7: Photo taken from the southeast corner of the location, facing north. Photo shows interim reclamation has not been conducted in accordance with COGCC rule 1003

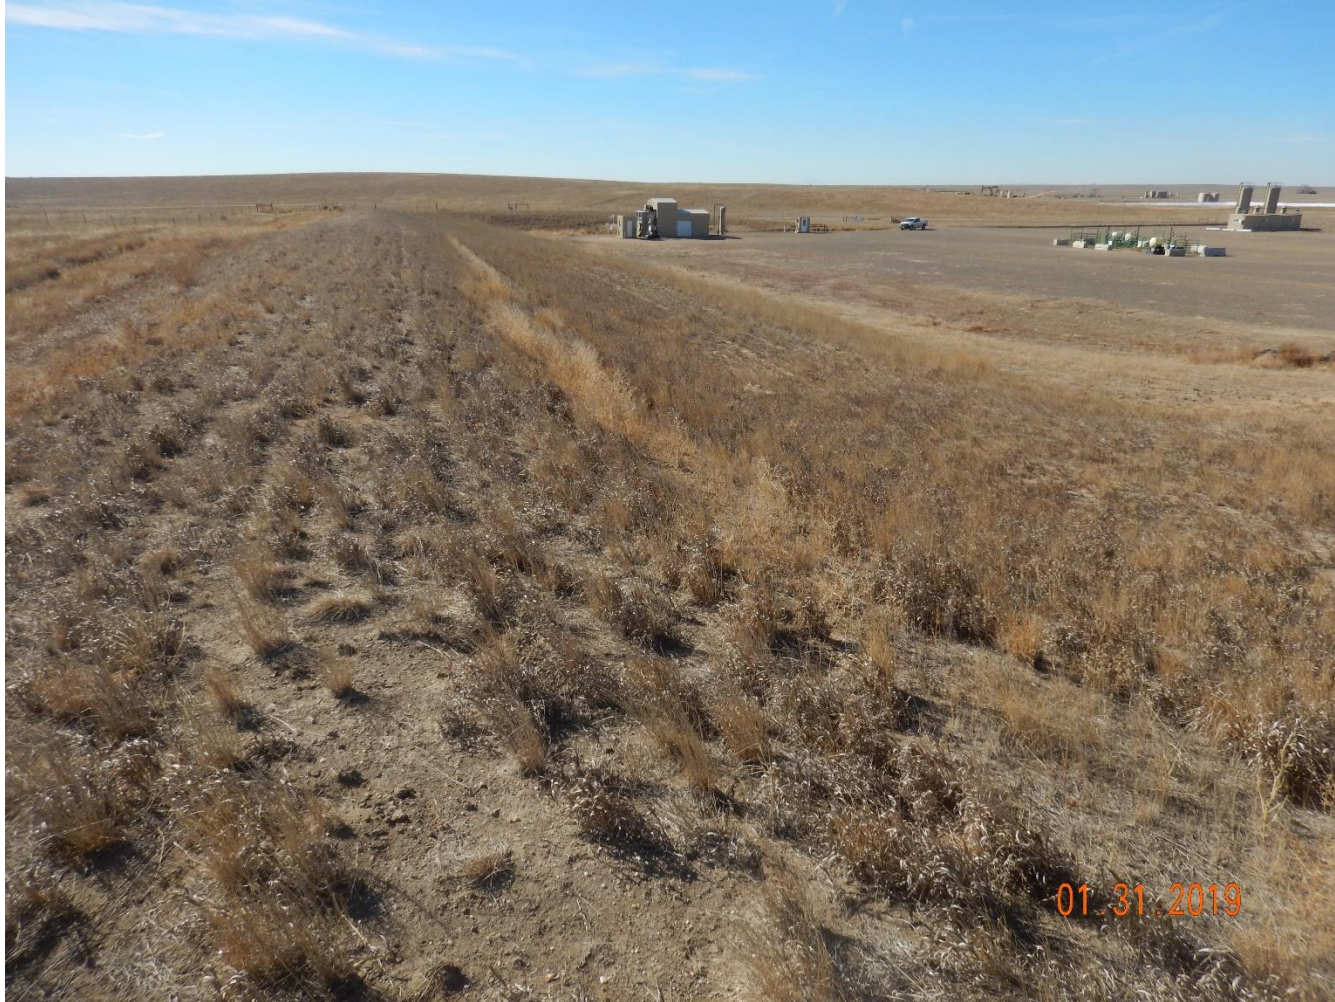
Photo 8: Photo taken from the northeast corner of the location, facing south. Photo shows interim reclamation has not been conducted in accordance with COGCC rule 1003

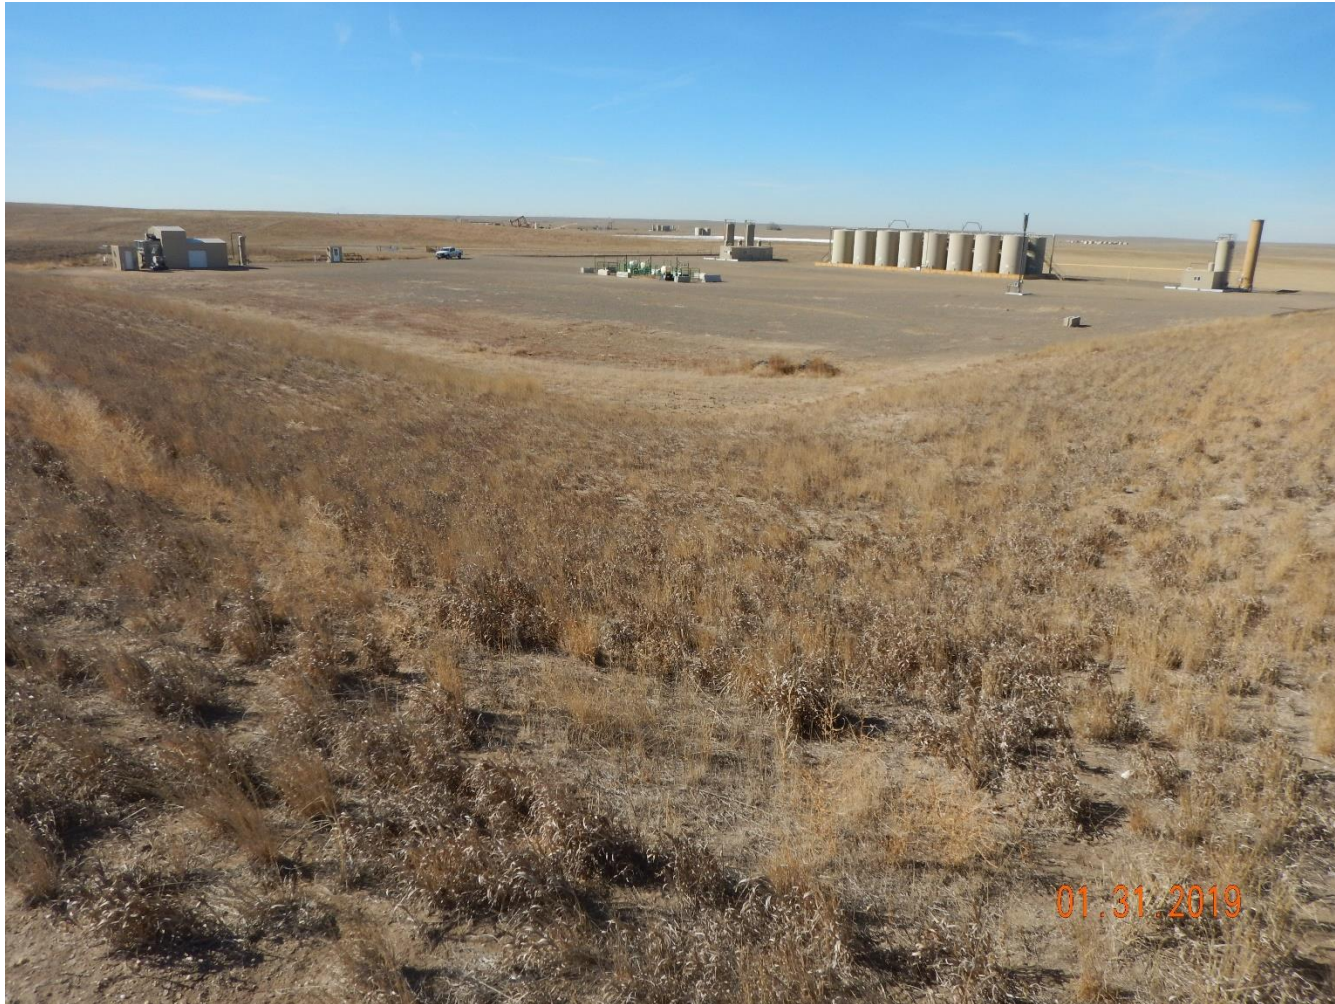
Photo 9: Photo taken from the northeast corner of the location, facing southwest. Photo shows interim reclamation has not been conducted in accordance with COGCC rule 1003

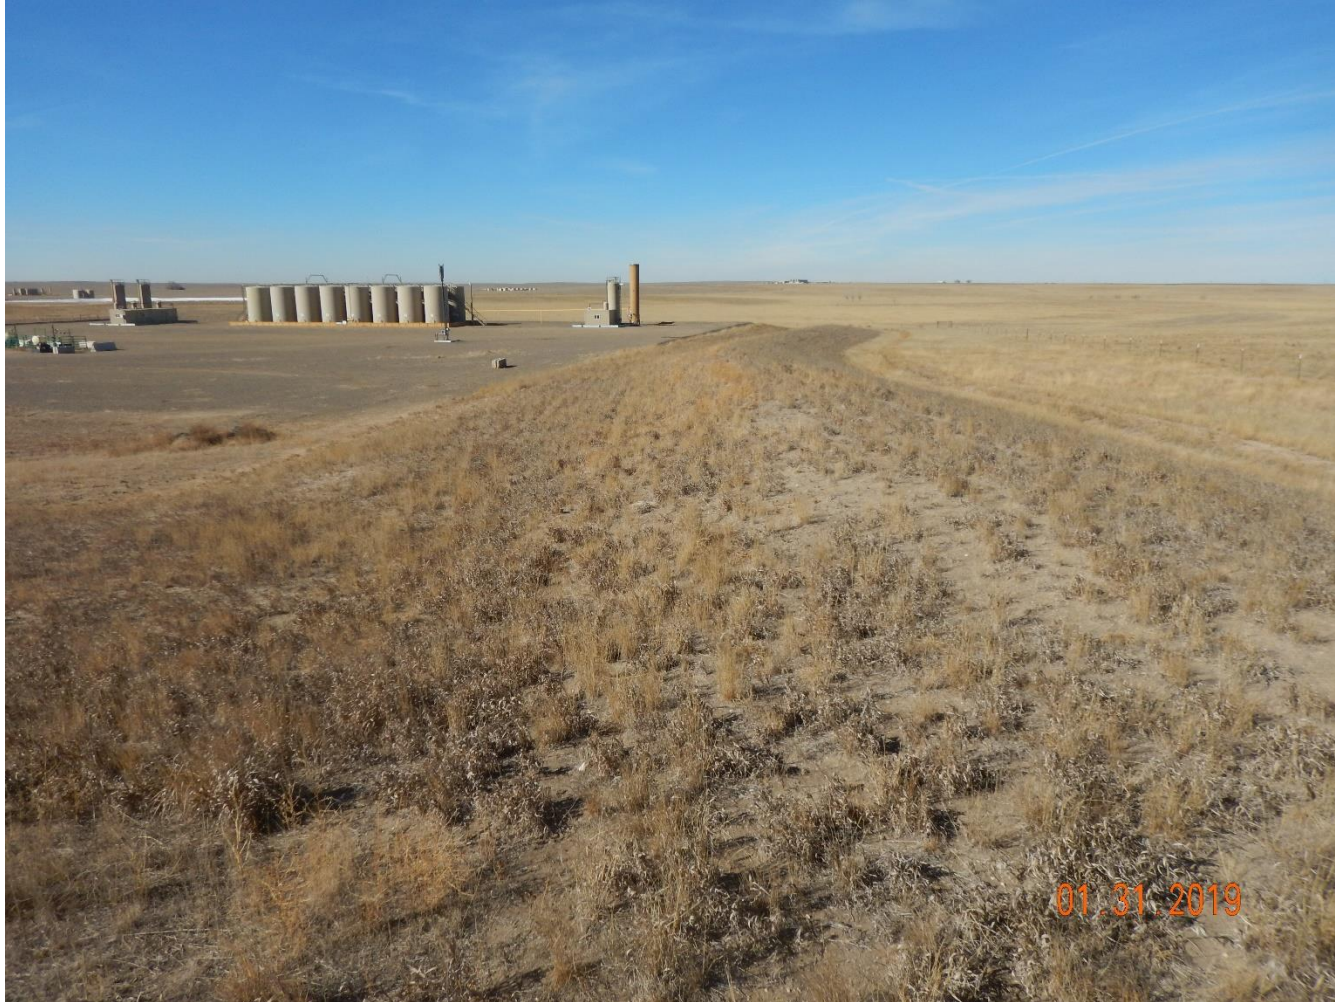
Photo 10: Photo taken from the northeast corner of the location, facing west. Photo shows interim reclamation has not been conducted in accordance with COGCC rule 1003
