Inspection Photos

Operator: FOUNDATION ENERGY
MANAGEMENT LLC - 10112

Location ID: 327492

Inspection Doc. Number: 682504488
Weld County, CO

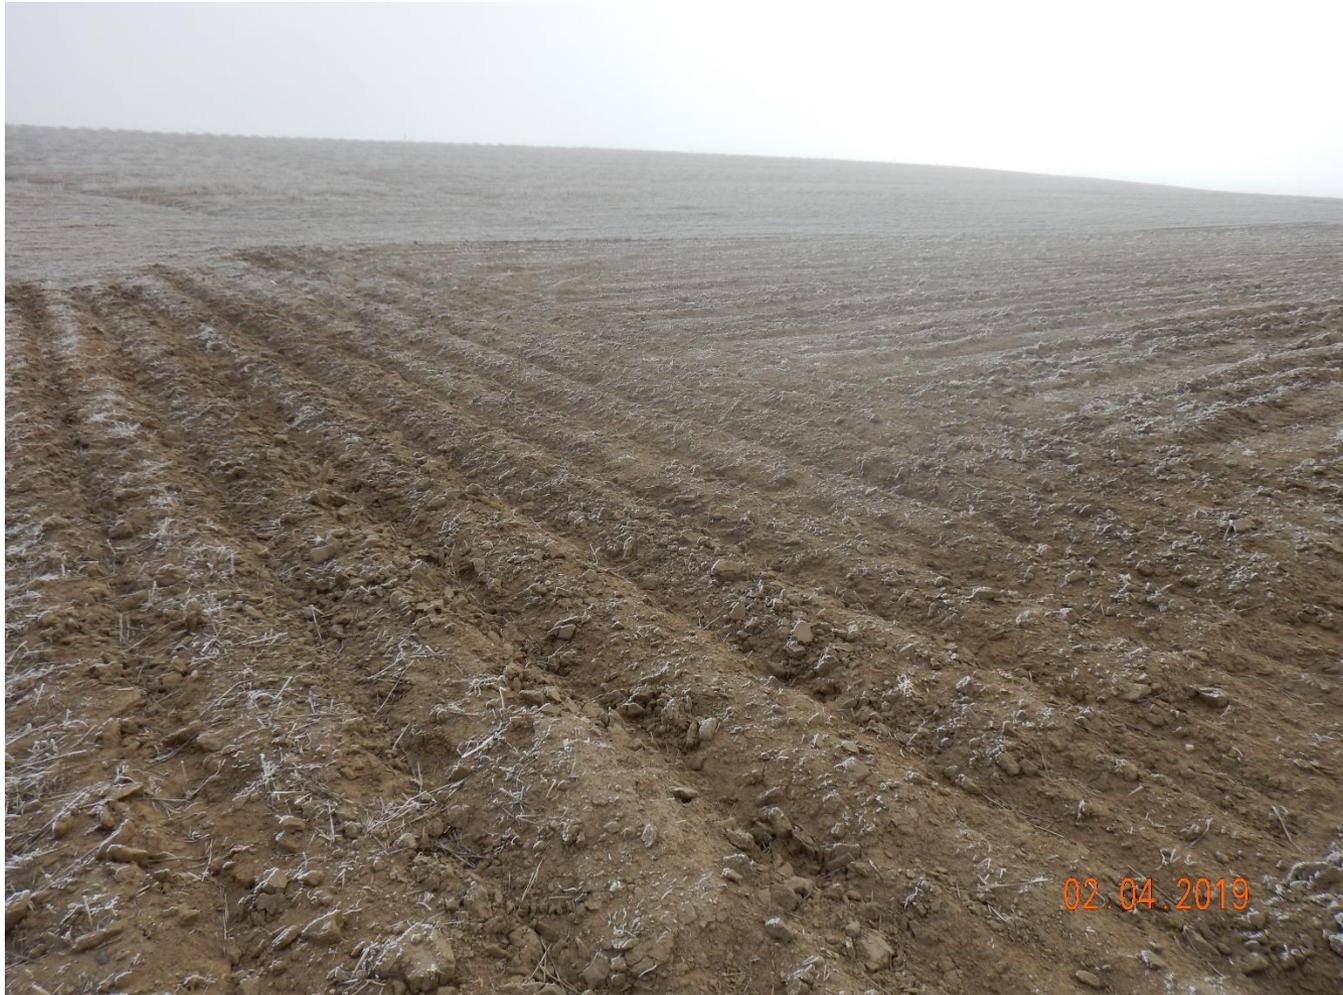
Photo 1: Photo taken from the north end of the location. Photos 1-3 provide an overview of the location from east, to south, to west. Previous inspections documented that compaction alleviation had not been conducted in accordance to reclamation requirements, and required operator to conduct reclamation in accordance to 1004. Photos show reclamation does not appear to have been conducted in accordance with 1000 reclamation requirements; 1004.a requires compaction alleviation to be conducted by cross-ripping to a depth of 18 inches. Location has not been cross-ripped.

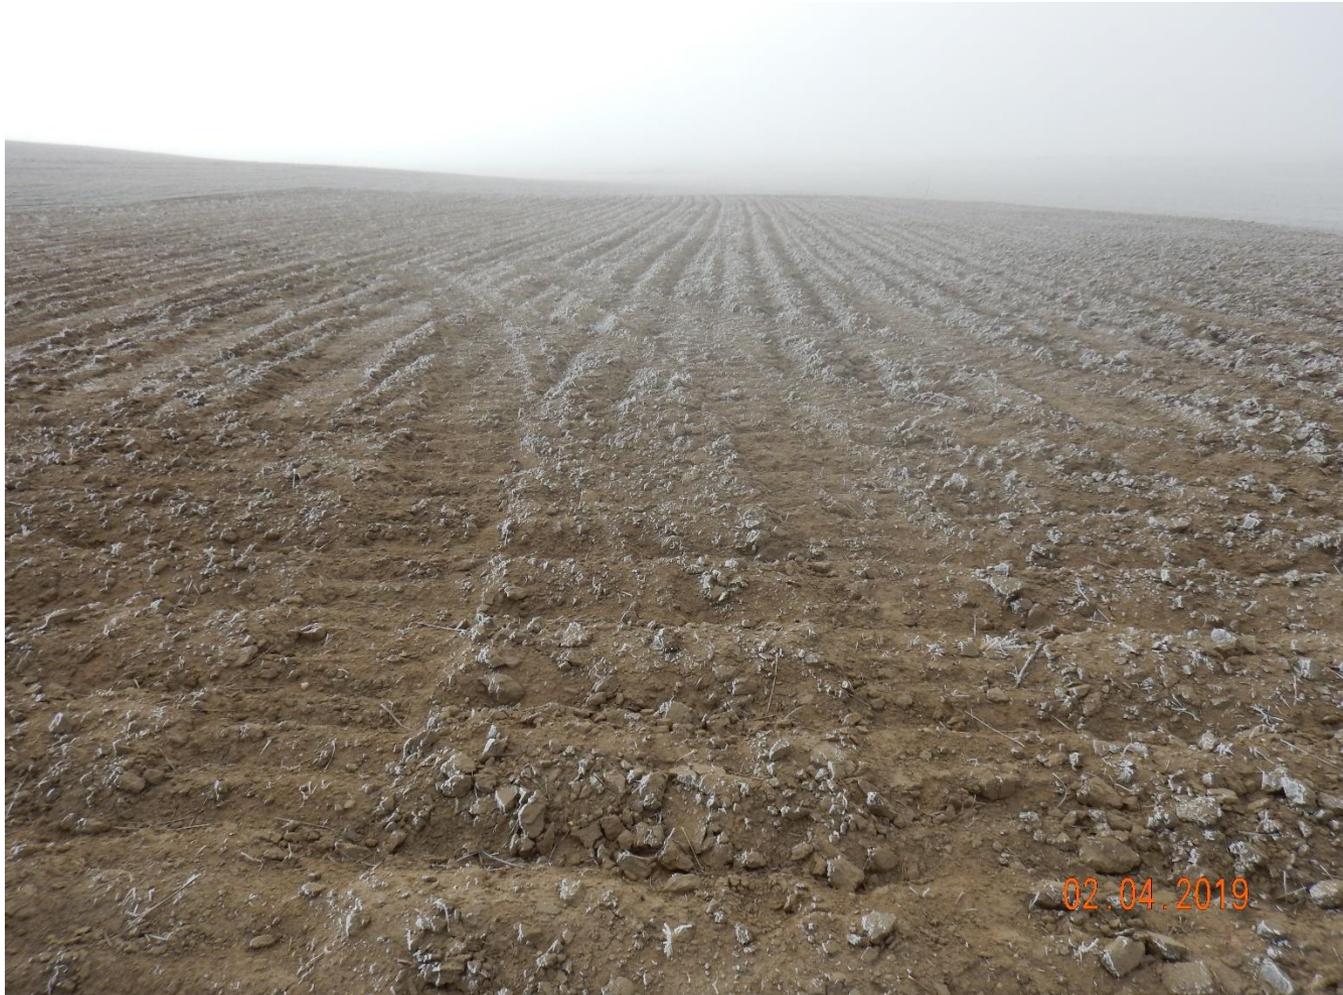
Photo 2: See comments under photo 1.

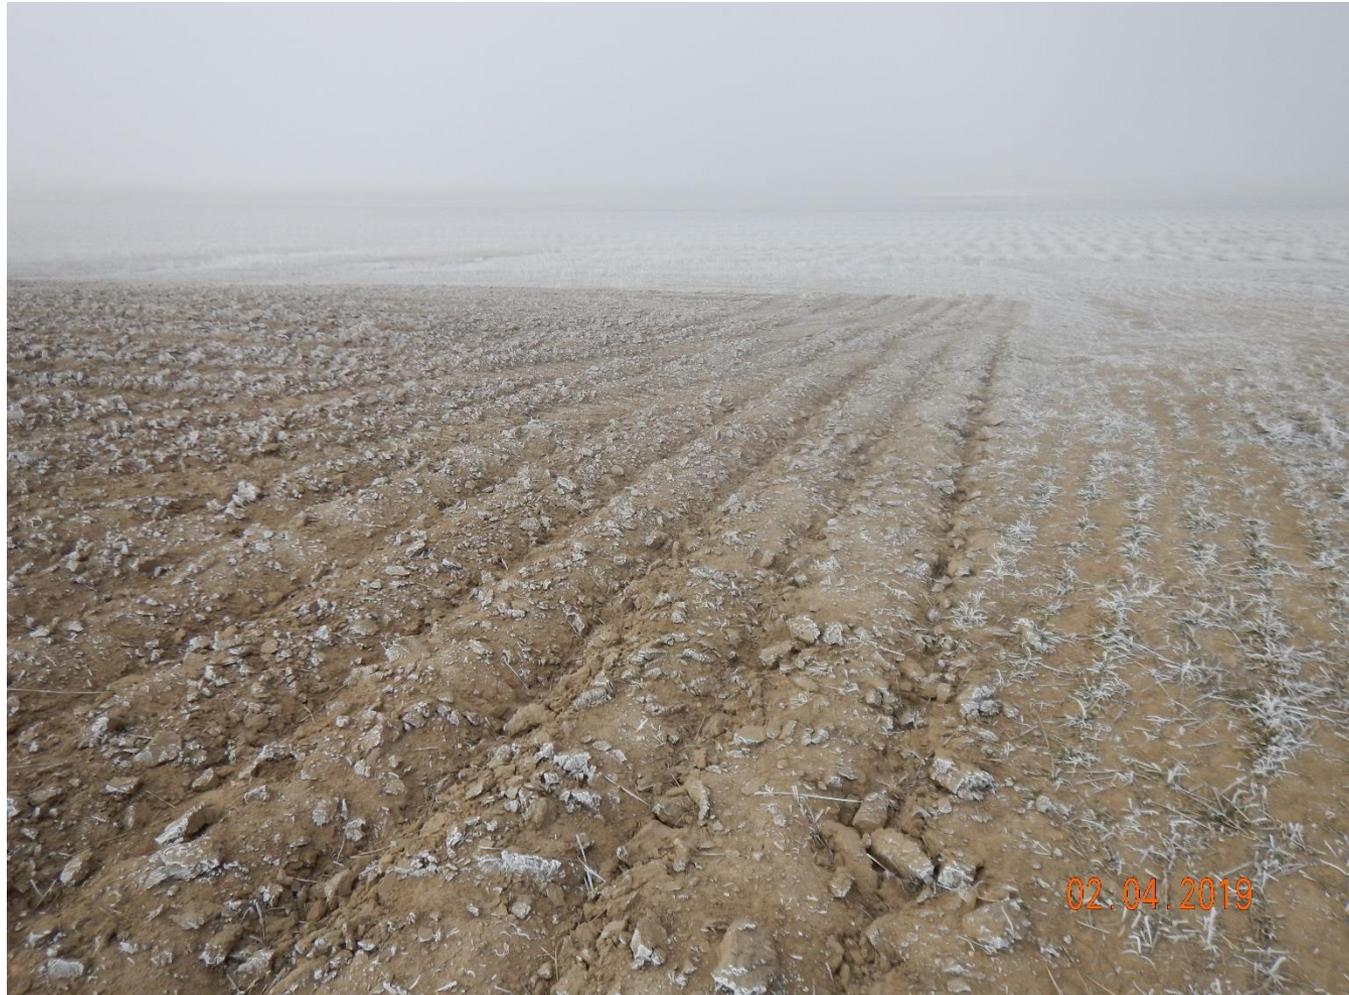
Photo 3: See comments under photo 1.

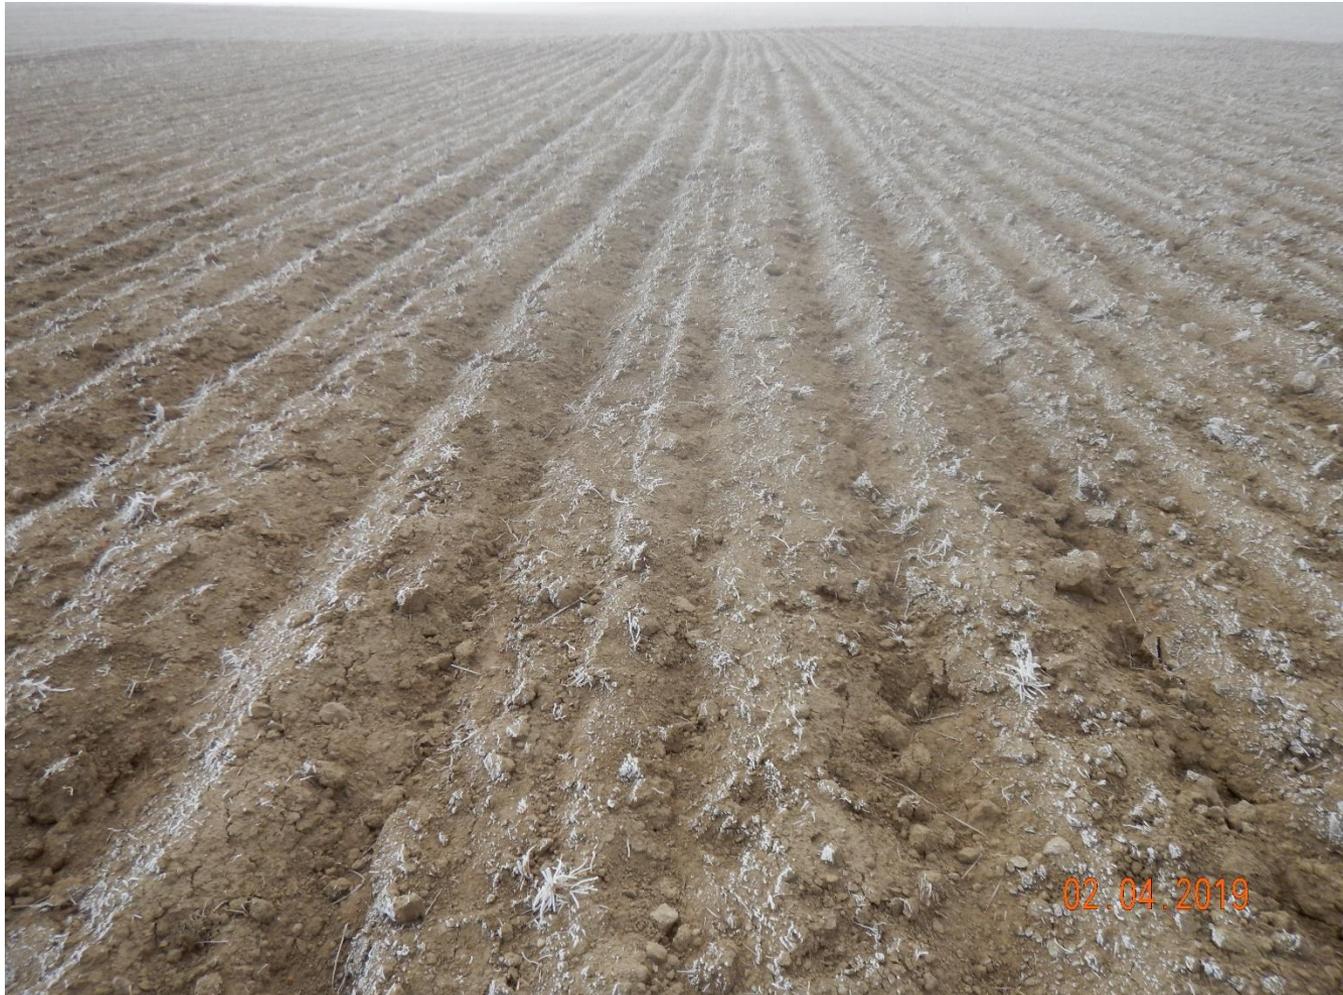
Photo 4: Photo taken from the location, facing south. Photo shows location appears to have been ripped in one direction. 1004.a requires compaction alleviation to be conducted by cross-ripping to a depth of 18 inches. Location has not been cross-ripped.

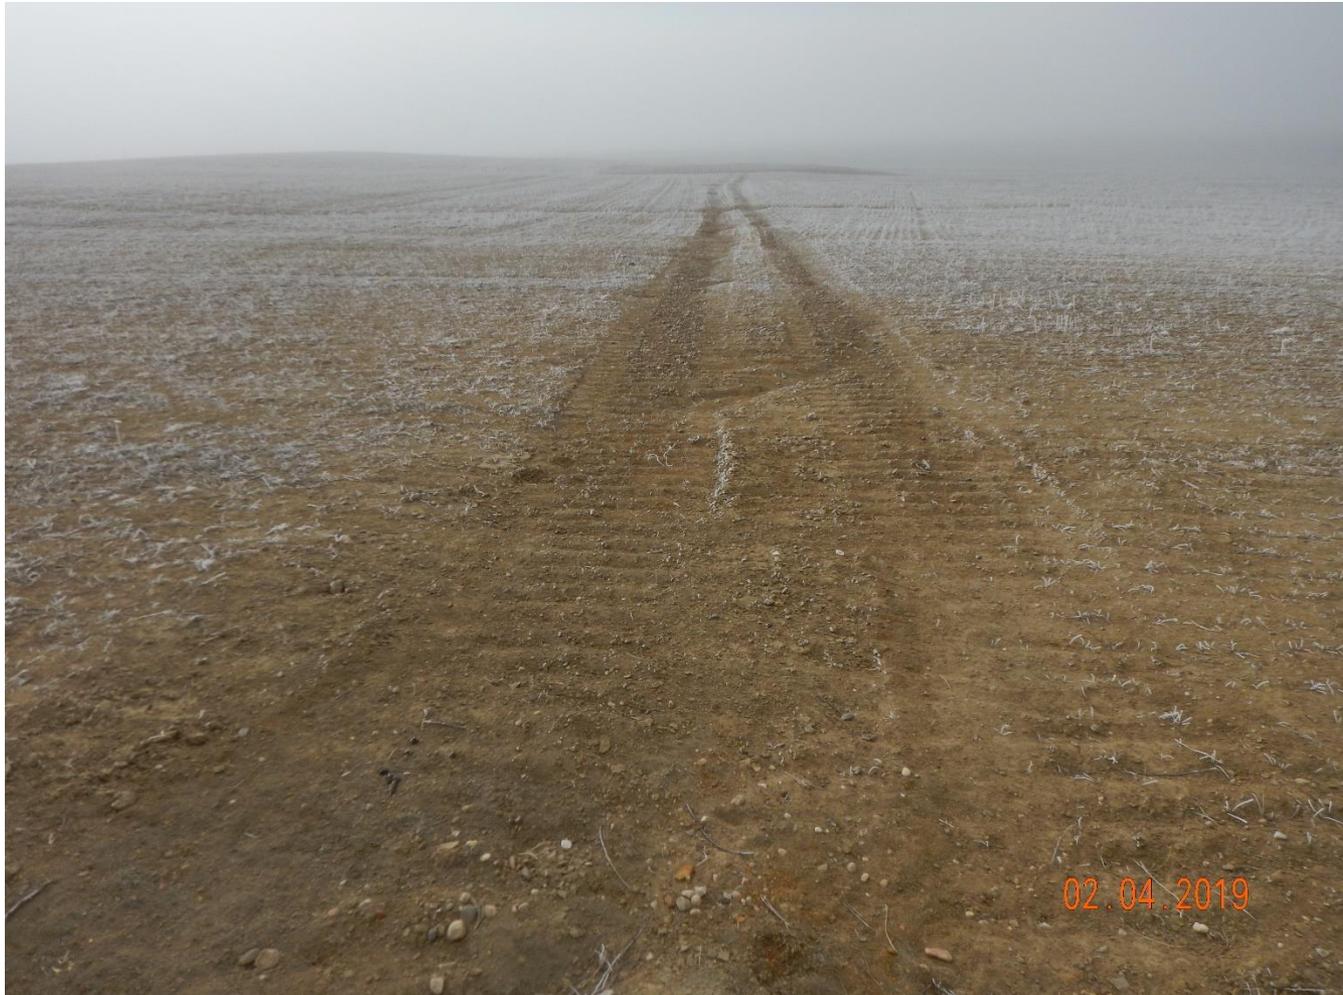
Photo 5: Photo taken from the access road, north of the location, facing south. Photo shows access road. Unable to find evidence that compaction alleviation has been conducted in accordance with 1004.a

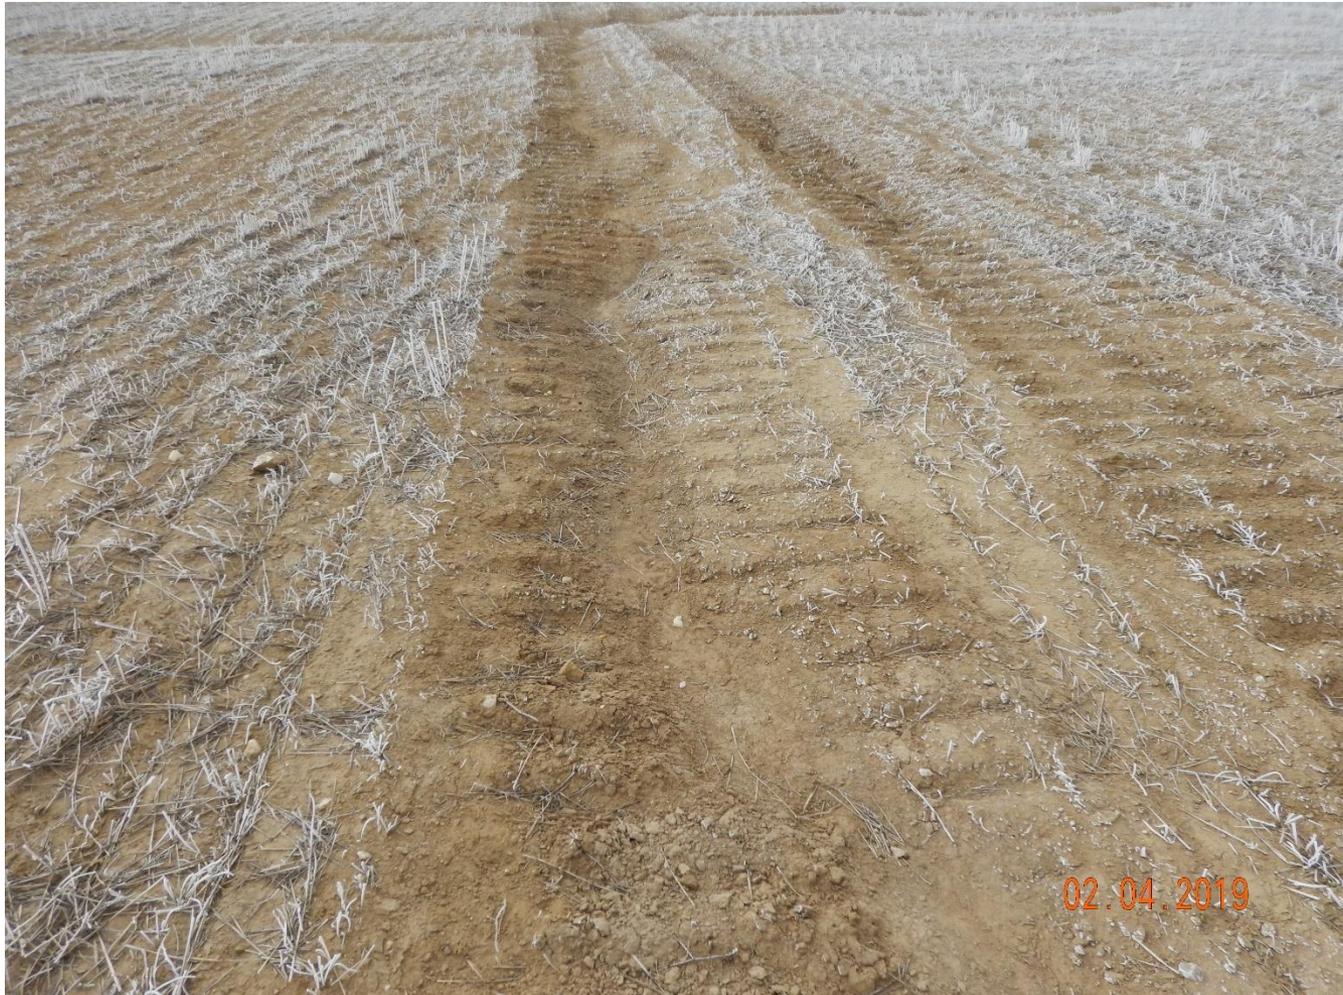
Photo 6: Photo taken from the access road, facing south. Previous inspection documented erosion degradation on road and required operator to repair erosion and conduct reclamation in accordance with 1004.a. No additional reclamation activities appear to have been conducted; Access road also does not appear to have been re-contoured or re-graded and erosion degradation remains.
