# Inspection Photos

Operator: FOUNDATION ENERGY  
MANAGEMENT LLC - 10112

Location ID: 327573

Inspection Doc. Number: 682504492  
Weld County, CO

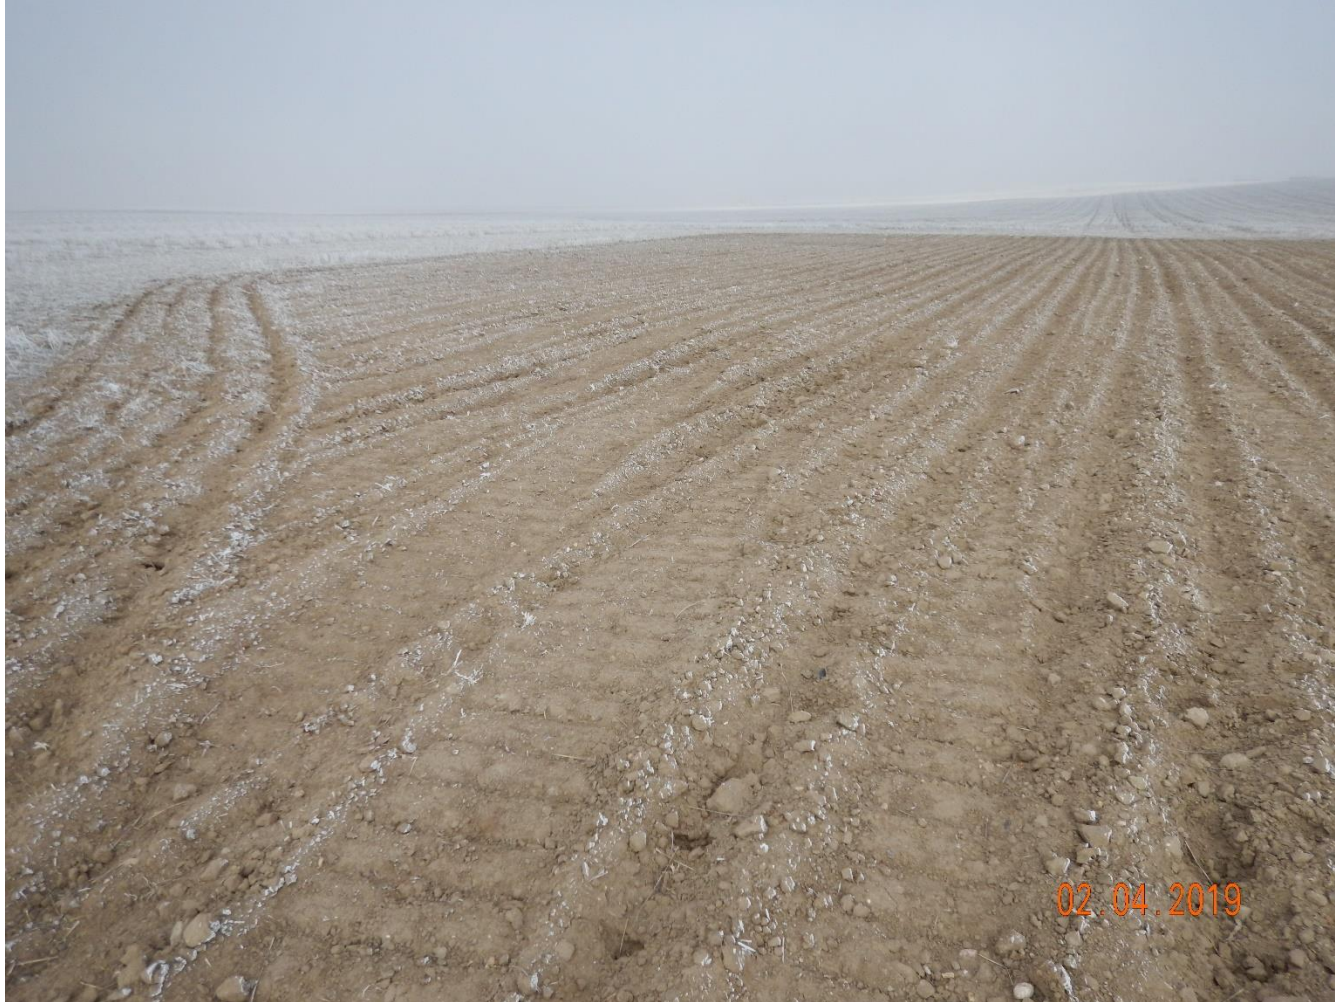
**Photo 1:** Photo taken from the south end of the battery location facing northwest. Previous inspection documented that location had not been cross-ripped in accordance to COGCC 1000 series rules. Photo shows location remains unchanged since previous inspection; compaction alleviation has not been conducted in accordance with reclamation requirements.

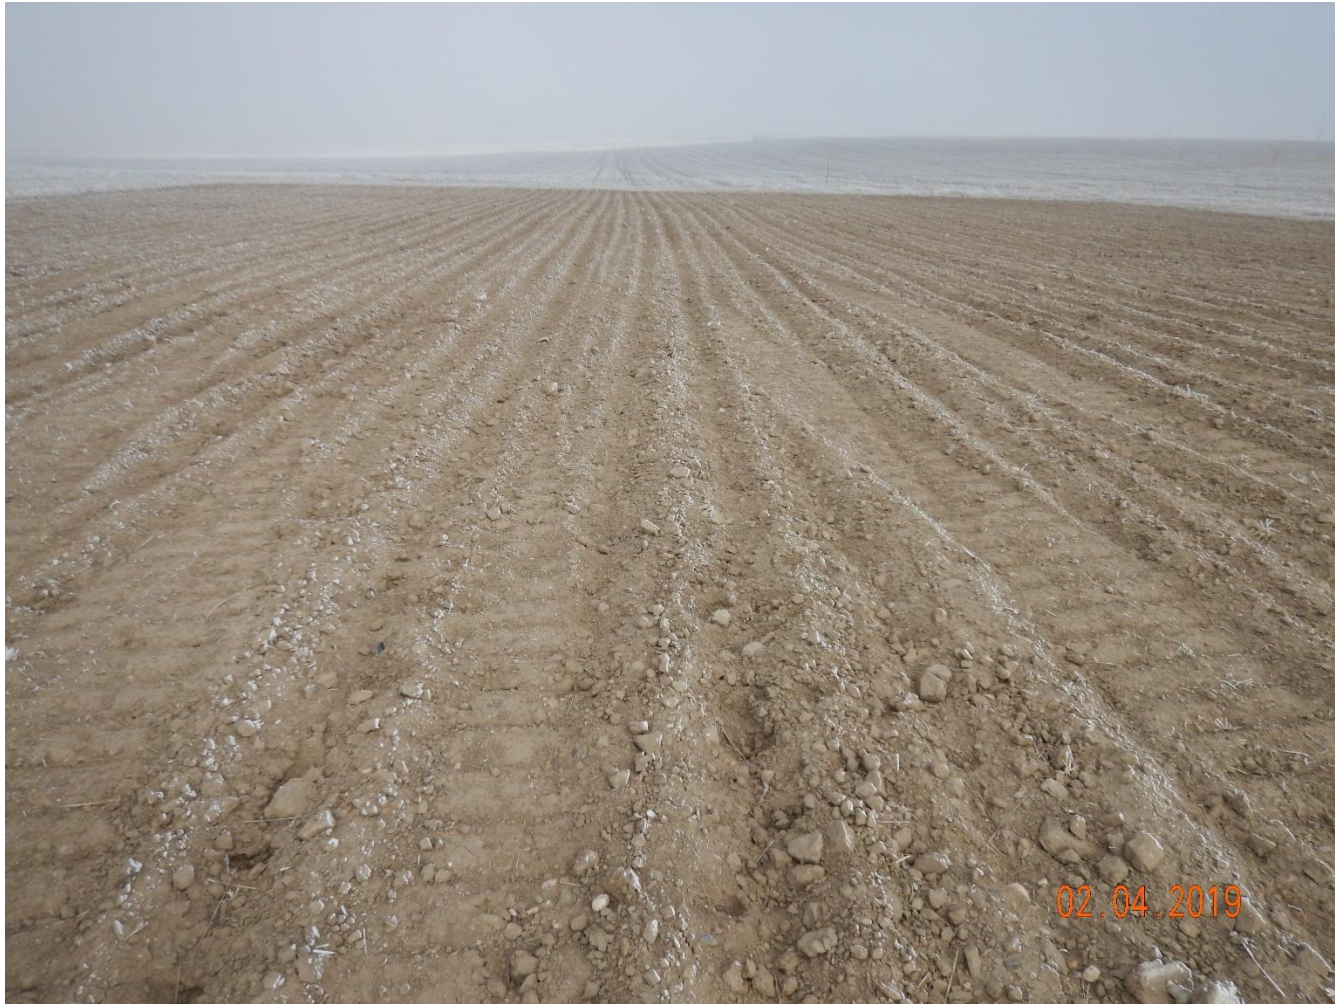
**Photo 2:** Photo taken from the south end of the battery location facing north. See comments under photo 1.

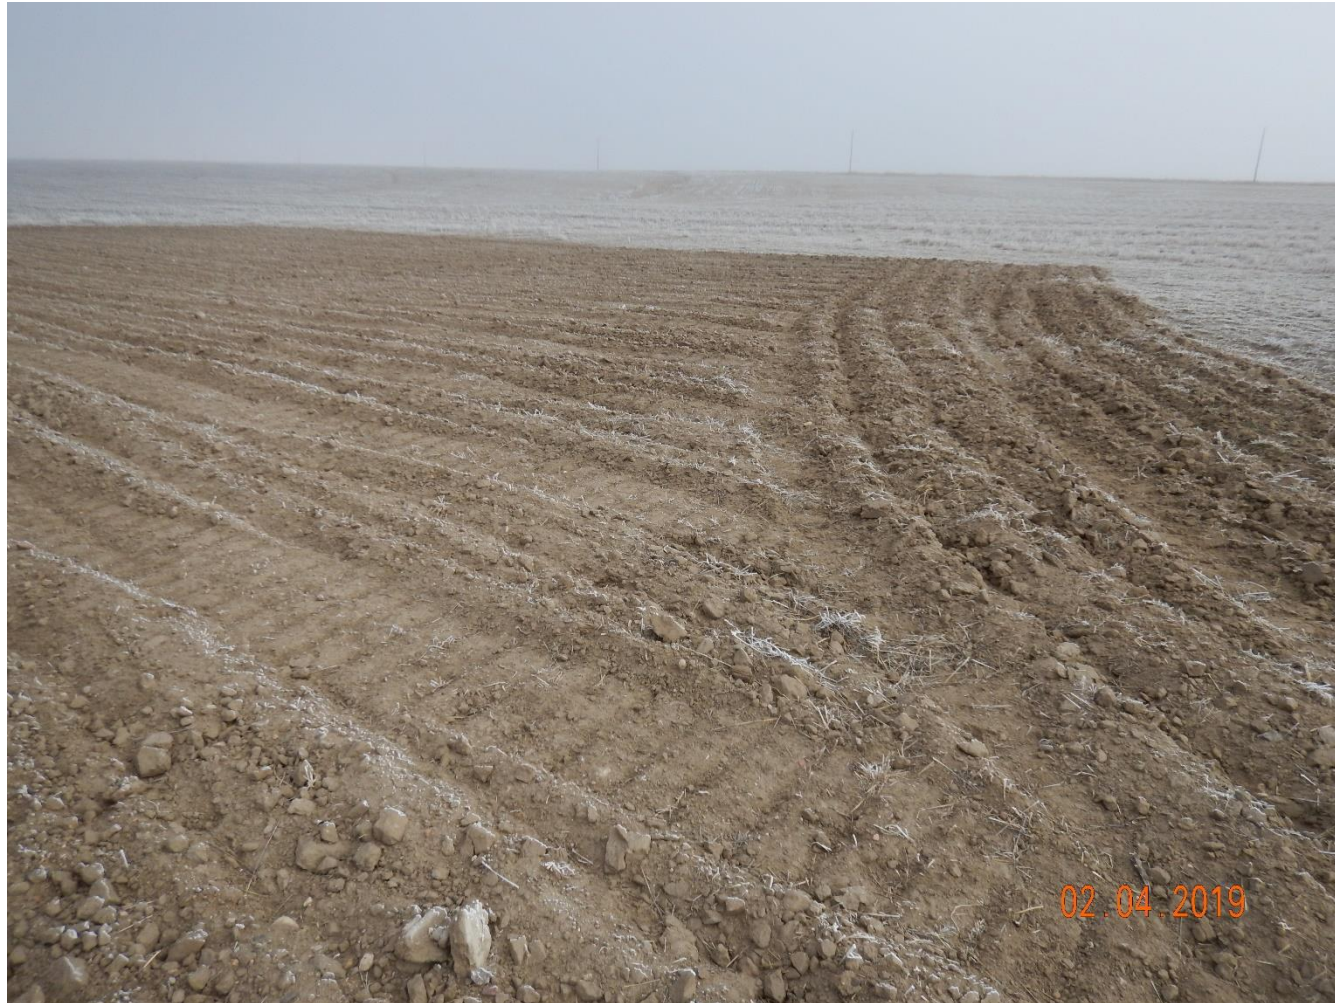
**Photo 3:** Photo taken from the south end of the battery location facing northeast. See comments under photo 1.

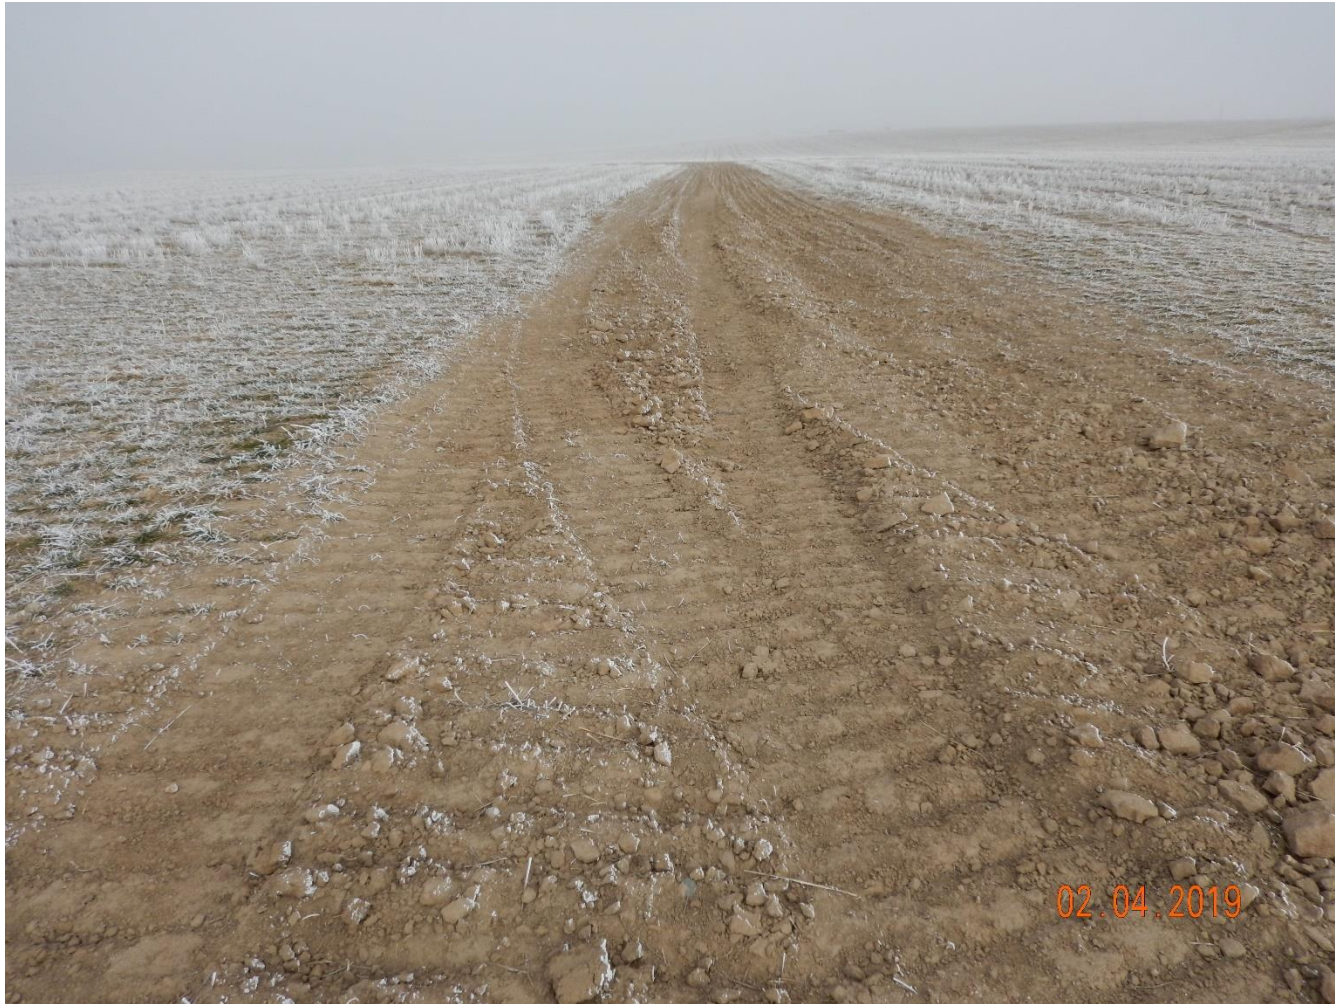
**Photo 4:** Photo taken from the access road, facing north. Access road appears unchanged since previous inspection; Unable to find evidence that compaction alleviation has been conducted in accordance with 1004.a on access road.
