Williams 16" Pipeline Spill Status Update – January 21, 2019.

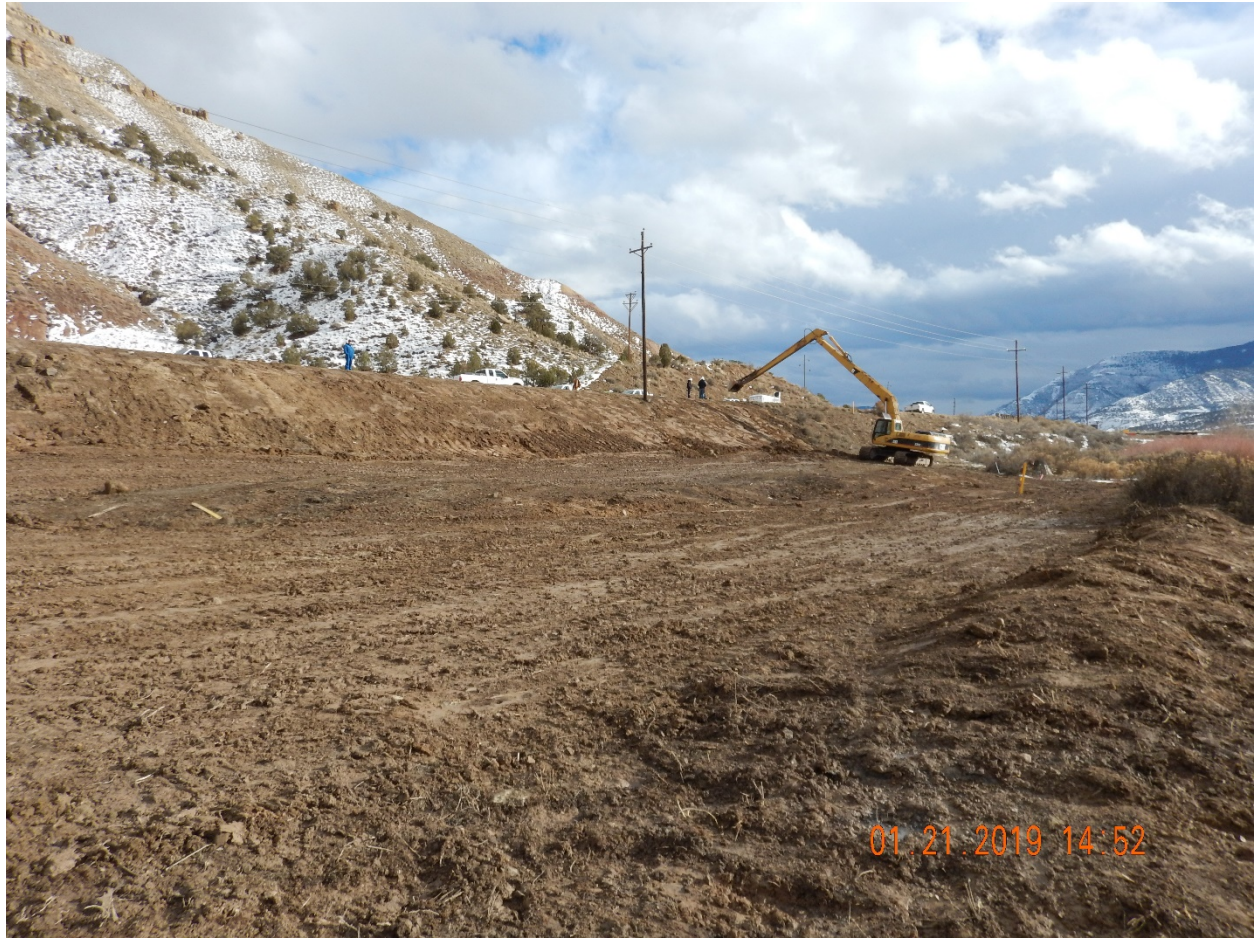
01.21.2019 14:52

- Operator continued scraping areas with surface impacts resulting from fluids sprayed from pipeline. An excavator was utilized to scrape surface impacts from slope leading to Co Rd 215. Photo below.

*Excavator scraping surface impacts along slope leading to Co Rd 215 (looking south)*

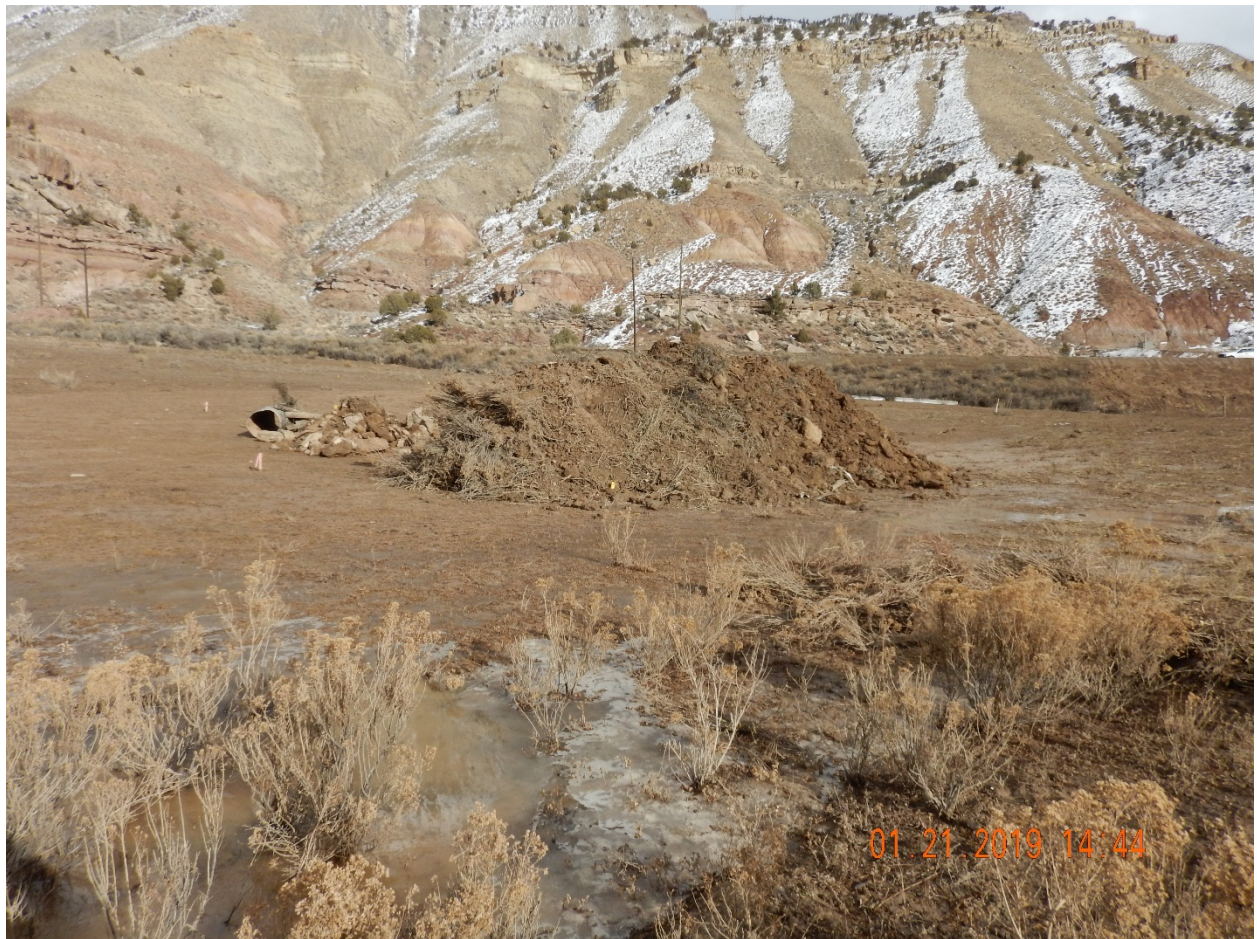
- Impacted soil east of irrigation ditch was being stockpiled in an area ~300' north of pipeline excavation (East Stockpile). This stockpile did not have a downgradient earthen berm constructed at the time of my field visit (2:15 PM), but the operator did express plans to construct the berm today. Photo below.

*View of East Stockpile (looking east)*

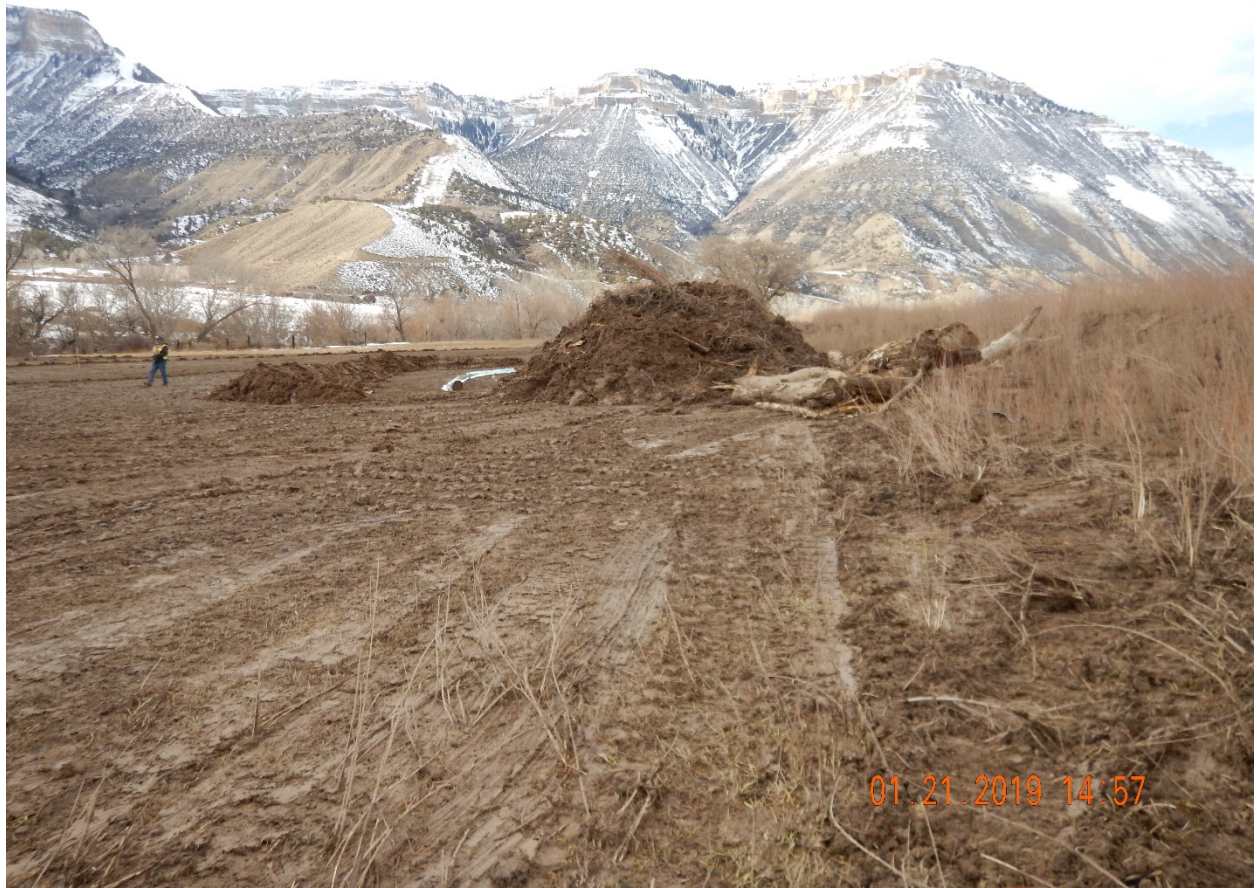
- Impacted soil west of irrigation ditch was being stockpiled in area ~150' WNW of pipeline excavation (West Stockpile).
- Operator had constructed earthen berm and absorbent boom downgradient from this stockpile to contain stormwater runoff. Photo below.

*View of West Stockpile (looking north) with absorbent boom and earthen berm*
