## January 18, 2019 Field Photos

Location Name: Bargath 16" Pipeline Release

Spill/Release ID #460855

Inspection Dates: January 18, 2019 – January 28, 2019

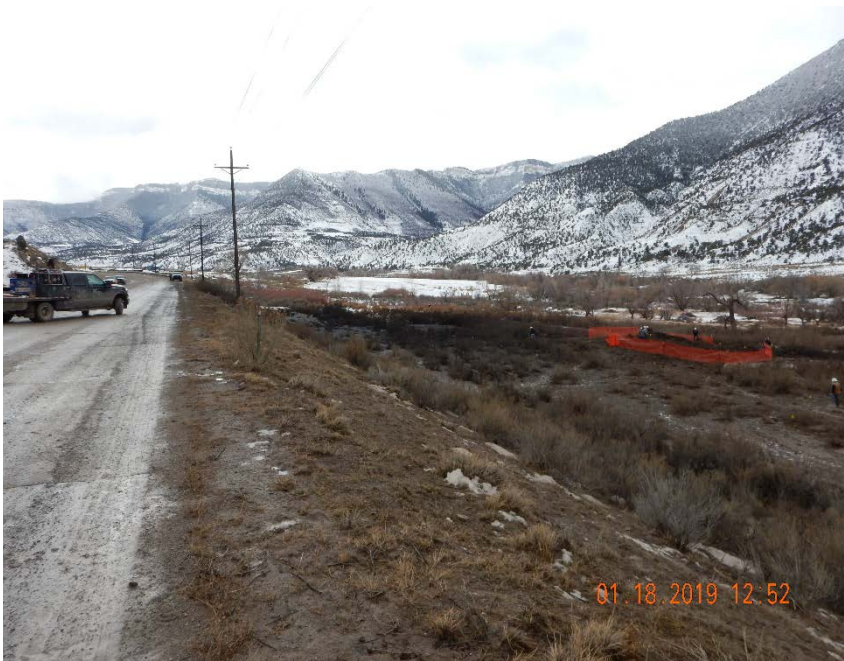
**Photo #1 – Overview of flowline excavation and area impacted by condensate spray from west side of Co Rd 215 (looking southwest).**

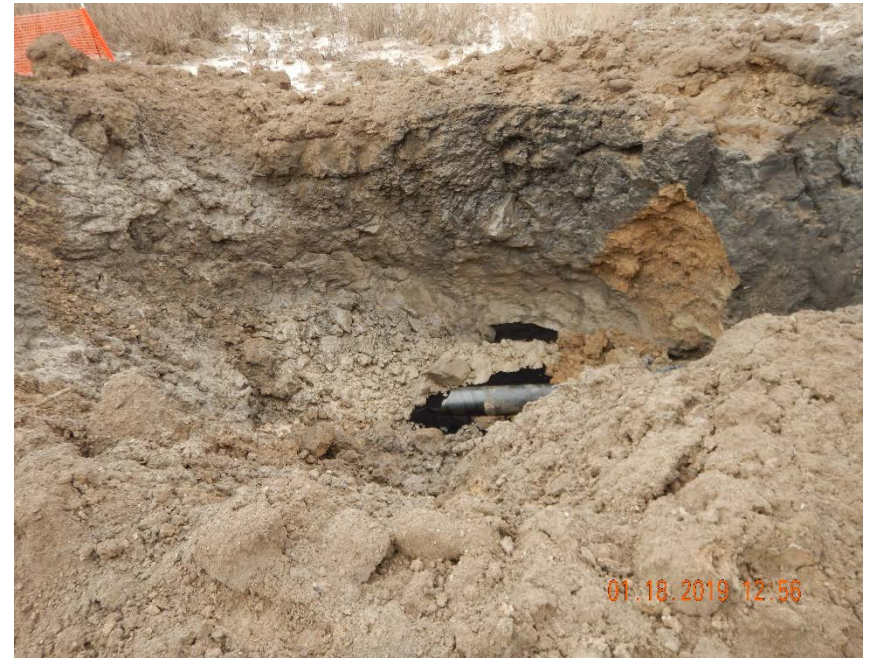
**Photo #2 – View into pipeline excavation from east side. Note exposed 16" pipeline and condensate present in base of excavation.**

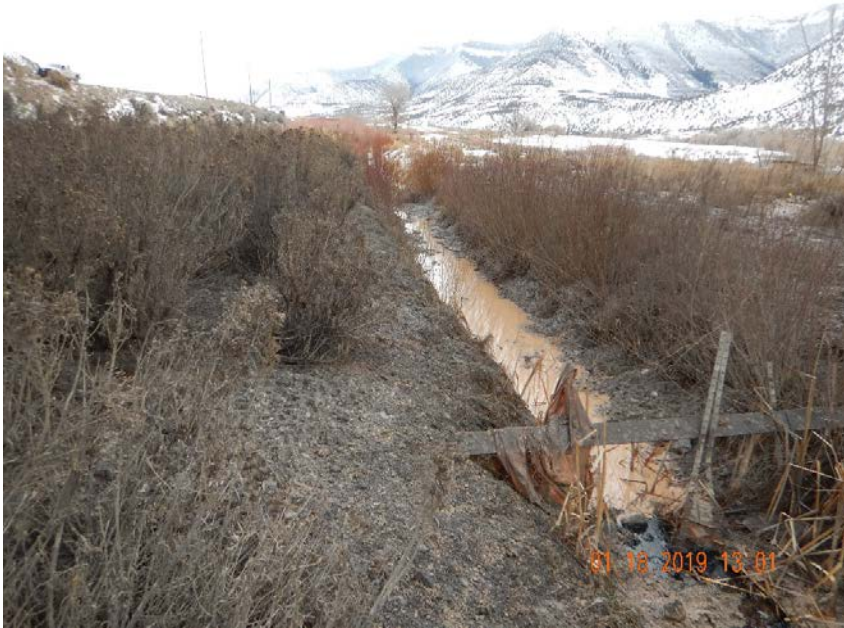
**Photo #3 – Visible hydrocarbon impacts along irrigation ditch southeast of pipeline excavation. Note that soil and vegetation on either side of ditch were sprayed by condensate by Spill/Release ID #460855.**

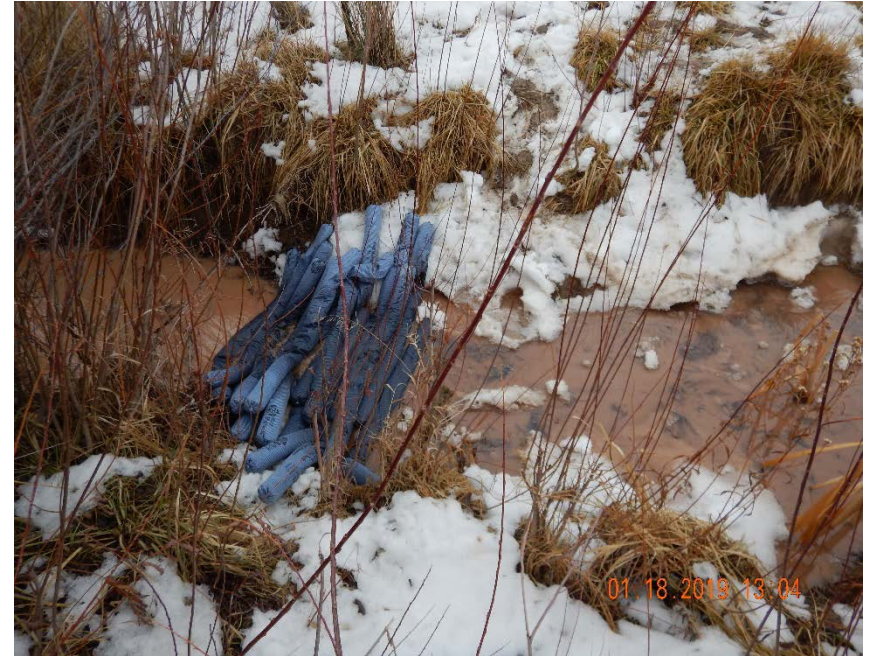
**Photo #4 – Absorbent booms had been installed inside of irrigation ditch from previous photo along a fenceline located approximately 300' southeast of pipeline excavation.**

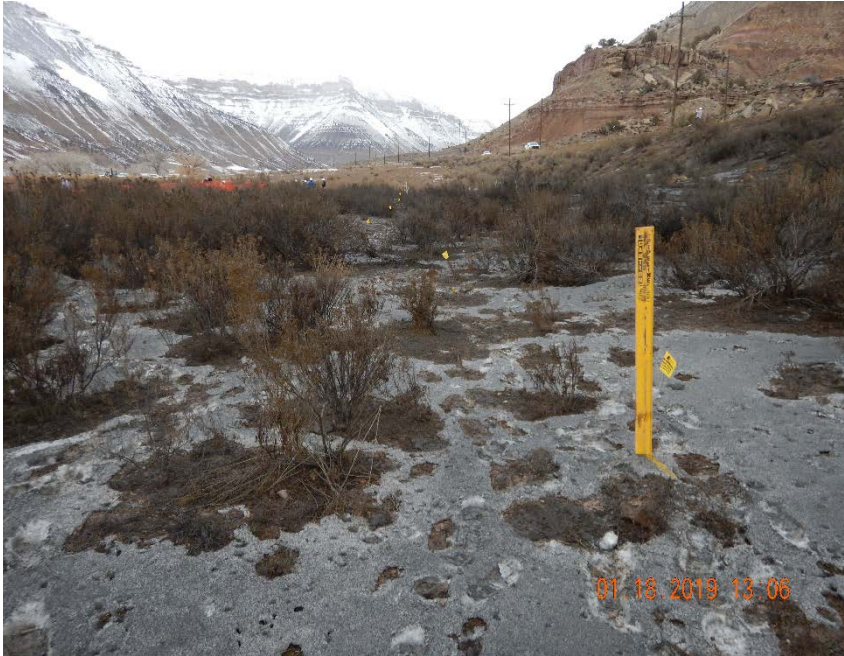
**Photo #5 – Hydrocarbon-impacted snow, vegetation, and soil located southeast of pipeline excavation.**

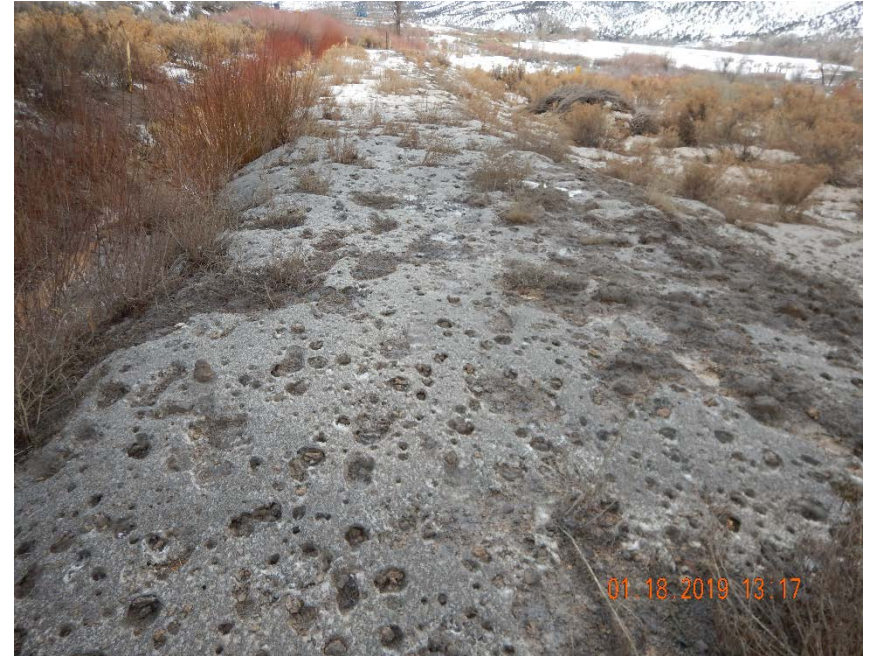
**Photo #6 - Hydrocarbon-impacted snow, vegetation, and soil located southwest of pipeline excavation.**

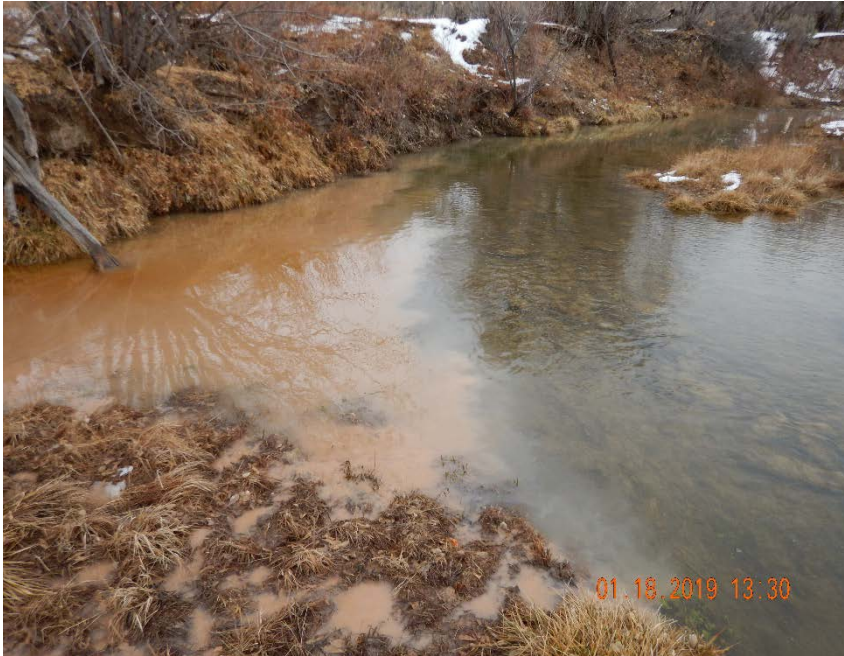
**Photo #7 – Confluence area of surface-water runoff and Parachute Creek, located ~670' southwest of pipeline excavation. Note that hydrocarbon odors and a hydrocarbon sheen on surface water were observed in this location.**

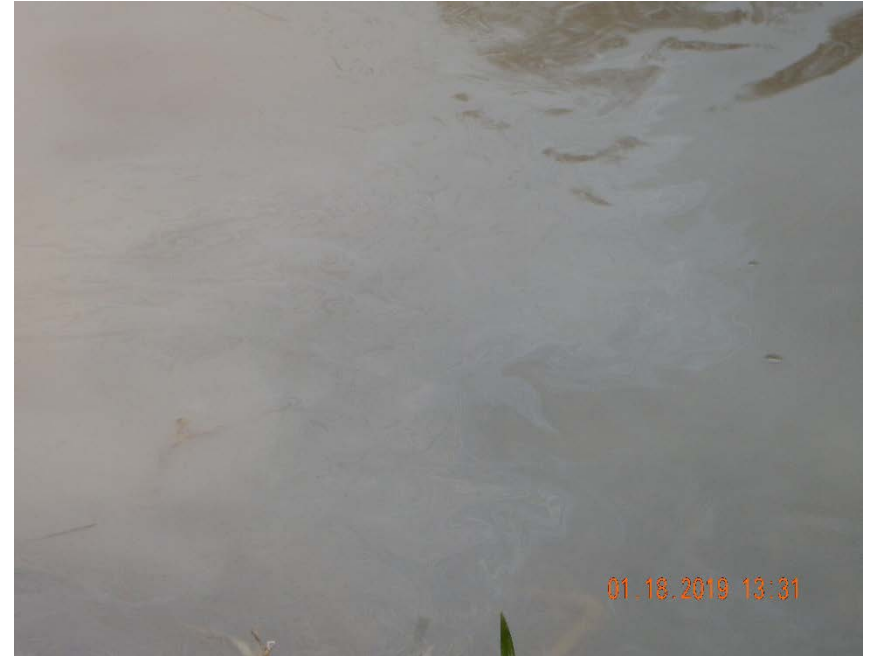
**Photo #8 – Close up shot of hydrocarbon sheen observed in confluence area from previous photo.**
