Construction and Storm Water Inspection

February 13, 2019

Operator: CRESTONE PEAK RESOURCES OPERATING LLC – 10633

Location ID: 451044

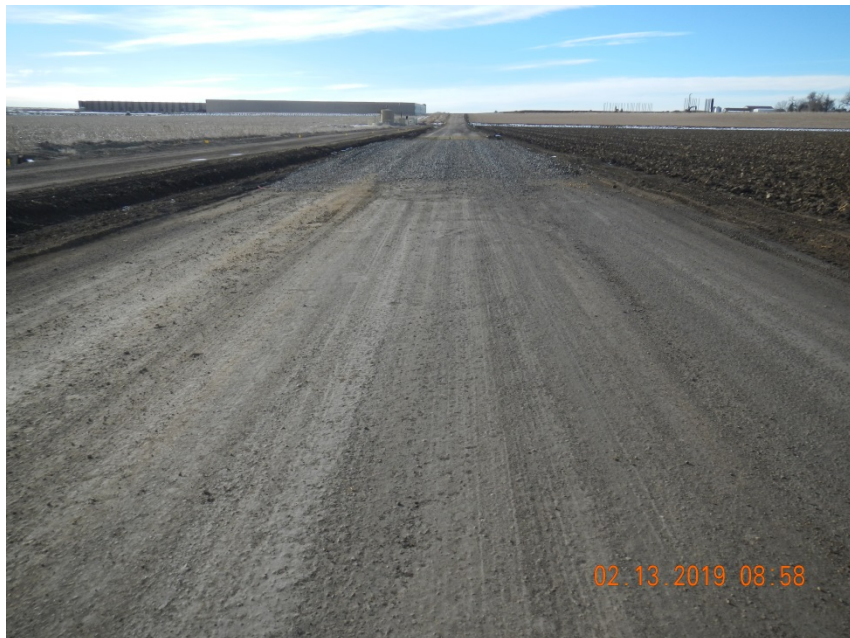
Photo 1. Photo taken from the access road near the entrance of the location off CR 20.5, facing South. Operator has installed a track pad and gravel potentially to limit tracking onto the county road.

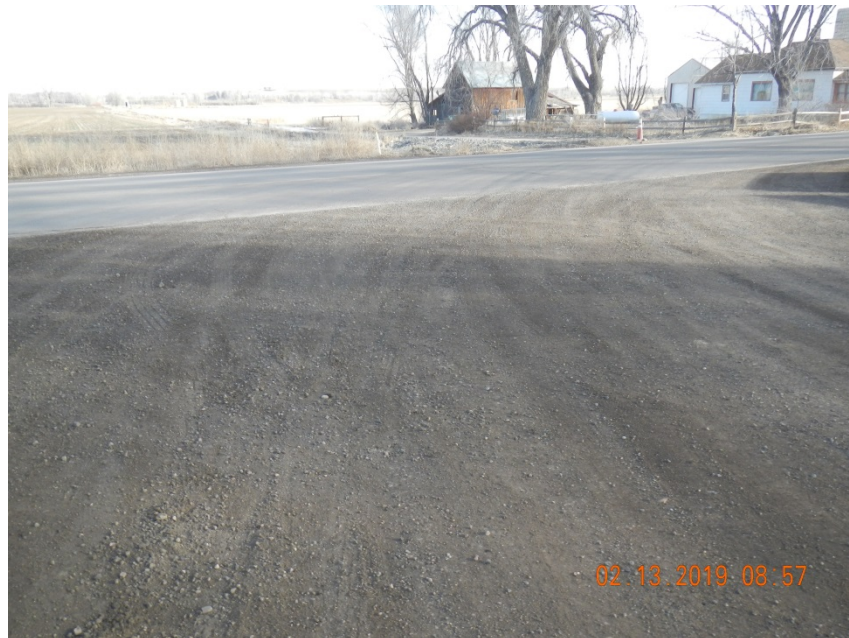
Photo 2. Photo taken from the entrance of the location off CR 20.5, facing North. See comments from Photo 1.

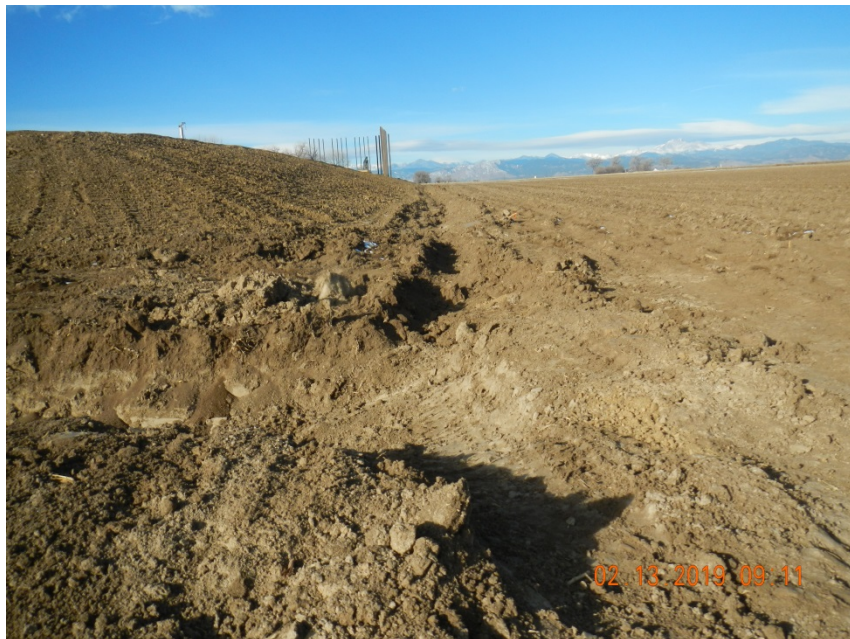
Photo 3. Photo taken from northeastern perimeter of the location, facing West. Photo illustrates the ditch and berm BMP that has been installed around the perimeter of the location. Appears the Operator is installing sediment traps with stabilized outlets around the original permitted location.

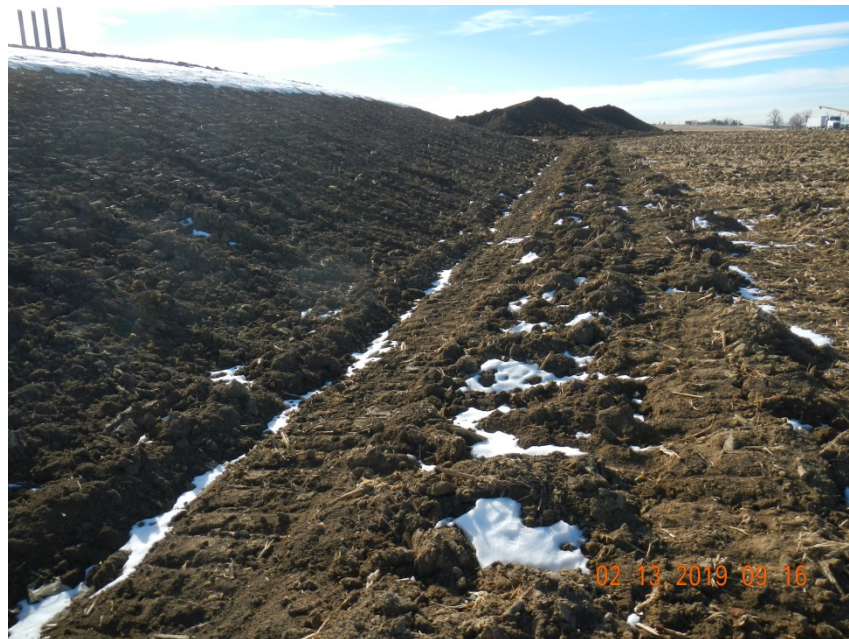
Photo 4. Photo taken from northwestern perimeter of the location, facing South. See comments from Photo 3.

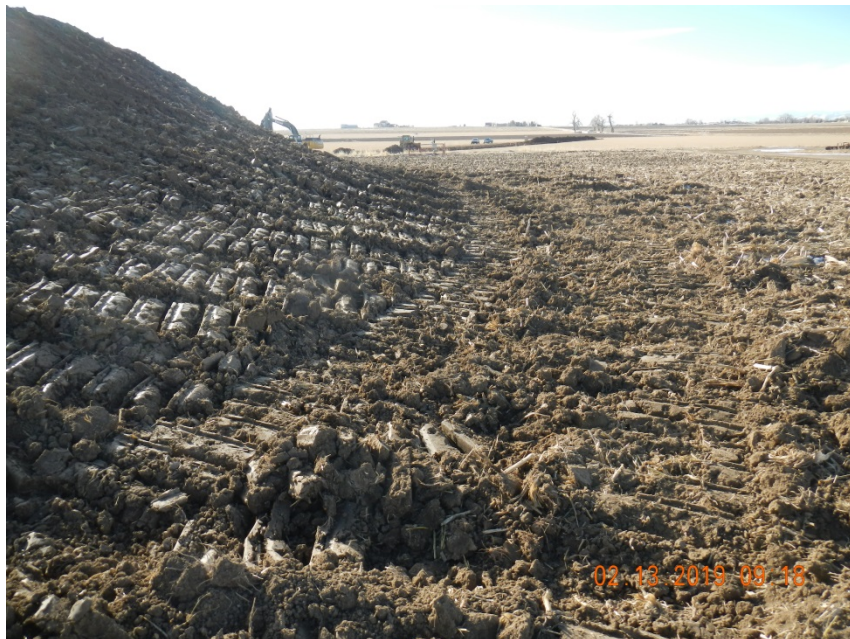
Photo 5. Photo taken from western perimeter of the unpermitted disturbance area, facing South. Stormwater BMPs have not been installed around the entire perimeter of the new unpermitted disturbance area.

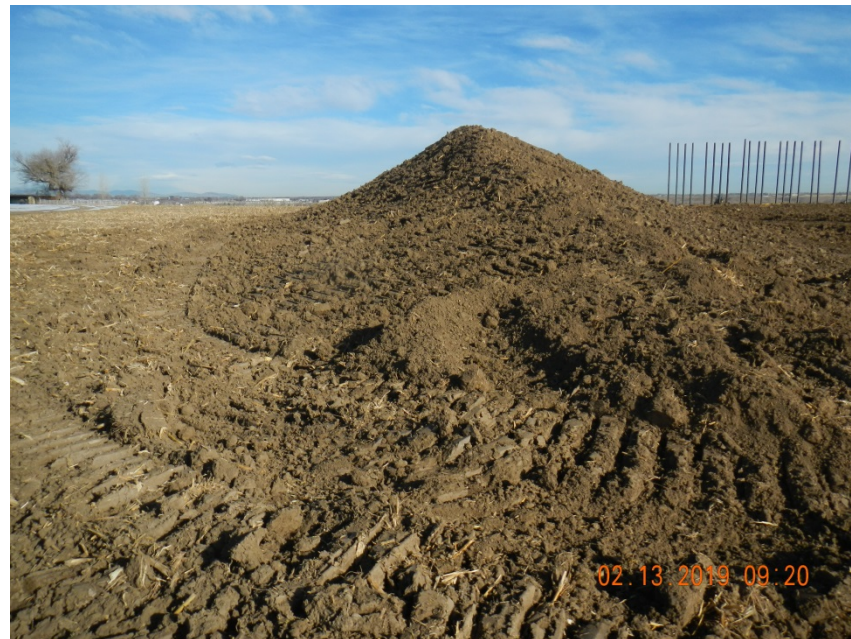
Photo 6. Photo taken from southwestern perimeter of the unpermitted disturbance area, facing North. See comment from Photo 5.

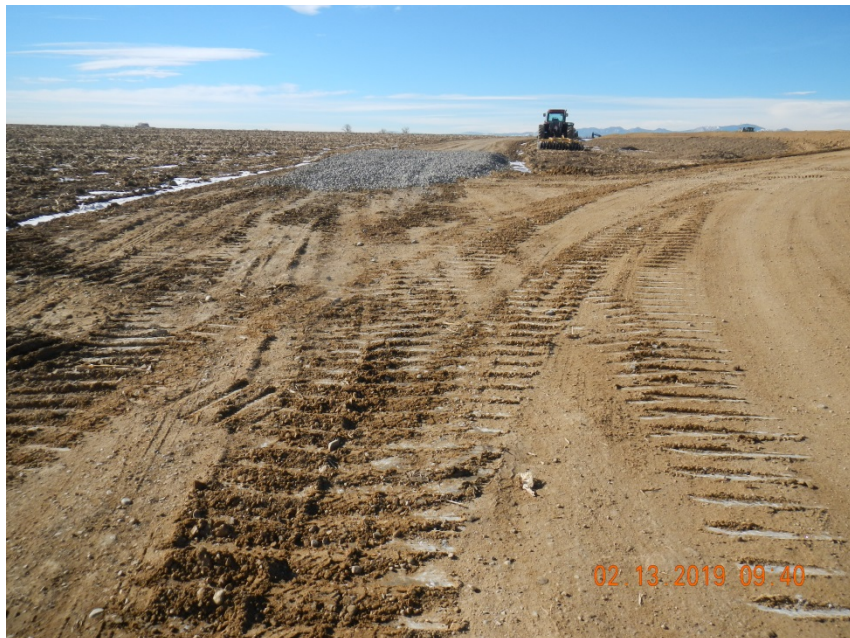
Photo 7. Photo taken from the access road looking Northwest into a new temporary access road built for the unpermitted area and the flowline work to the south. See comments from Photo 1.

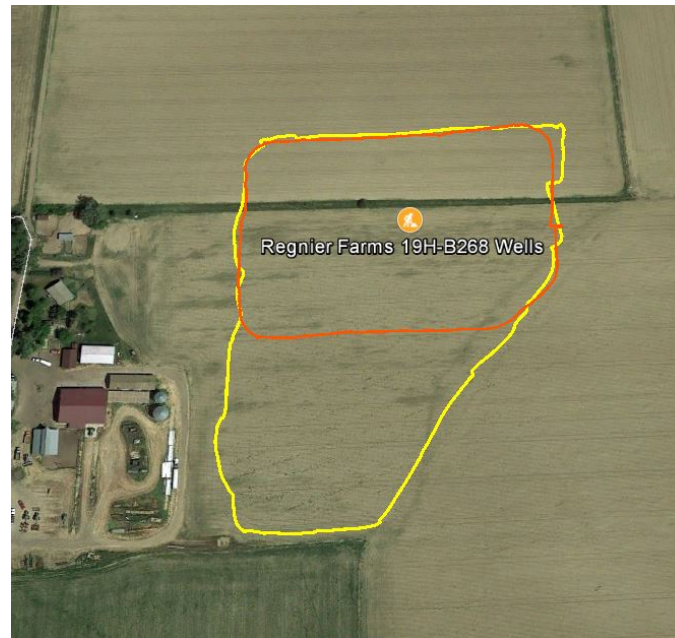
Photo 8. Aerial imagery showing the permitted disturbance area in the orange polygon and the newly disturbed unpermitted area to the south in yellow.
