Inspection Photos

Operator: WESTERN OPERATING COMPANY -
95620

Location ID: 312233

Inspection Doc. Number: 682504521
Logan County, CO

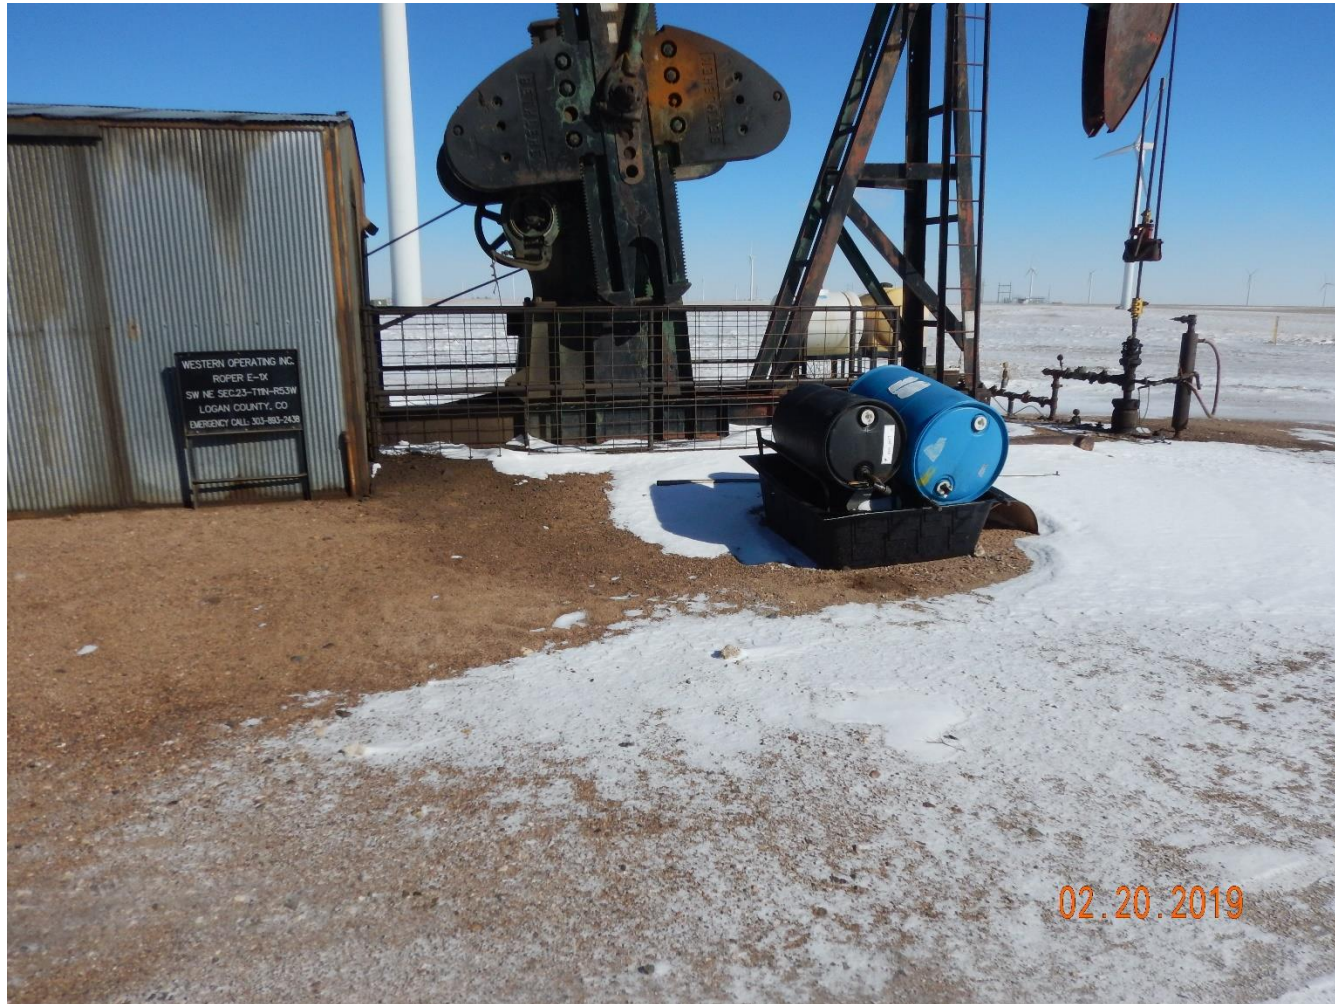
Photo 1: Photo taken from the south end of the well. Photo shows barrels have been placed into secondary containment.

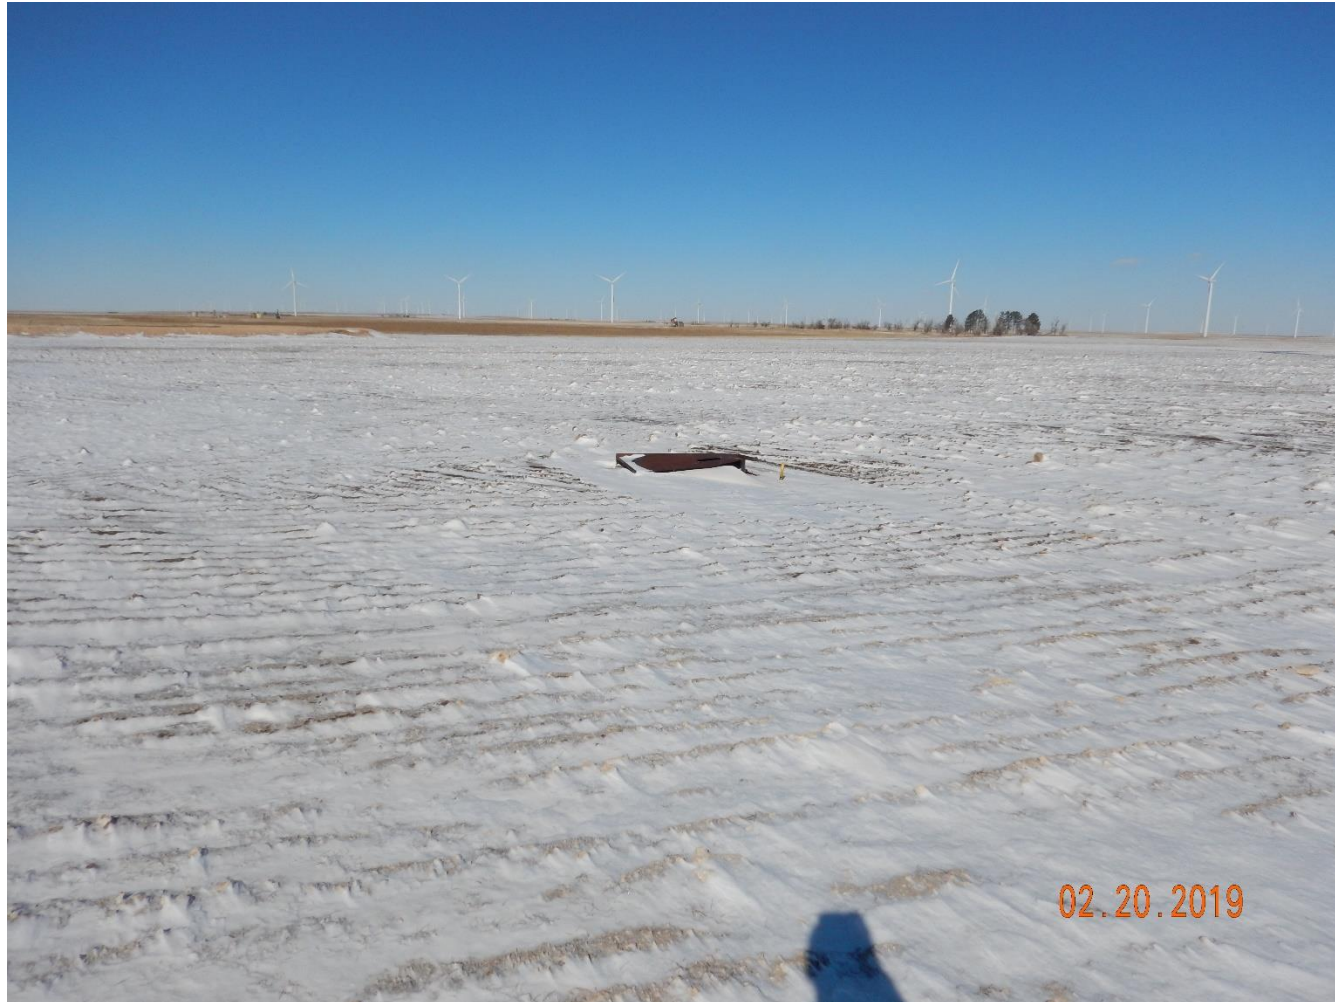
Photo 2: Photo taken from the north end of the well, facing northwest. Photo shows northwest anchor has not been marked in accordance with 1003.a

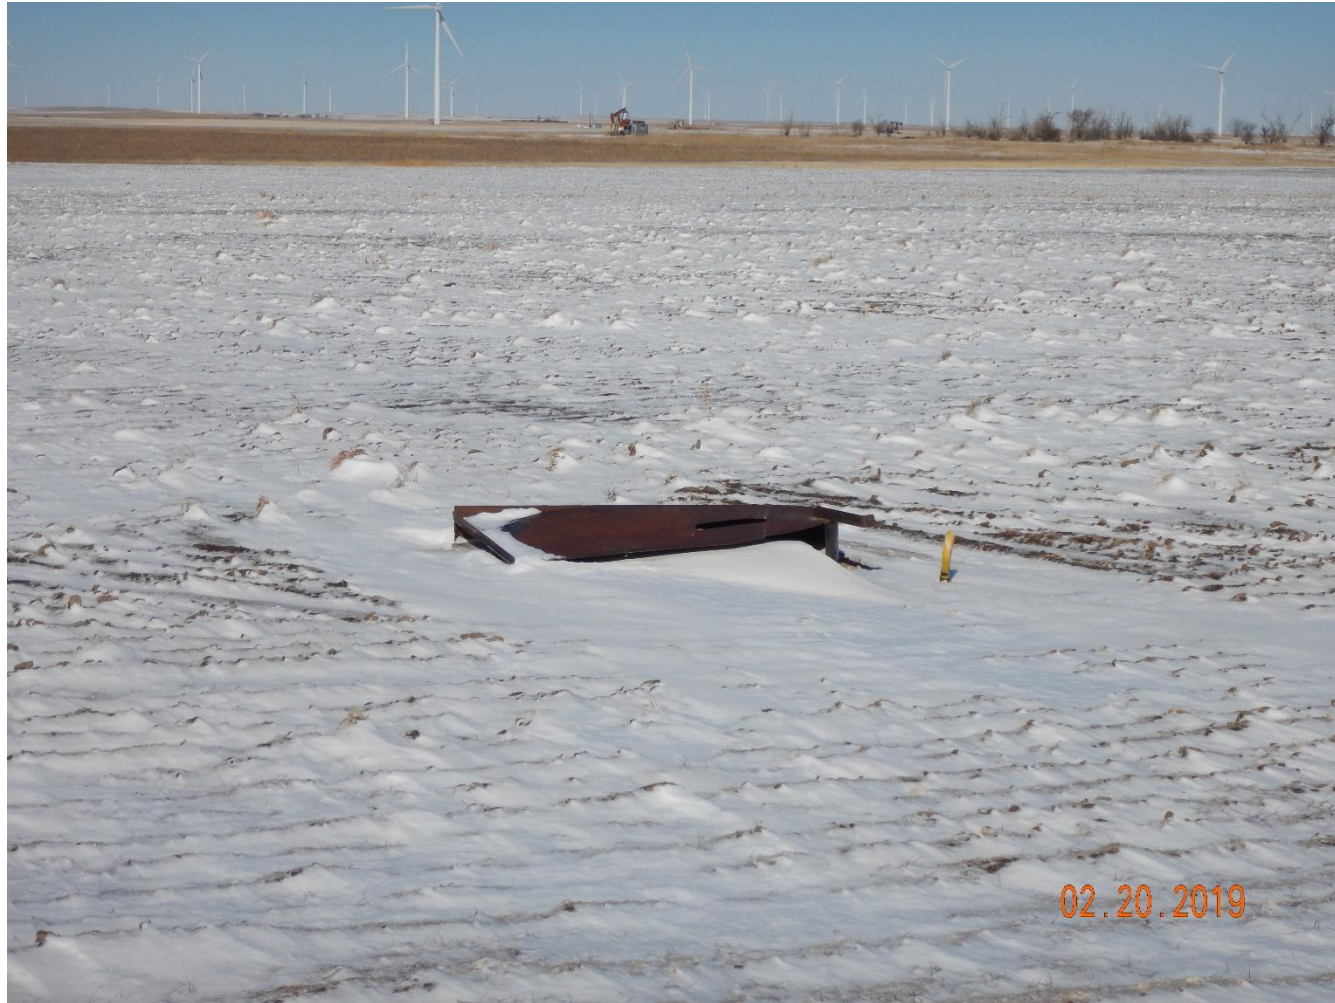
Photo 3: Photo taken from the north end of the well, facing northwest. Photo shows northwest anchor has not been marked in accordance with 1003.a
