# Construction and Storm Water Inspection

February 26, 2019

Operator: NOBLE ENERGY INC – 100322

Location ID: 458932

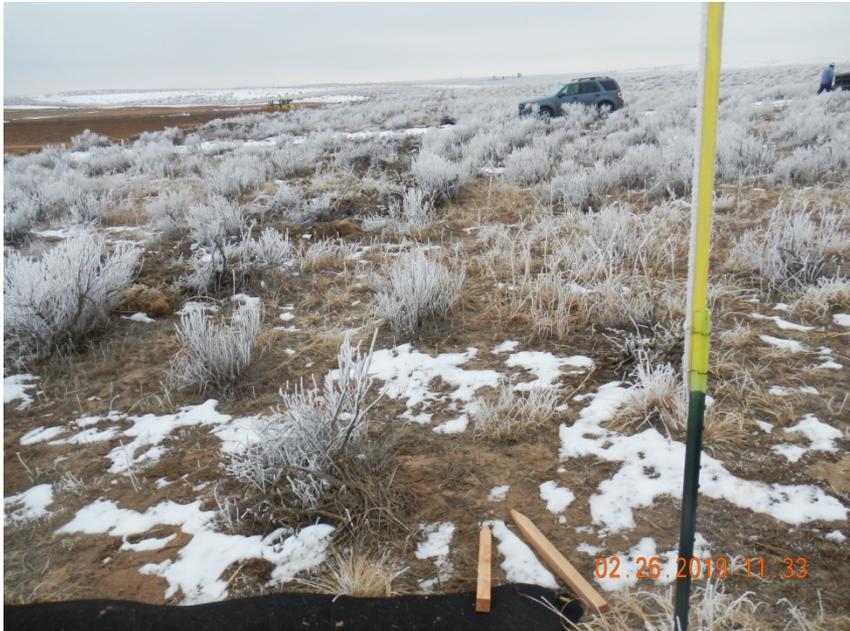
**Photo 1.** Photo taken from the northwestern perimeter of the location, facing South. Photo illustrates a Filtrexx BMP that has been installed around the perimeter of the location. However it appears the Operator has left a gap in the Filtrexx along northwestern perimeter. BMPs are not in proper functioning condition at the time of this inspection.

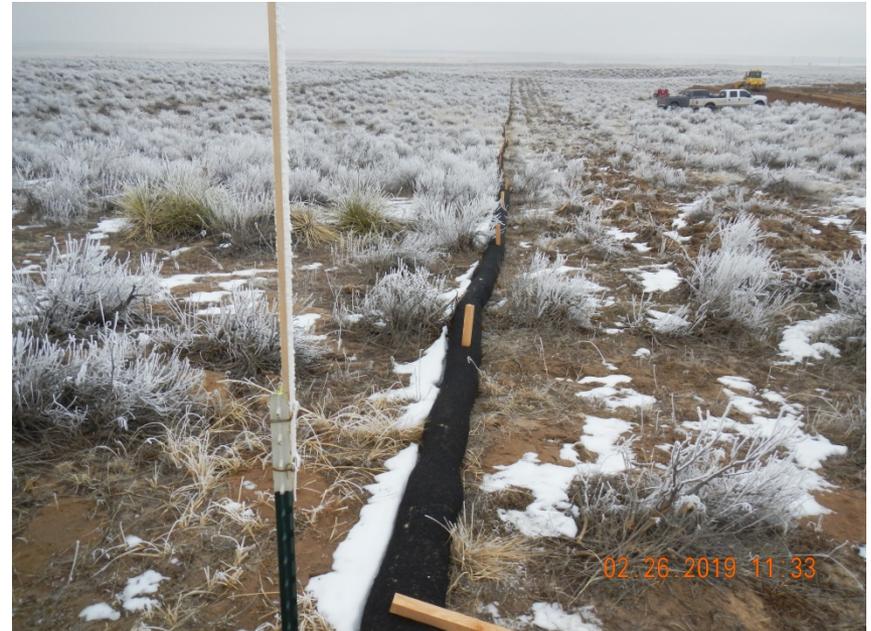
**Photo 2.** Photo taken from the northwestern perimeter of the location, facing North. Photo illustrates a Filtrexx BMP that has been installed around the perimeter of the location.

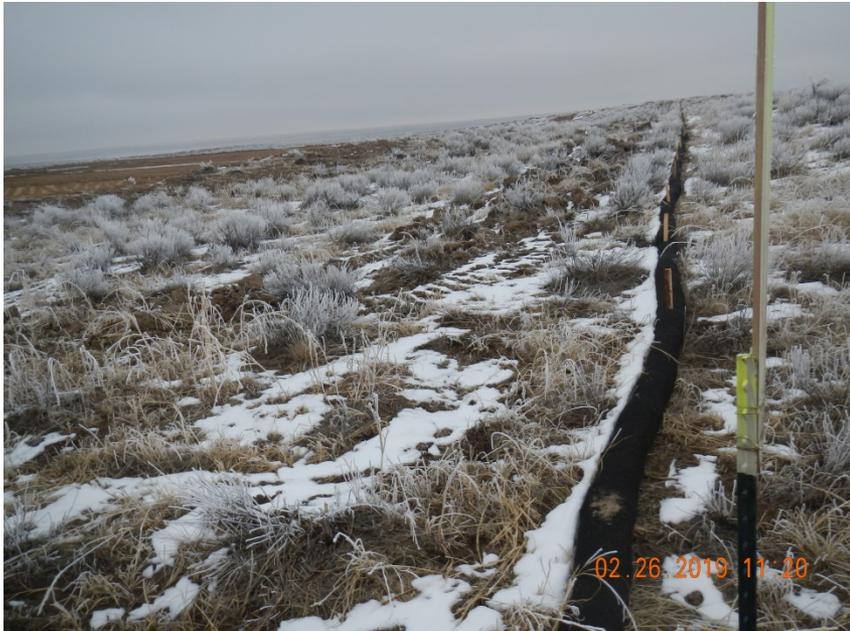
**Photo 3.** Photo taken from the southwestern perimeter of the location, facing East. See comments from Photo 2.

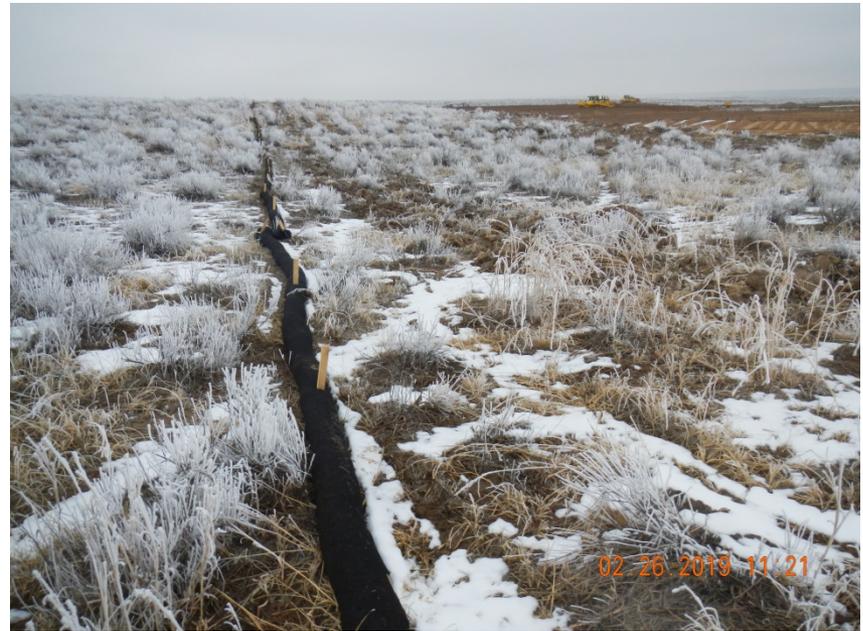
**Photo 4.** Photo taken from the southwestern perimeter of the location, facing North. See comments from Photo 2.

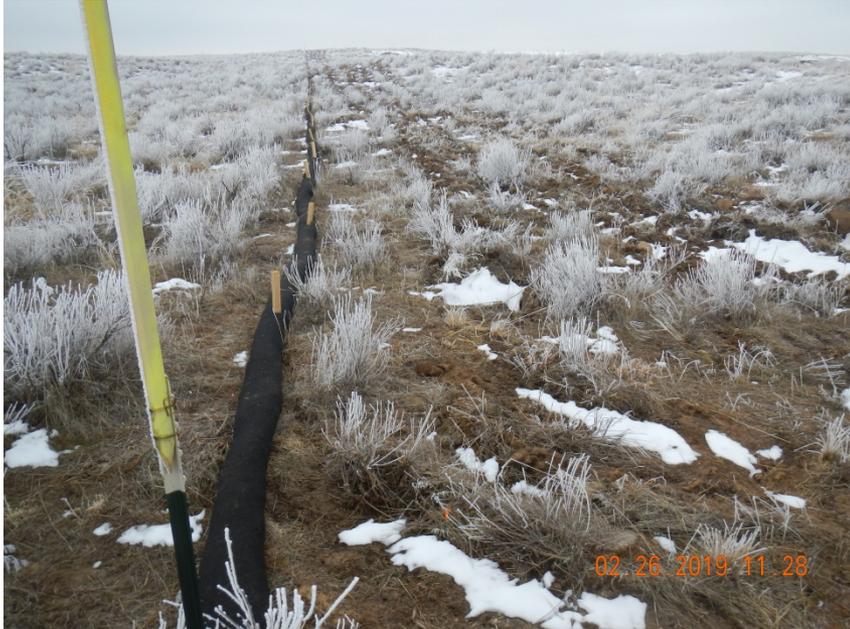
**Photo 5.** Photo taken from the southeastern perimeter of the location, facing West. See comments from Photo 2.

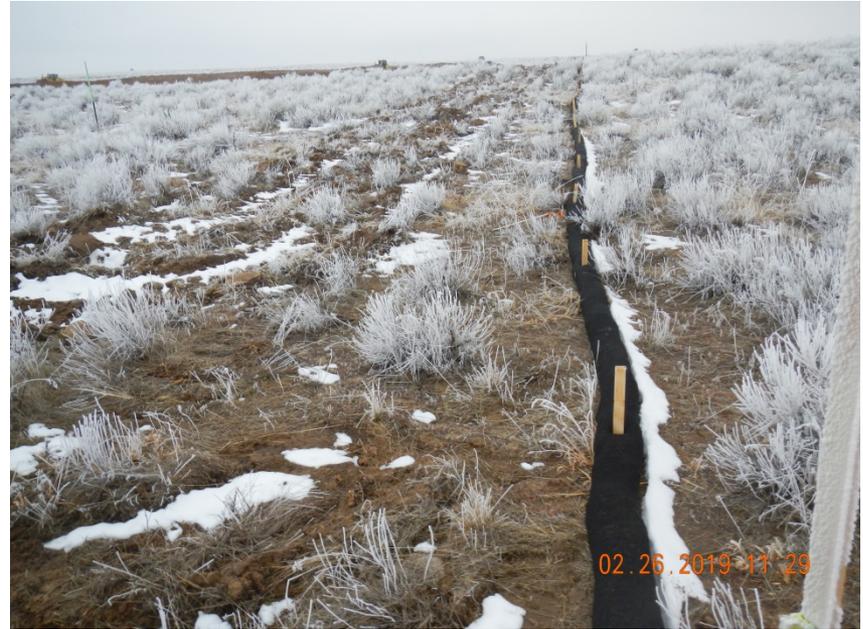
**Photo 6.** Photo taken from the southeastern perimeter of the location, facing North. See comments from Photo 2.

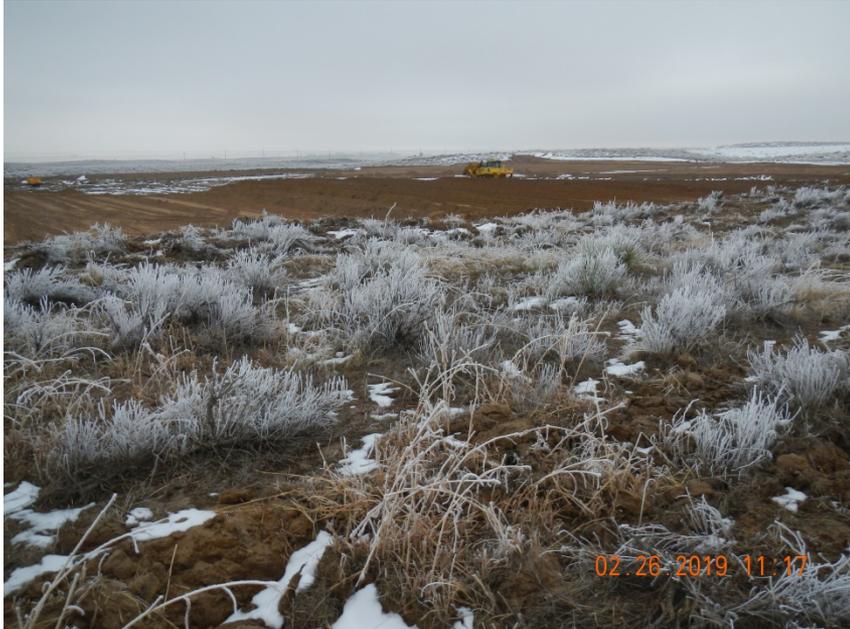
**Photo 7.** Photo taken from the northwestern perimeter of the location, facing East. Location is currently under construction.

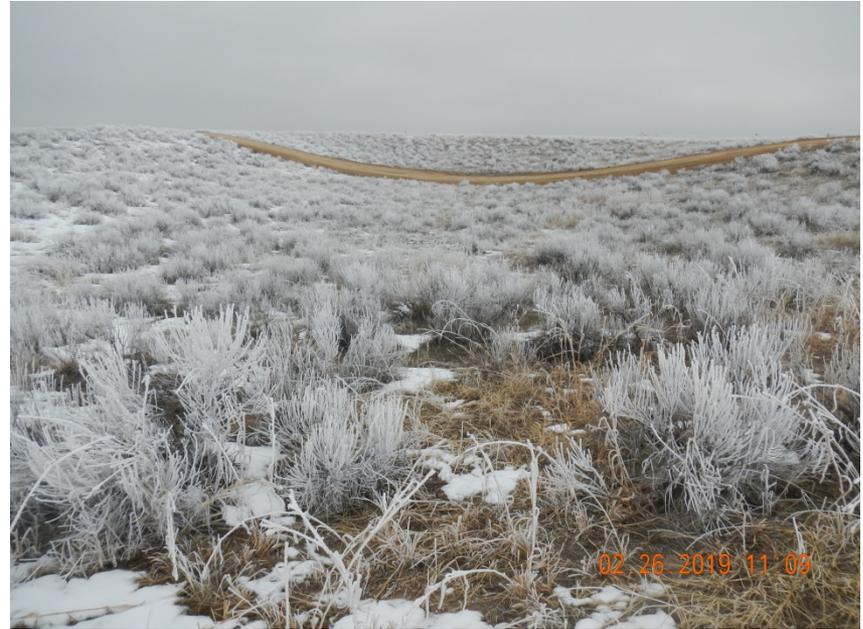
**Photo 8.** Photo taken from the northern perimeter of the location looking towards the access road under current construction, facing North.
