Figure 2
Troudt 44-7
Facility Layout & Sample Locations

Legal Location: SESE, Sec 7, T1N R67W
County: Weld
Land Use: Non-cropland
Topography: 1-3% Slopes
Run-Off Risk: Low
Soil Type: Colombo clay loam

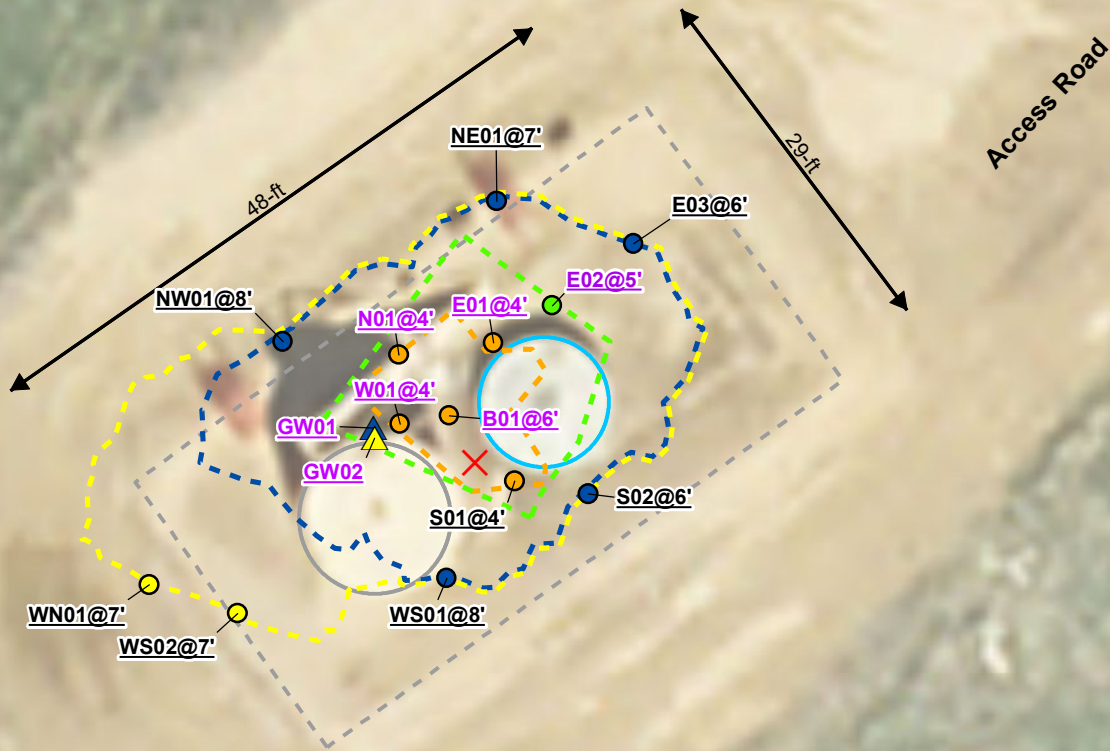
REVISED	BY	COMMENT
3/11/2019	BJB	Figure 2

Sample Label in Purple indicates lab exceedances.
