**Inspection Photos**  
**Location Name: JOHNSON-66N66W /11SESE**  
**Location #: 329817**

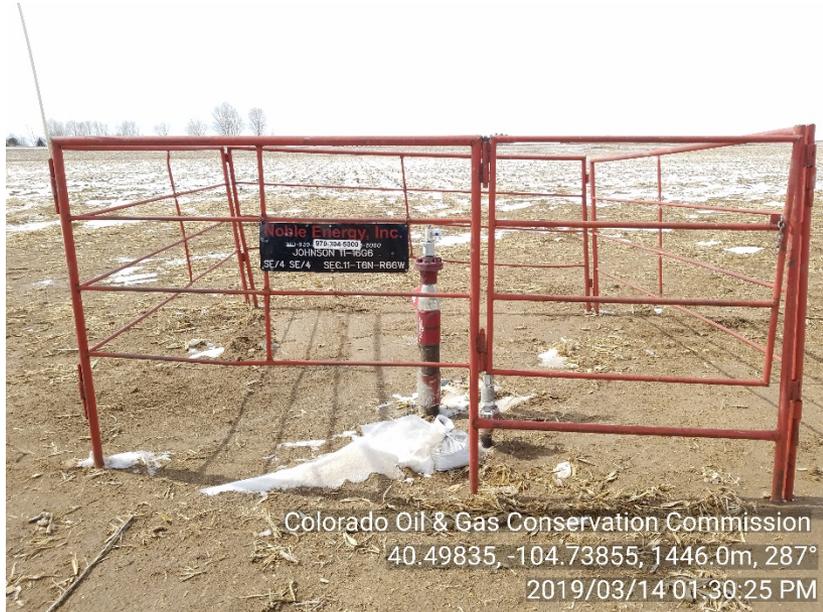
**Photo #1**  
**Johnson 11-16G6 (05-123-17881) Wellsite**  
**Plugged & Abandoned | PA**  
**NOT Cut & Capped – Casing & Valve appears in place**

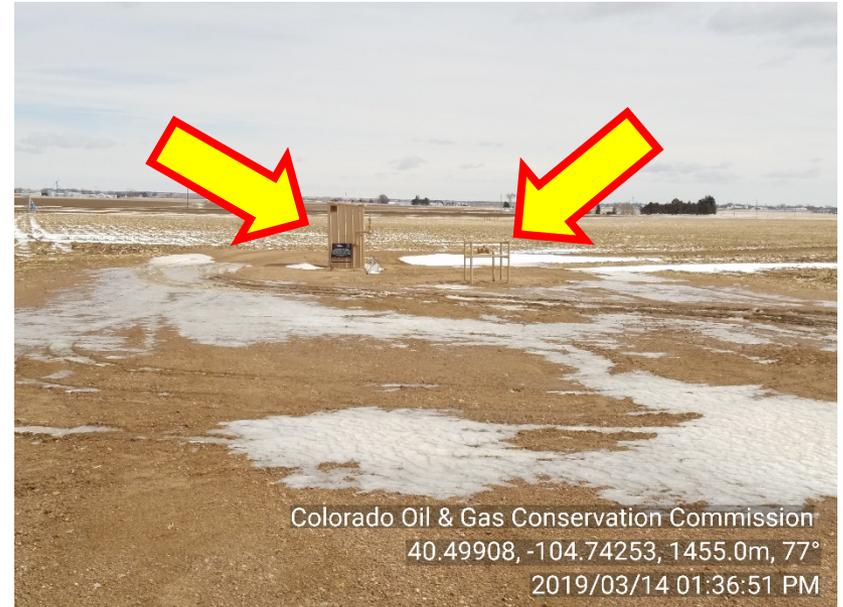
**Photo #2**  
**Johnson 11-16G6 Abandoned Battery site**  
**Unused Equipment**  
**Gas meter run, Gas line riser, Signs**
