Final Reclamation and Stormwater Inspection

Operator: PDC ENERGY INC # 69175

Location ID: 305082

Weld County, CO

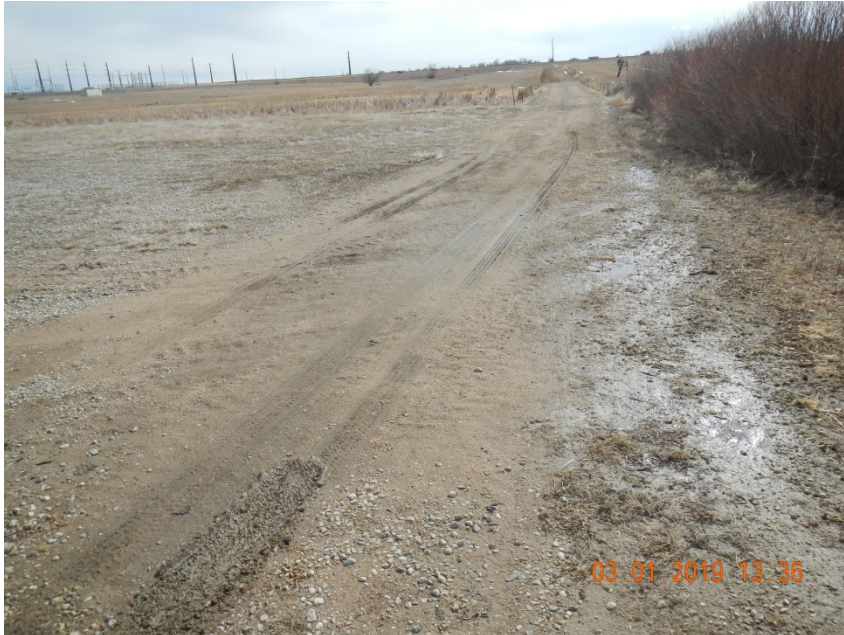
Photo 1. Photo taken from the access road off CR 18, facing South. Photo depicts the access road is still in tact with gravel remaining along the northern portion.

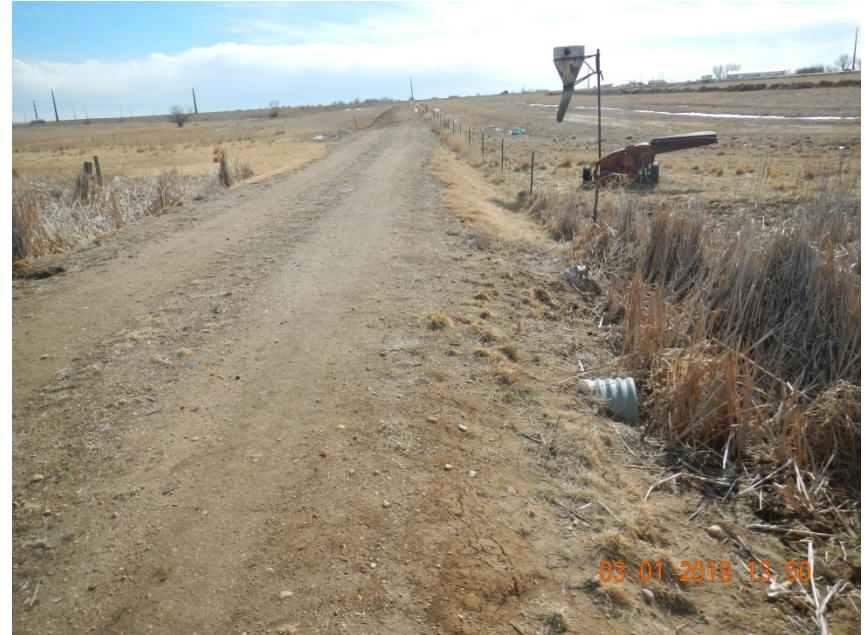
Photo 2. Photo taken from the access road off CR 18, facing South. Photo depicts the access road is still in tact and the culvert remains on location.

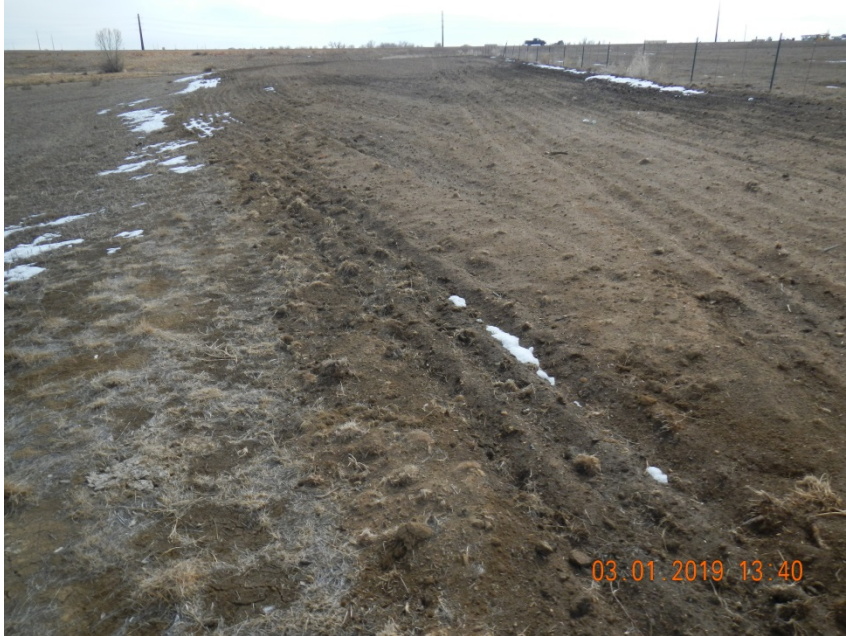
Photo 3. Photo taken from the facility location, facing South. Appears Operator has recently performed reclamation activities with drill rows observed but no straw crimped mulch.

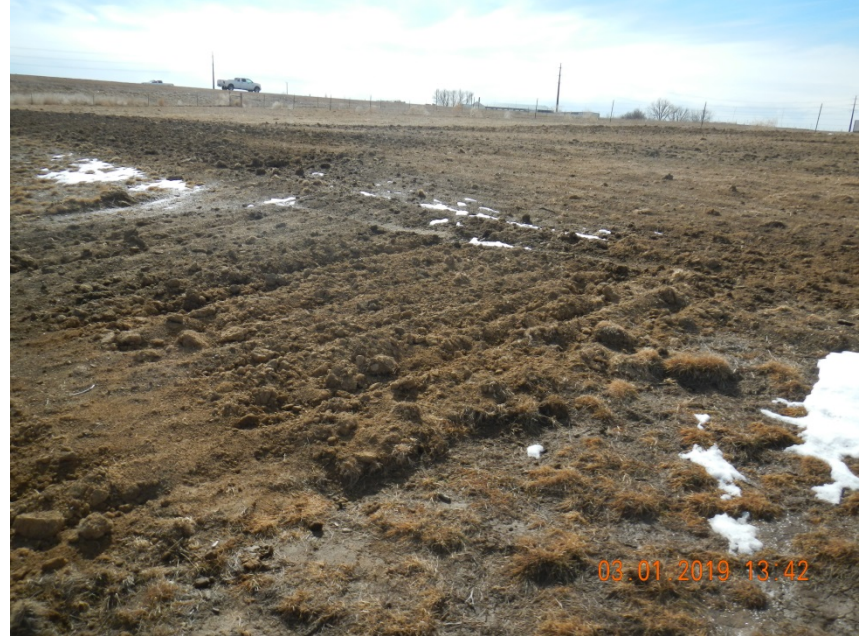
Photo 4. Photo taken from the location, facing Southwest. See comments from Photo 3.

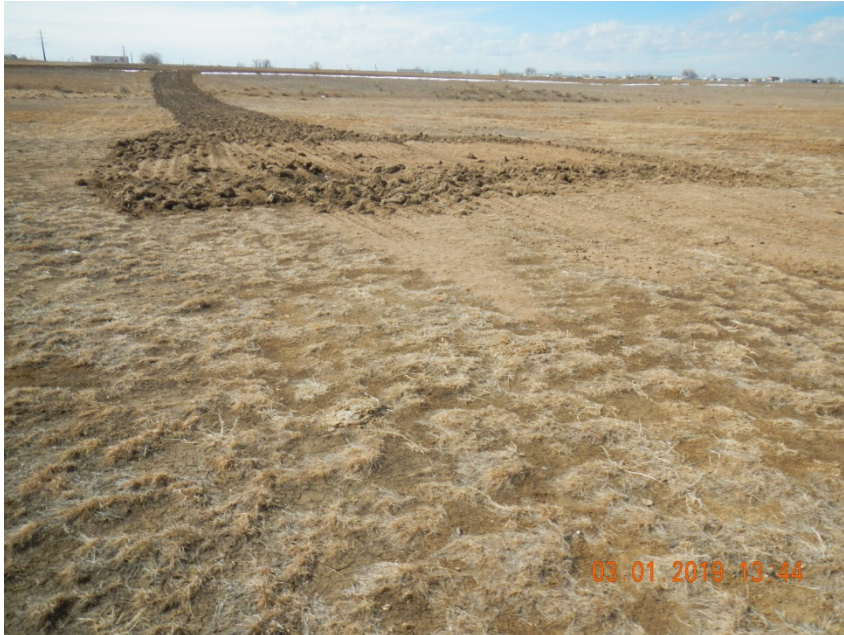
Photo 5. Photo taken from the location, facing West. Appears Operator has recently performed reclamation activities at the location and access road with drill rows observed but no straw crimped mulch. No stormwater BMPs observed at location.

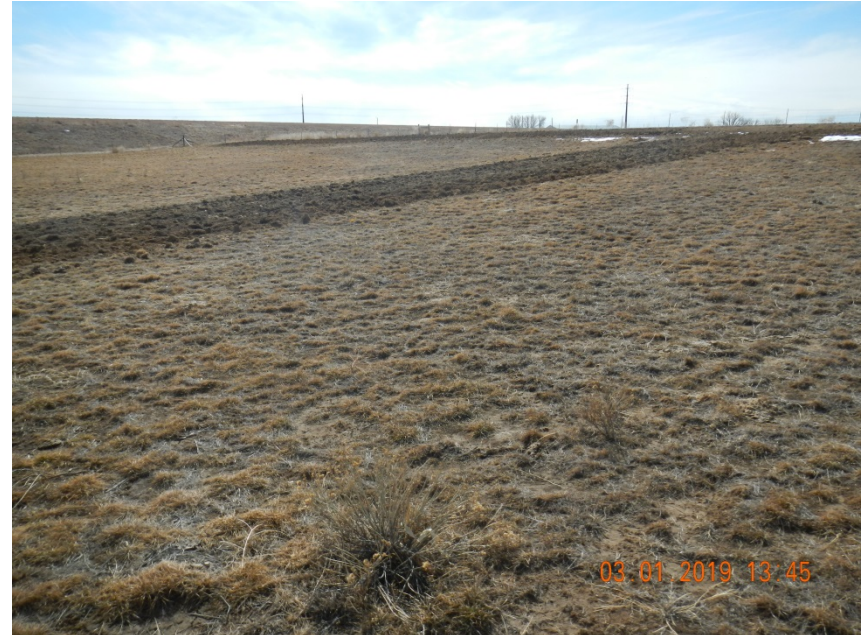
Photo 6. Photo taken from north of the access road, facing Southwest. See comments from Photo 5.
