# Final Reclamation Inspection

March 15, 2019

Operator: VERDAD RESOURCES LLC - #10651

Inspection Photos  
Location Name: Pergamos /8-11-7-60  
Location ID: 424579

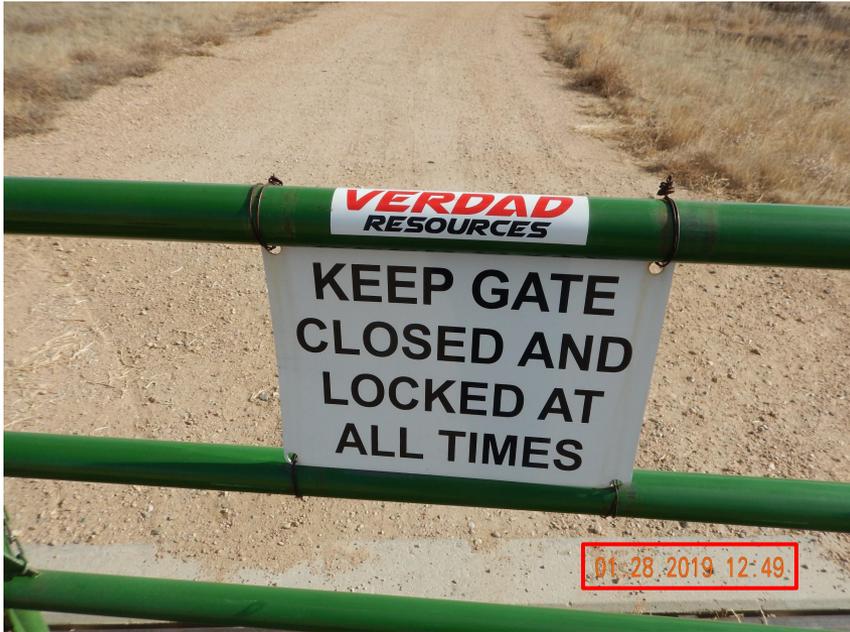
**Photo 1.** Photo taken from the entrance of the location on January 28, 2019, facing East. Photo taken from the locked gate entrance to the location. Operator constructed the location but never drilled the proposed well. Operator has instead turned the location into a storage yard. Spills were observed throughout the location outside of containment, as well as unmanaged weeds. Operator shall clean up all spills, control/remove weeds, remove all equipment, and perform Final Reclamation.

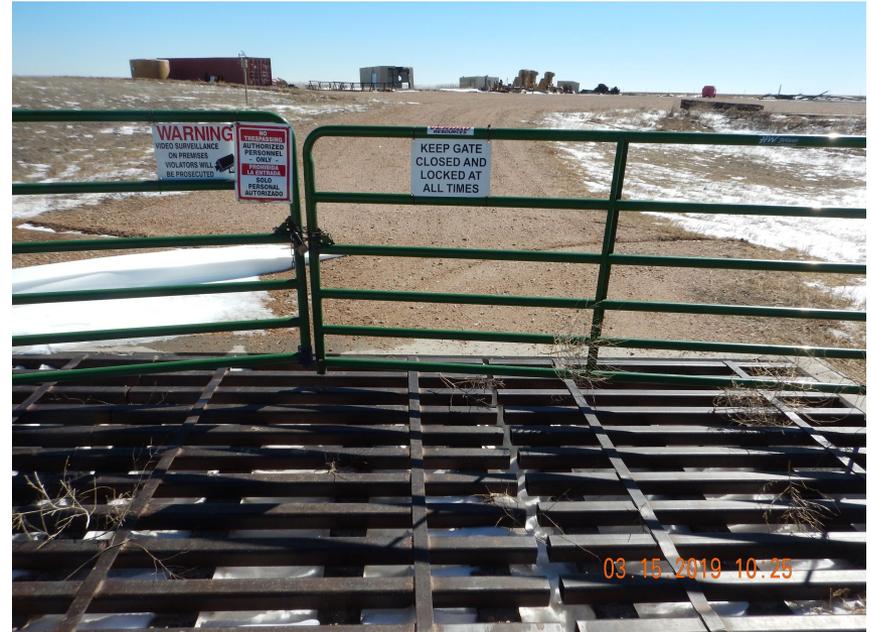
**Photo 2.** Photo taken from the entrance of the location on March 15, 2019, facing East. See comments under Photo 1.

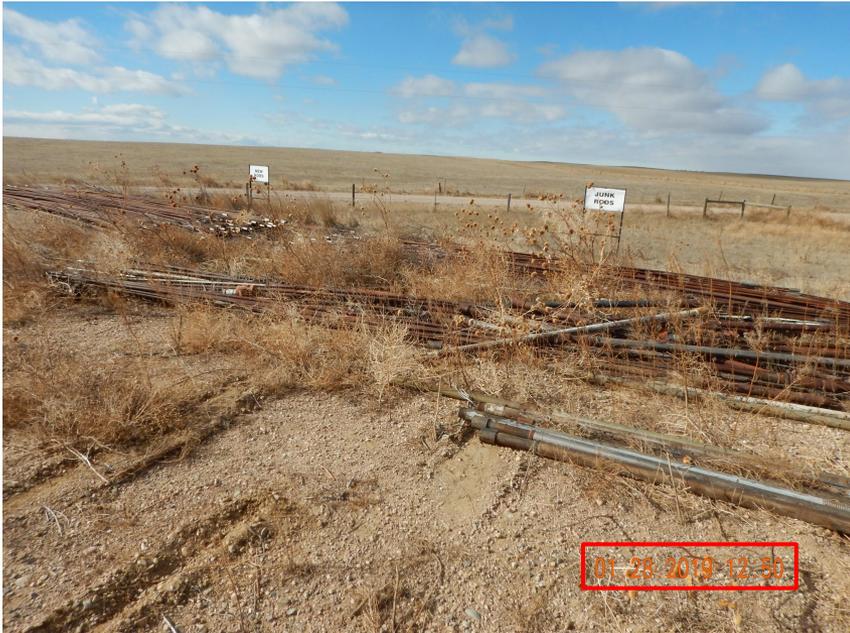
**Photo 3.** Photo taken from the northwestern location on January 28, 2019, facing West. See comments under Photo 1.

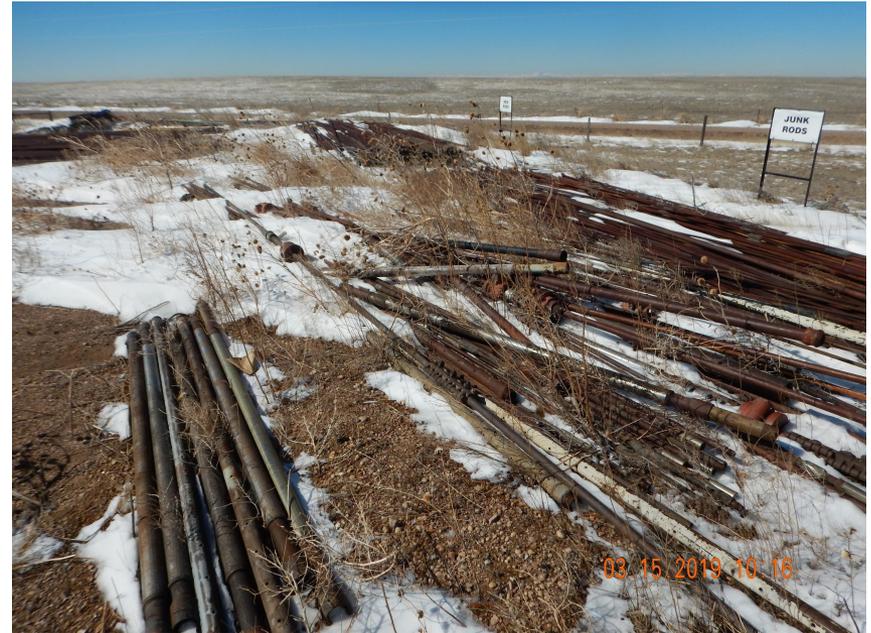
**Photo 4.** Photo taken from the northwestern location on March 15, 2019, facing West. Operator has failed to remove trash, debris, storage of supplies and unused equipment.

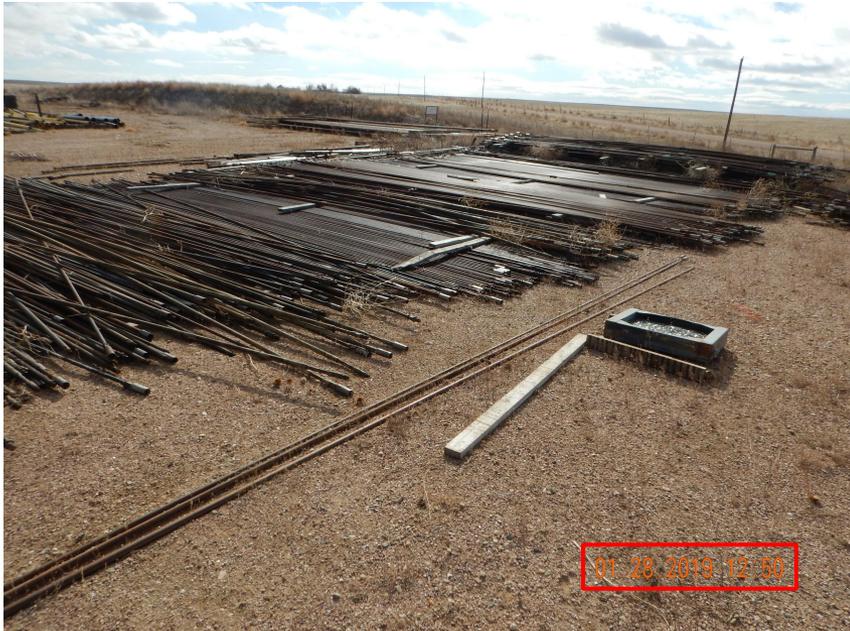
**Photo 5.** Photo taken from the northwestern location on January 28, 2019, facing Southwest. See comments under Photo 1.

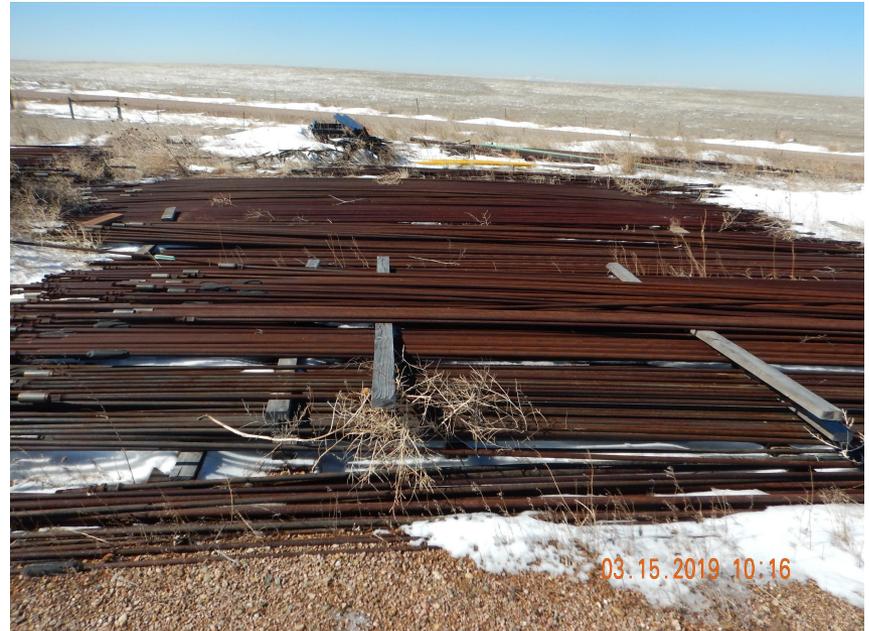
**Photo 6.** Photo taken from the northwestern location on March 15, 2019, facing Southwest. See comments under Photo 4.

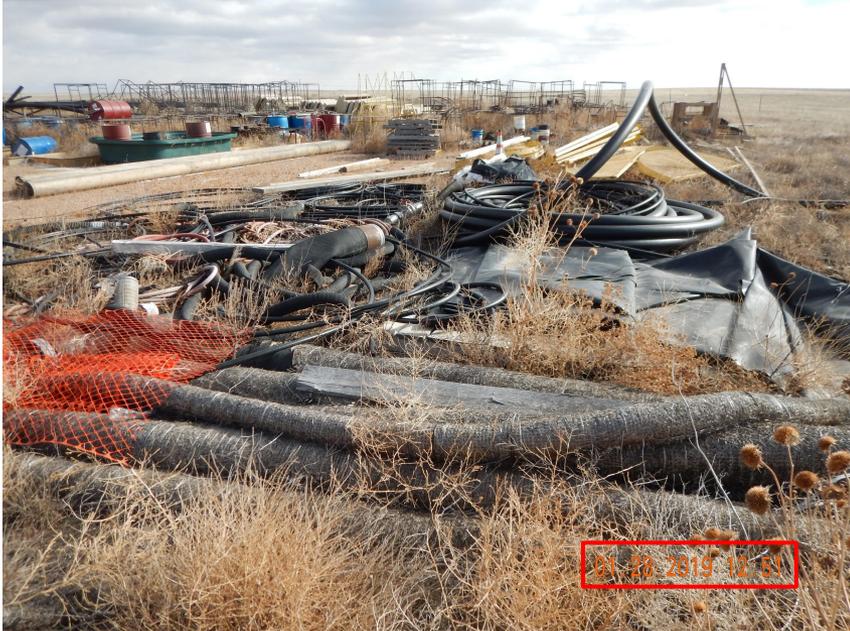
**Photo 7.** Photo taken from the western location on January 28, 2019, facing South. See comments under Photo 1.

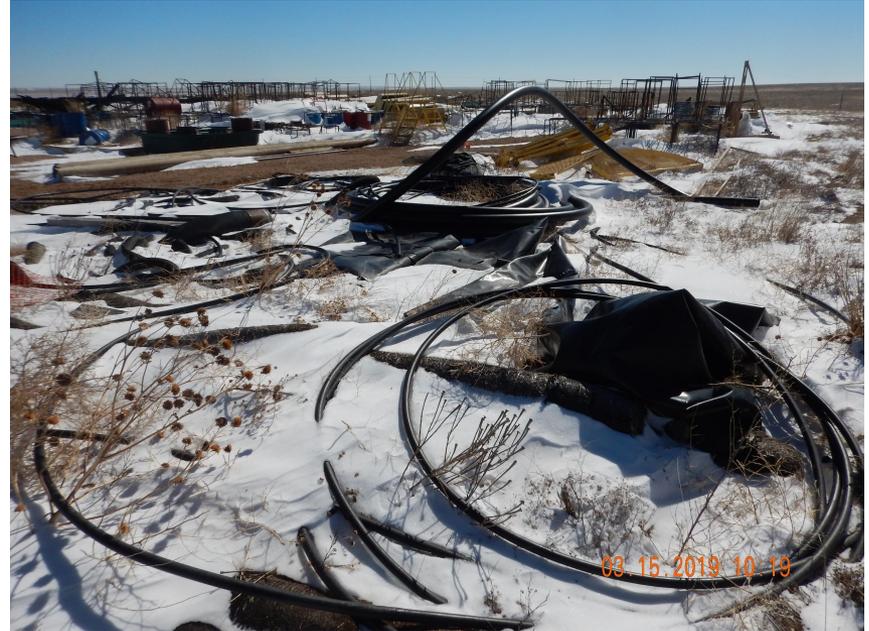
**Photo 8.** Photo taken from the western location on March 15, 2019, facing South. See comments under Photo 4.

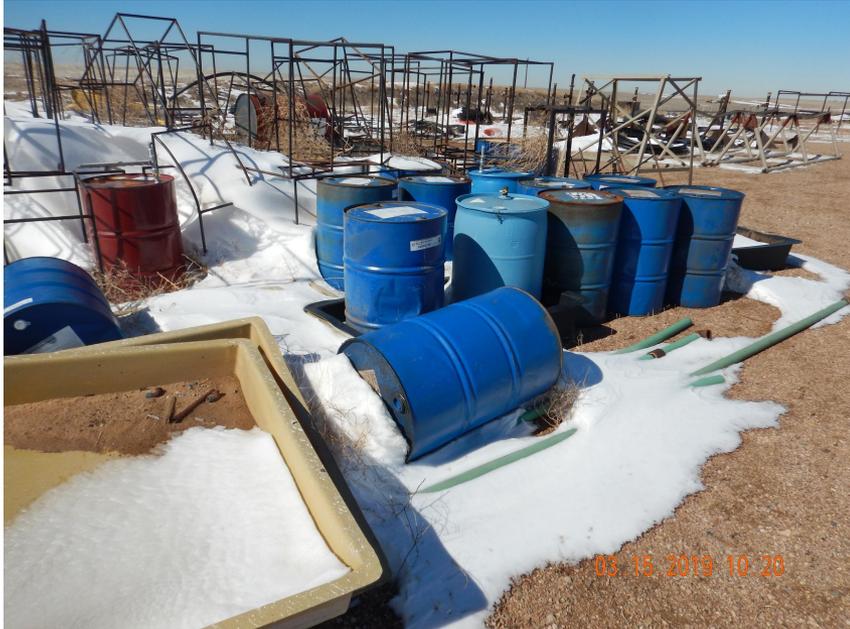
**Photo 9.** Photo taken from the southern location on March 15, 2019, facing Northwest. Barrels have not been put in containment. Note: Snow cover did not allow COGCC staff to make an accurate assessment to determine whether or not all spills were cleaned up.

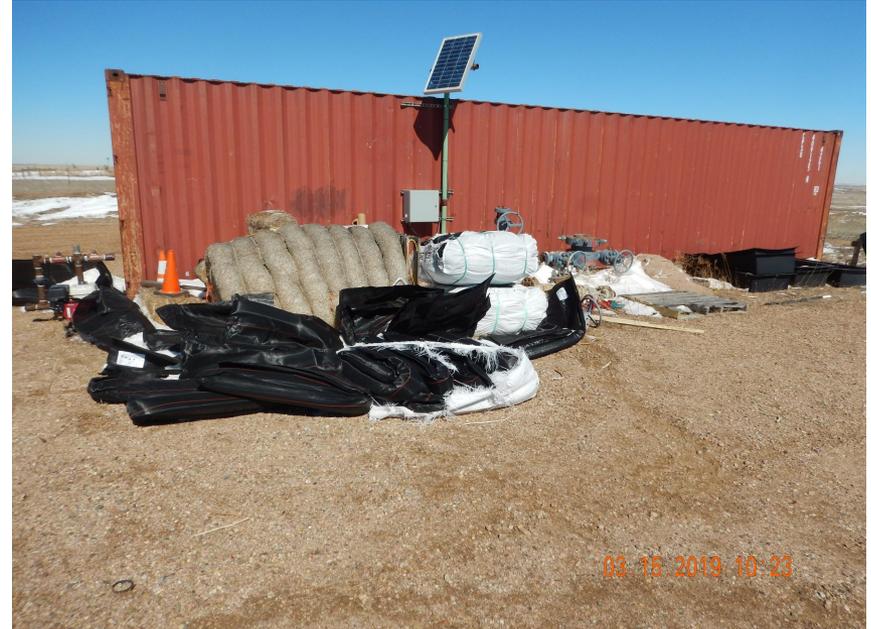
**Photo 10.** Photo taken from the northeast location on March 15, 2019, facing North. See comments under Photo 4.
