Interim Reclamation Inspection

April 2, 2019

Operator: EXTRACTION OIL & GAS LLC- #10459

Location Name: Hergert /35-D Facility

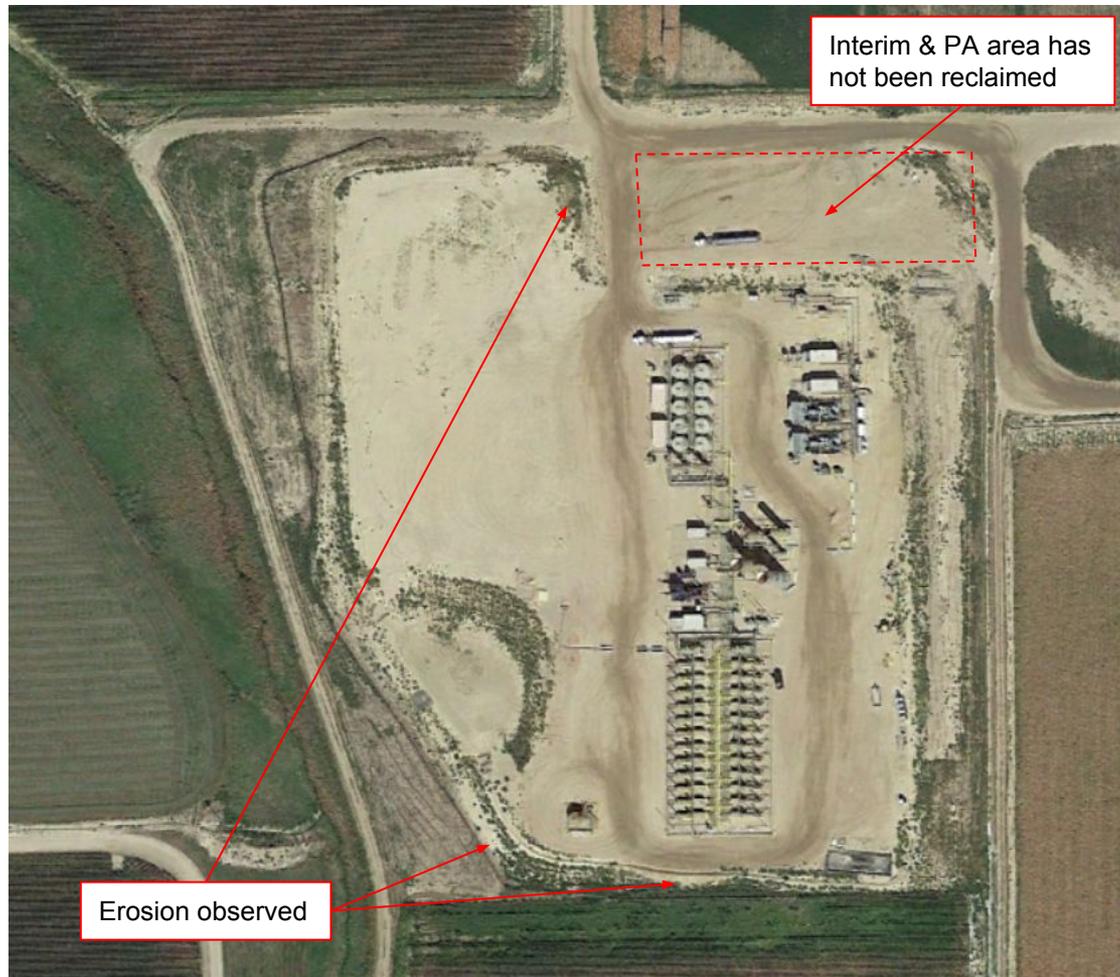
Google Earth aerial imagery taken September 12, 2018 illustrating the Hergert 35-D Facility Location. At the time of this inspection on April 2, 2019, an area located to the north has not been reclaimed and stormwater erosion was observed along the northwestern and southern perimeter of the location.

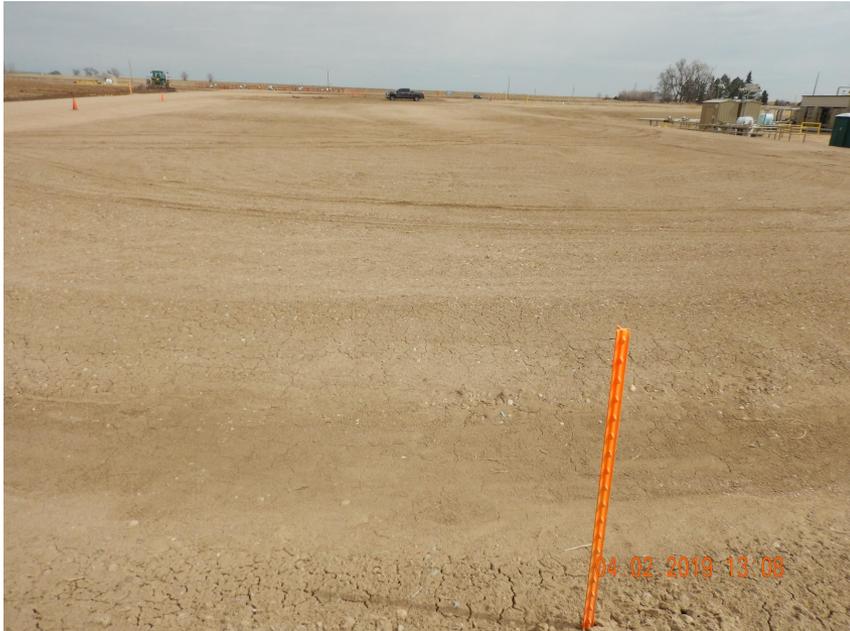
Photo 1. Photo taken from the northern interim area, facing East. Portions of this area were used during the drilling operations for the Hergert 35-D Facility. Also, there was a tank battery located along this eastern area used for well that have been plugged and abandoned.

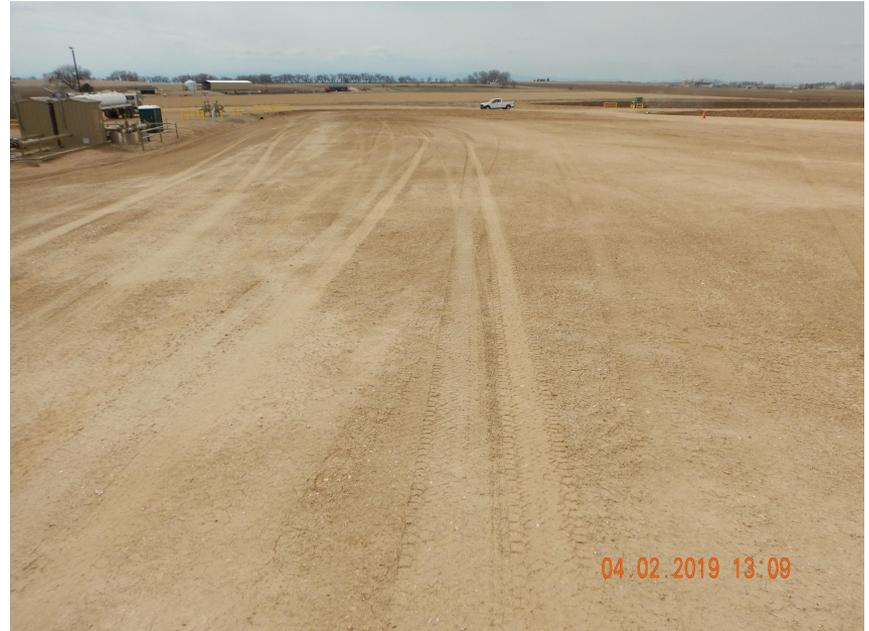
Photo 2. Photo taken from the northeastern interim area, facing West. See comments under Photo 1.

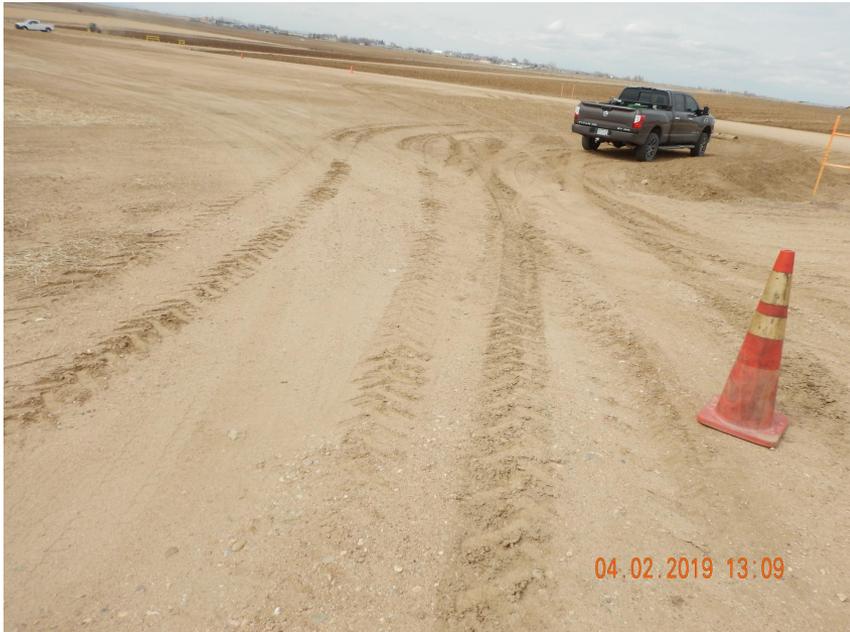
Photo 3. Photo taken from the northeastern interim area, facing North. See comments under Photo 1.

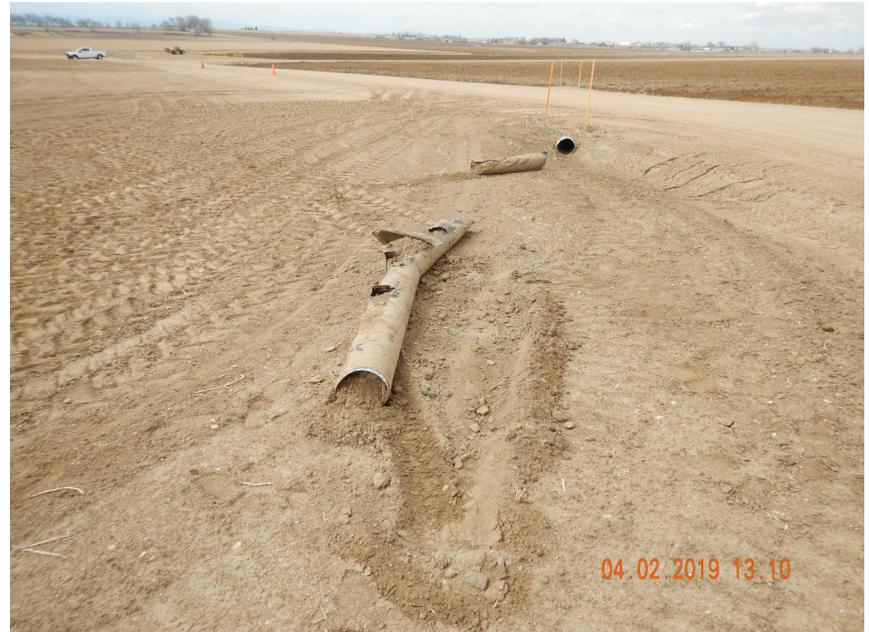
Photo 4. Photo taken from the northeastern interim area, facing Northwest. Operator needs to remove trash/debris from the location.

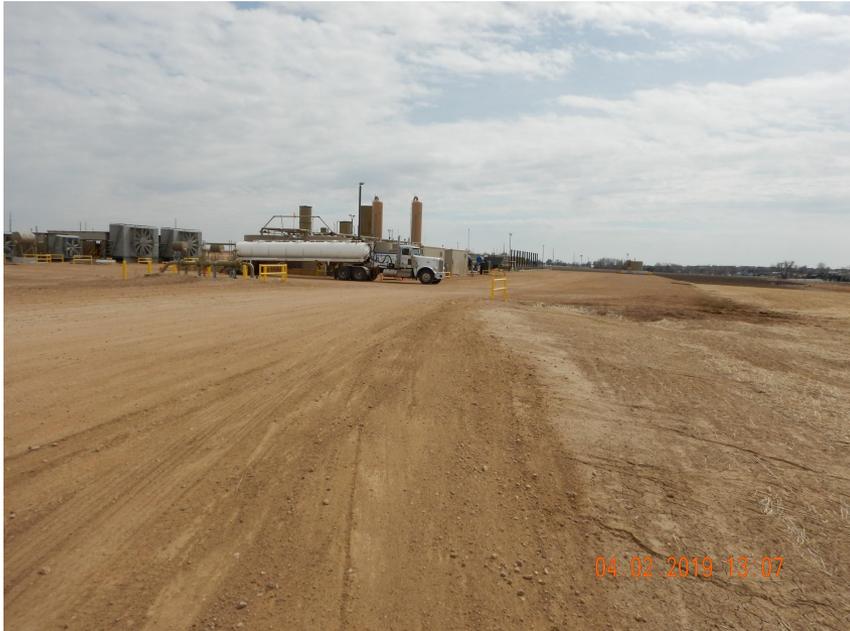
Photo 5. Photo taken from the entrance of the location, facing South. Rill erosion observed along the western portion of the access road. Operator does not have sufficient long-term stormwater BMP to prevent sediment laden stormwater erosion from leaving location.

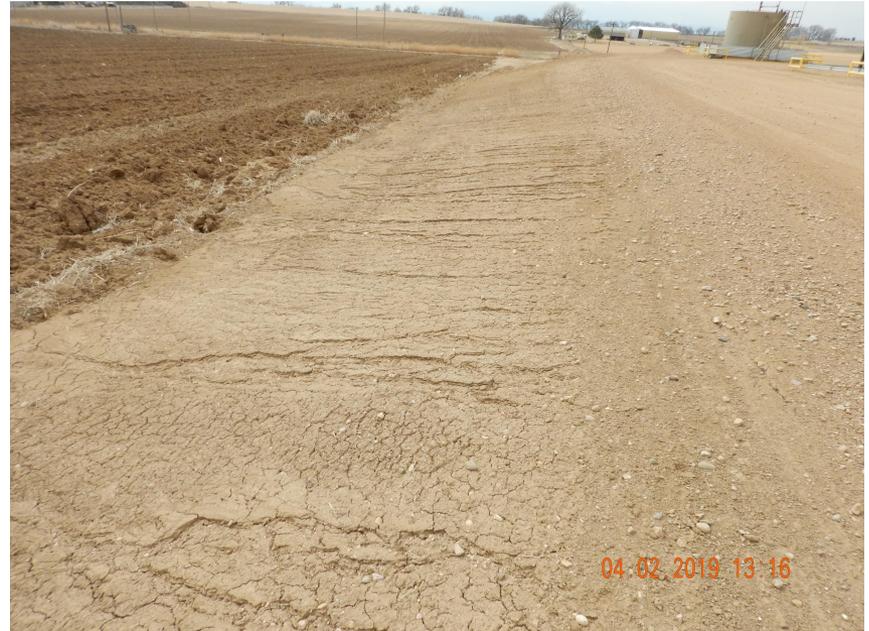
Photo 6. Photo taken from the southern interim area, facing West. See comments under Photo 5.

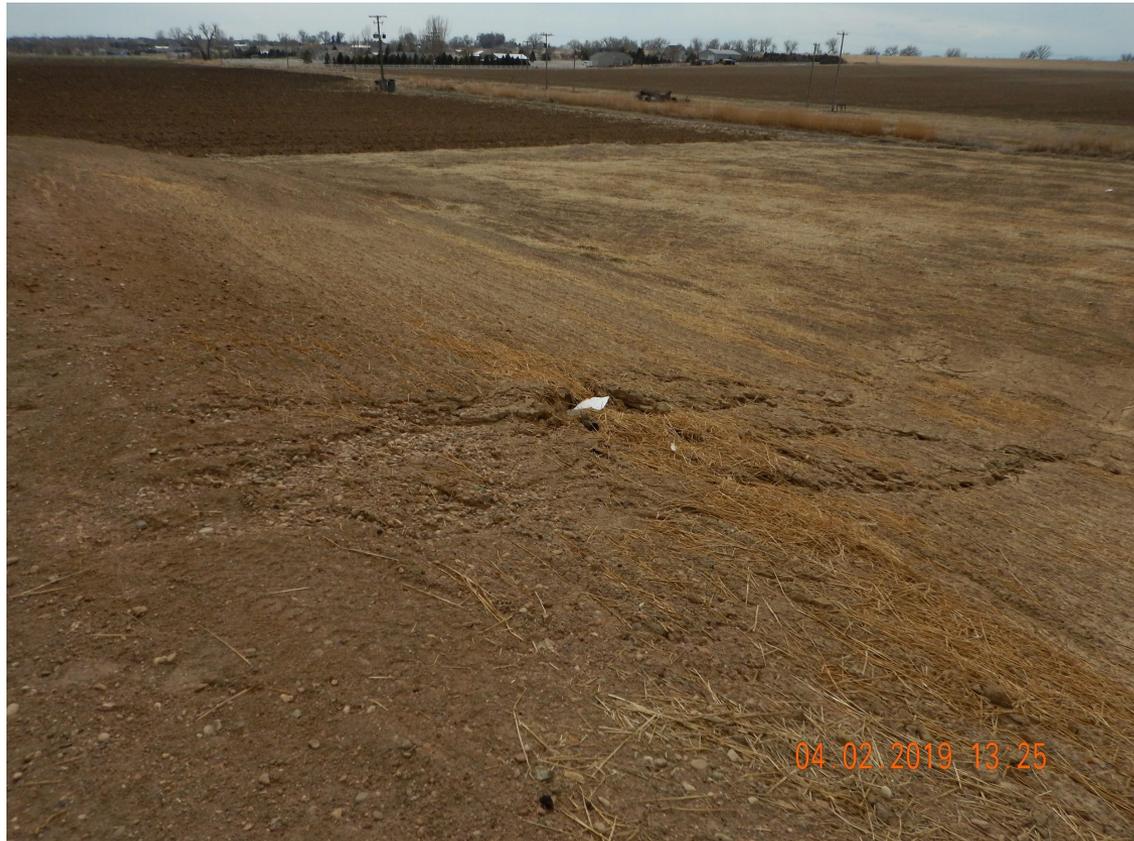
Photo 7. Photo taken from the southwestern location, facing Southwest. See comments under Photo 5.
