Final Reclamation and Stormwater Inspection

Operator: KERR MCGEE OIL & GAS # 47120

Location ID: 329527

Weld County, CO

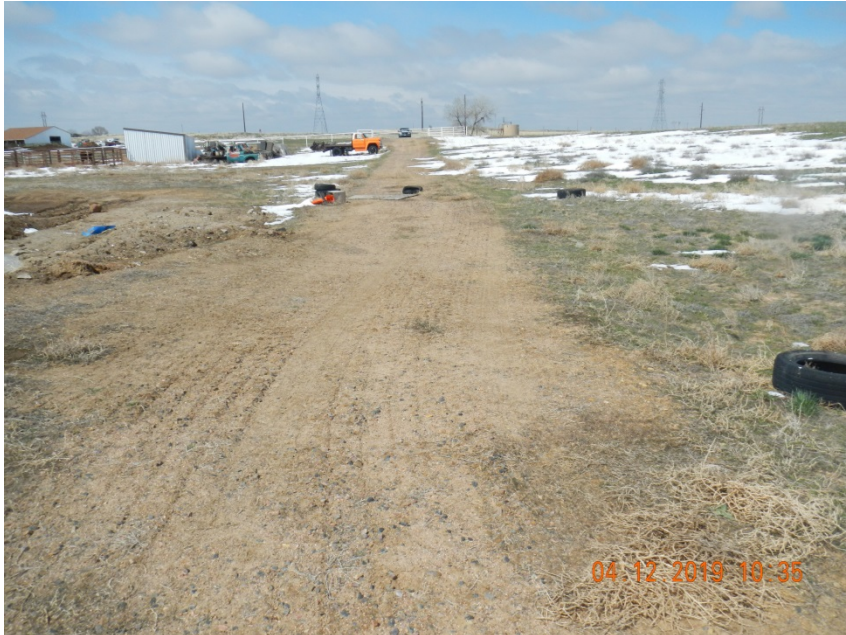
Photo 1. Photo taken from the access road, facing West. Appears Operator has performed final reclamation activities at the location with evidence of drilling rows. However along the access road the reclamation is not at percent cover and has non-uniform establishment of vegetation cover.

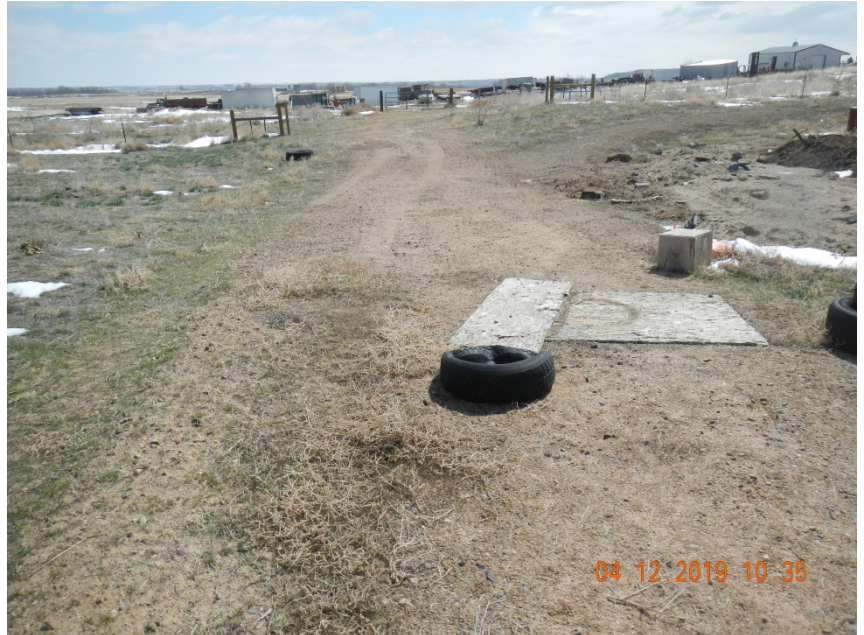
Photo 2. Photo taken from the access road, facing East. See comments from Photo 1.

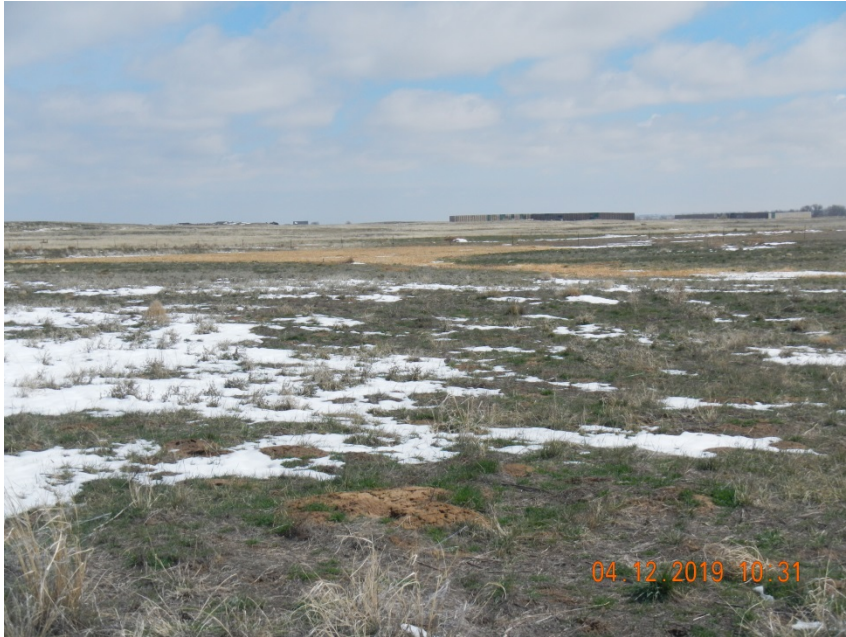
Photo 3. Photo taken looking into the location, facing Northeast. Appears Operator has performed final reclamation activities at the location with evidence of drilling rows and straw crimped mulch.

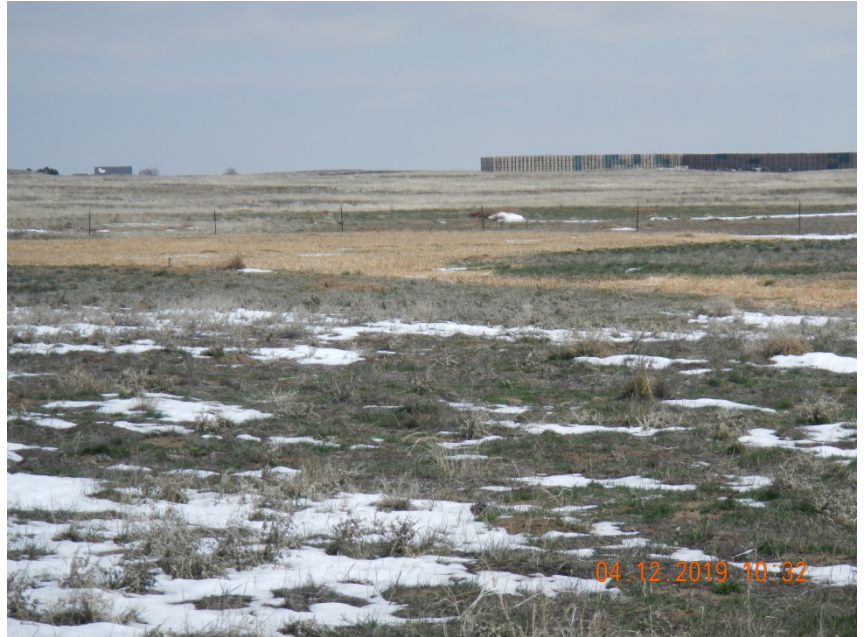
Photo 4. Photo taken looking into the location, facing Northeast. See comments from Photo 3.
