# Final Reclamation and Stormwater Inspection

Operator: KERR MCGEE OIL & GAS # 47120

Location ID: 305428

Inspection Document #: 674902788

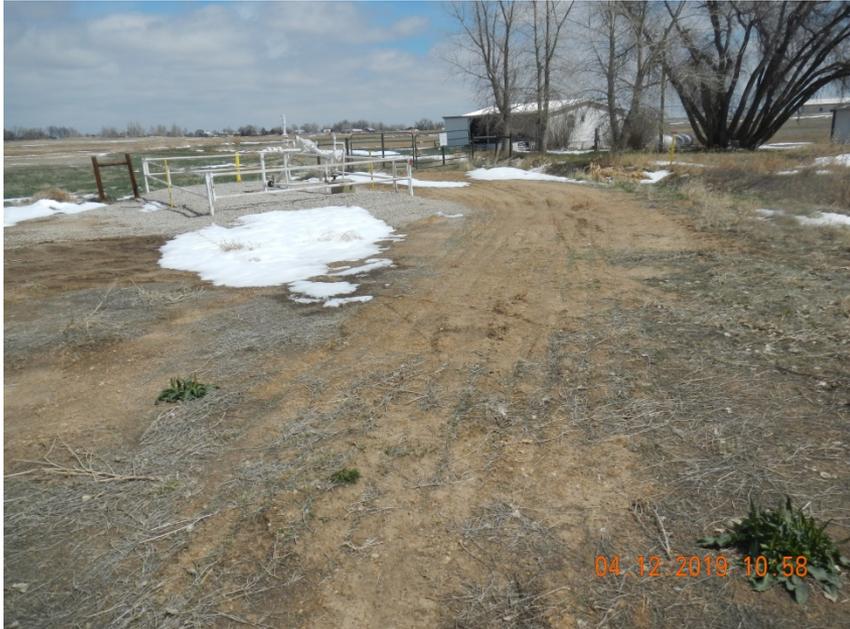
**Photo 1.** Photo taken from the access road off CR 8, facing Northeast. Appears Operator has performed final reclamation activities at the access road and facility with the evidence of drill rows, straw crimped mulch and some revegetation. However, parts of the reclamation is not at percent cover and has non-uniform establishment of vegetation cover.

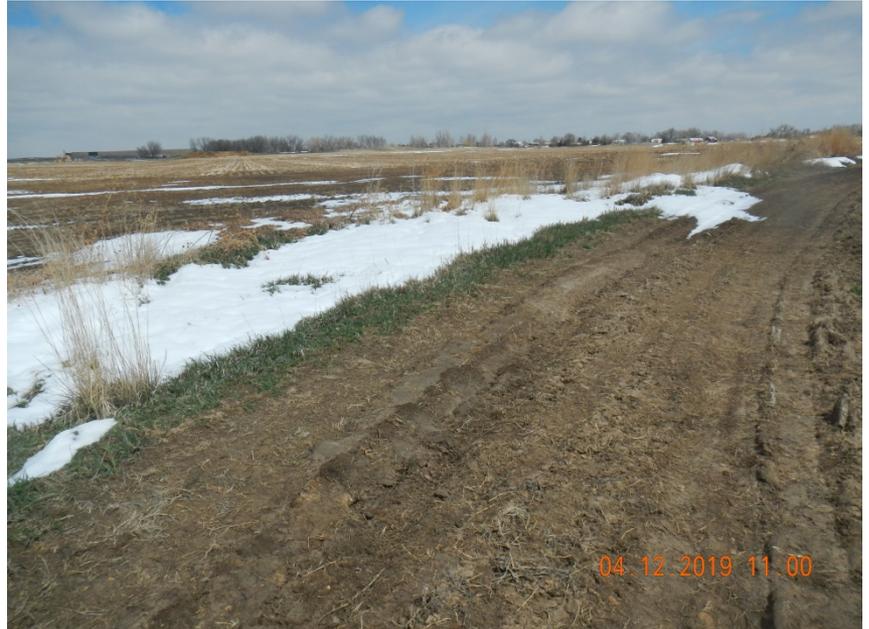
**Photo 2.** Photo taken from the existing land owner access road looking towards the location, facing North. Appears Operator has performed final reclamation activities at the location and northern part of the access road with the evidence of drill rows matching the adjacent cropland.

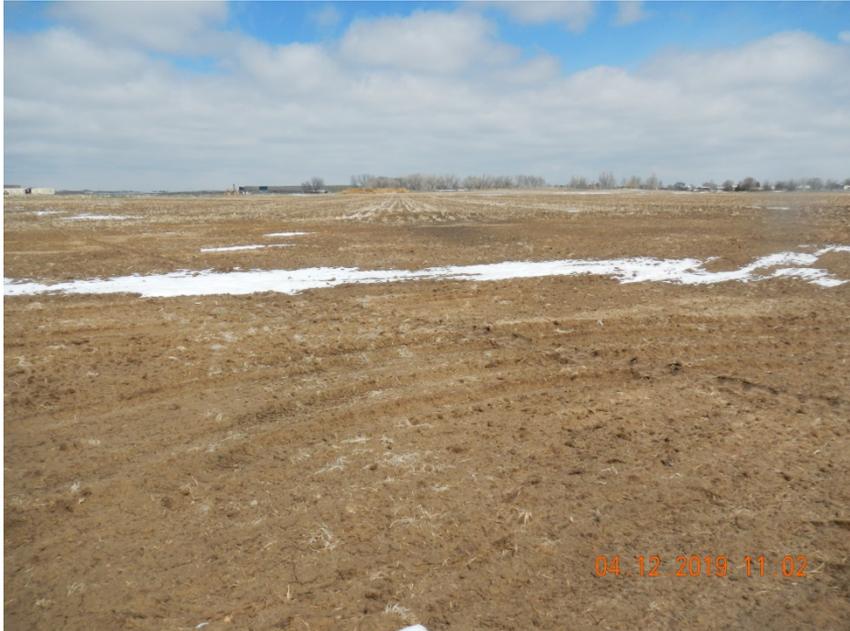
**Photo 3.** Photo taken from the location, facing North.  
See comments from Photo 2.

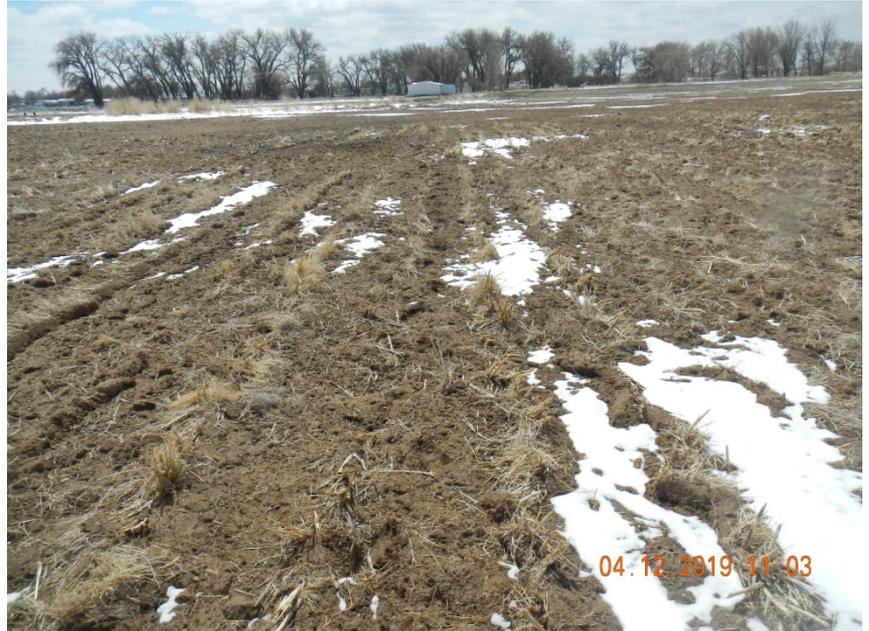
**Photo 4.** Photo taken from the location, facing South.  
See comments from Photo 2.
