Inspection Photos

Operator: BENCHMARK ENERGY LLC - 10380

Location ID: 312205

Inspection Doc. Number: 682504801

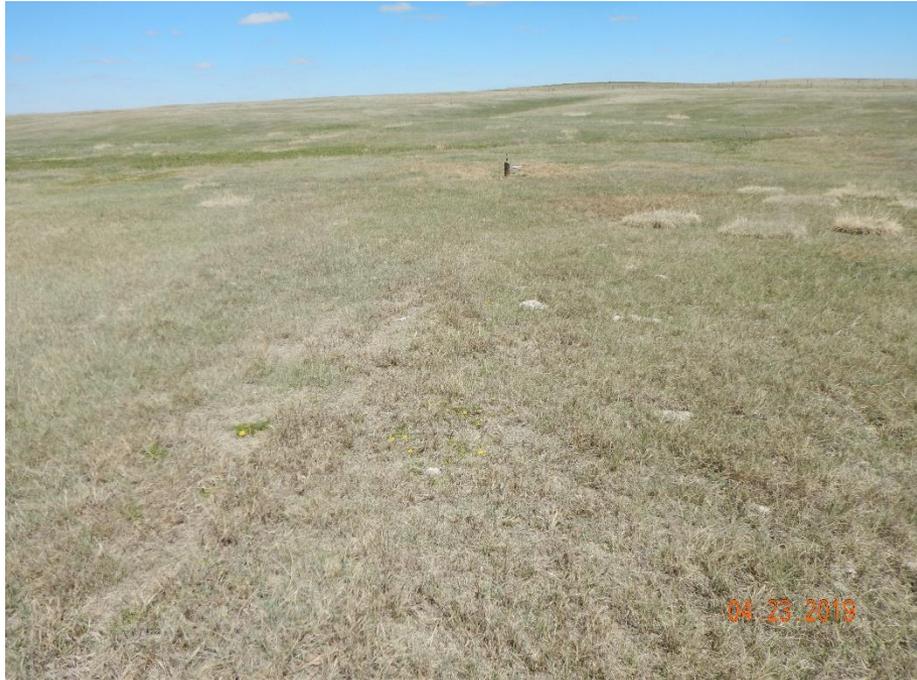
Photo 1: Photo taken from the south end of the location, facing west. Photo provides overview of the location.

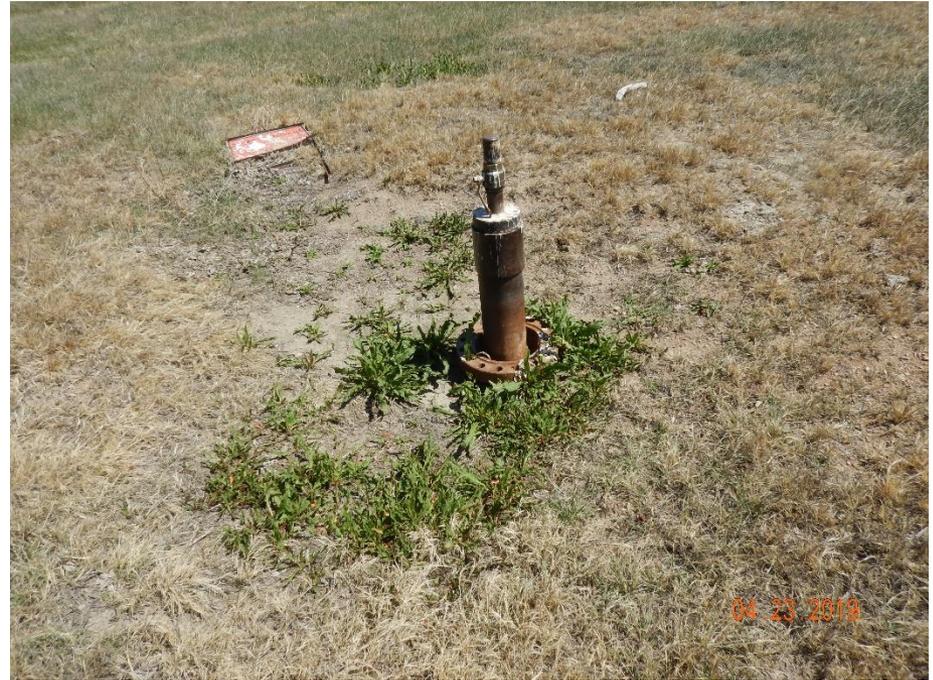
Photo 2: Photo taken from the well. Photo shows undesirable weedy plant species such as kochia and salsola sp. Have established on areas adjacent to well head. Other plant species such as Curly dock evident.

What appears to be Canada thistle rosettes evident at the well head. This is a Colorado State listed noxious weed.

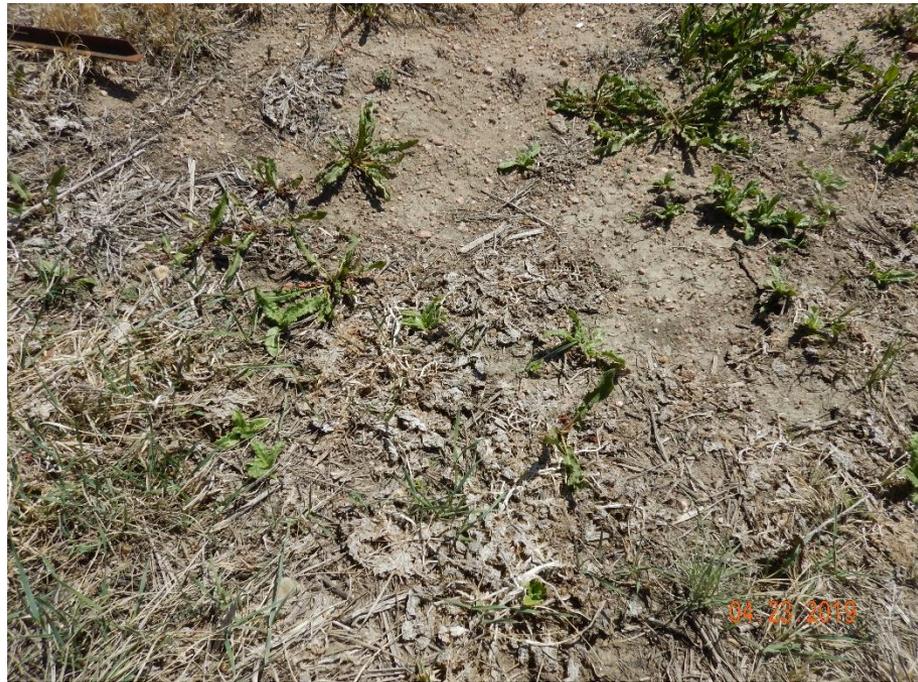
Photo 3: Photo taken from the well head. What appears to be Canada thistle rosettes evident at the well head. This is a Colorado State listed noxious weed.

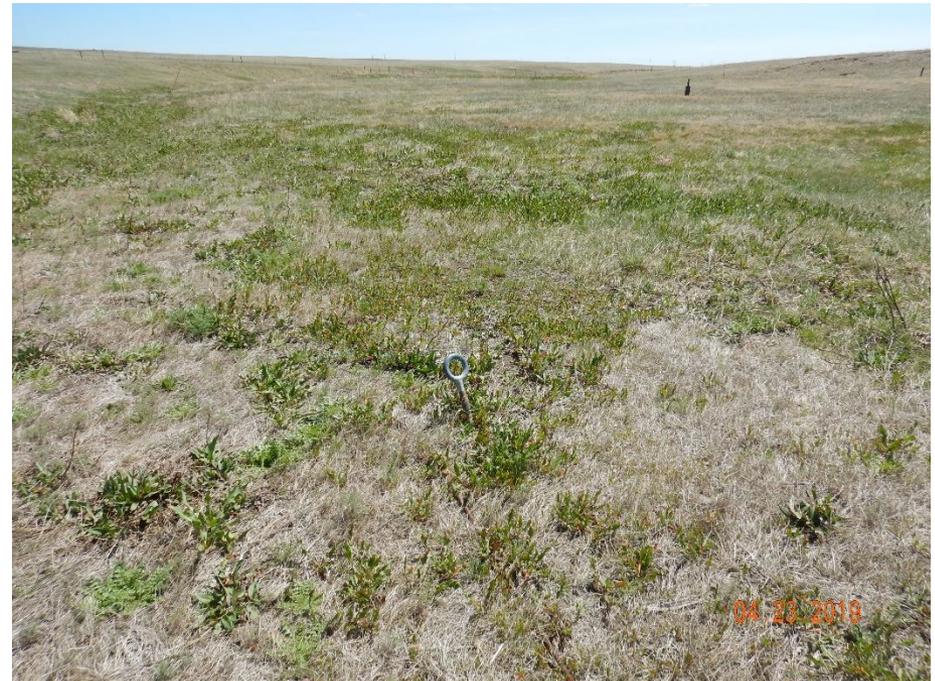
Photo 4: Photo taken from the northwest anchor, facing east. Photo shows what appears to be Canada thistle rosettes evident at the northwest and northeastern anchors. This is a Colorado State listed noxious weed.
