Inspection Photos

Operator: BENCHMARK ENERGY LLC - 10380

Location ID: 312210

Inspection Doc. Number: 682504805

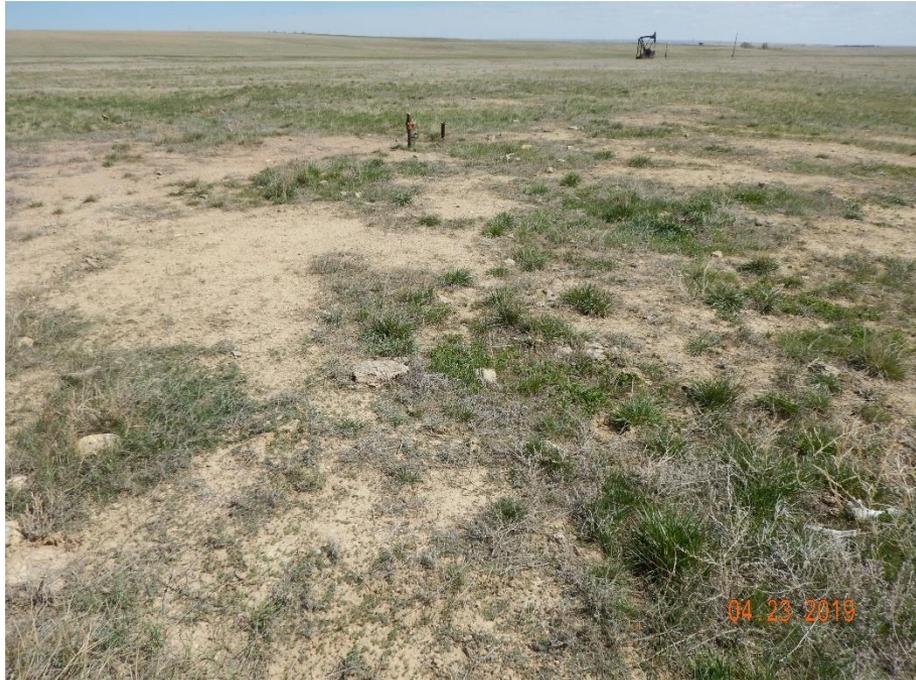
Photo 1: Photo taken from the west end of the location, facing east. Photo shows overview of the location. Undesirable weedy plant species such as kochia and salsola sp. have established on areas adjacent to, and bare areas beyond, the well head, .

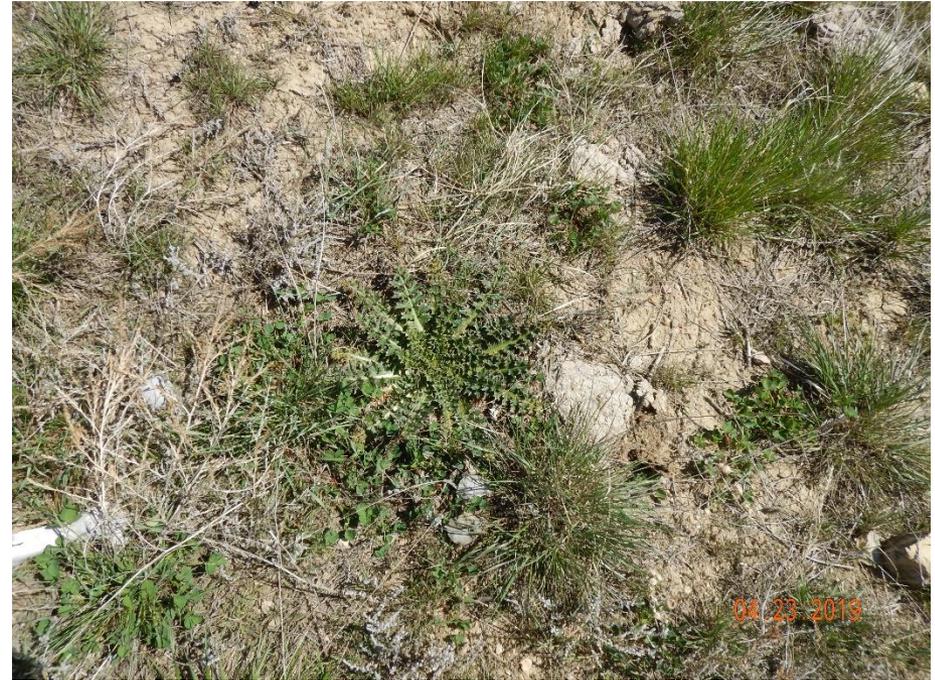
Photo 2: Photo taken from the north end of the location. Photo shows what appears to be Musk thistle rosettes evident on the location. This is a Colorado State listed noxious weed.

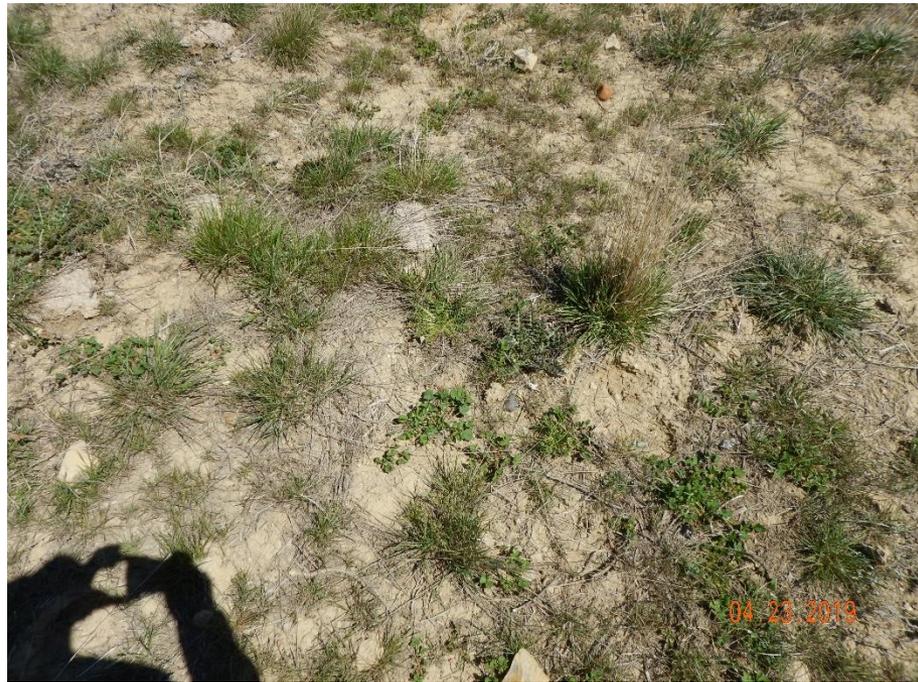
Photo 3: Photo taken from the north end of the location. Photo shows what appears to be Musk thistle rosettes evident on the location. This is a Colorado State listed noxious weed.

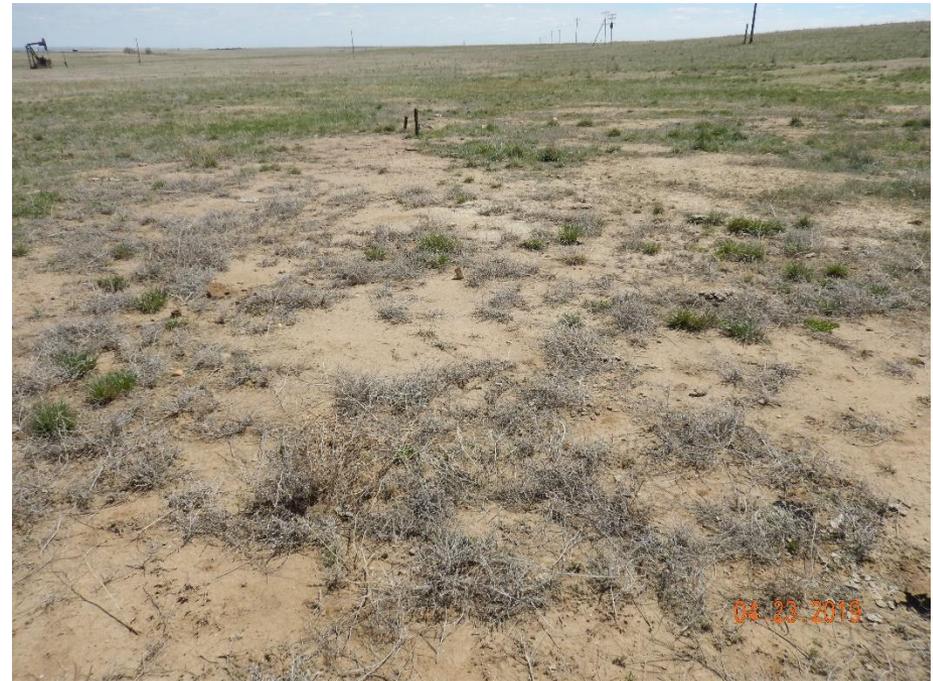
Photo 4: Photo taken from the north end of the location, facing south. Photo shows areas of the location that predominantly vegetated by undesirable weedy plant species such as Kochia and Salsola sp.
