Inspection Photos

Operator: VERDAD RESOURCES LLC # 10651

Location ID: 462872

Inspection Doc. Number: 682504821

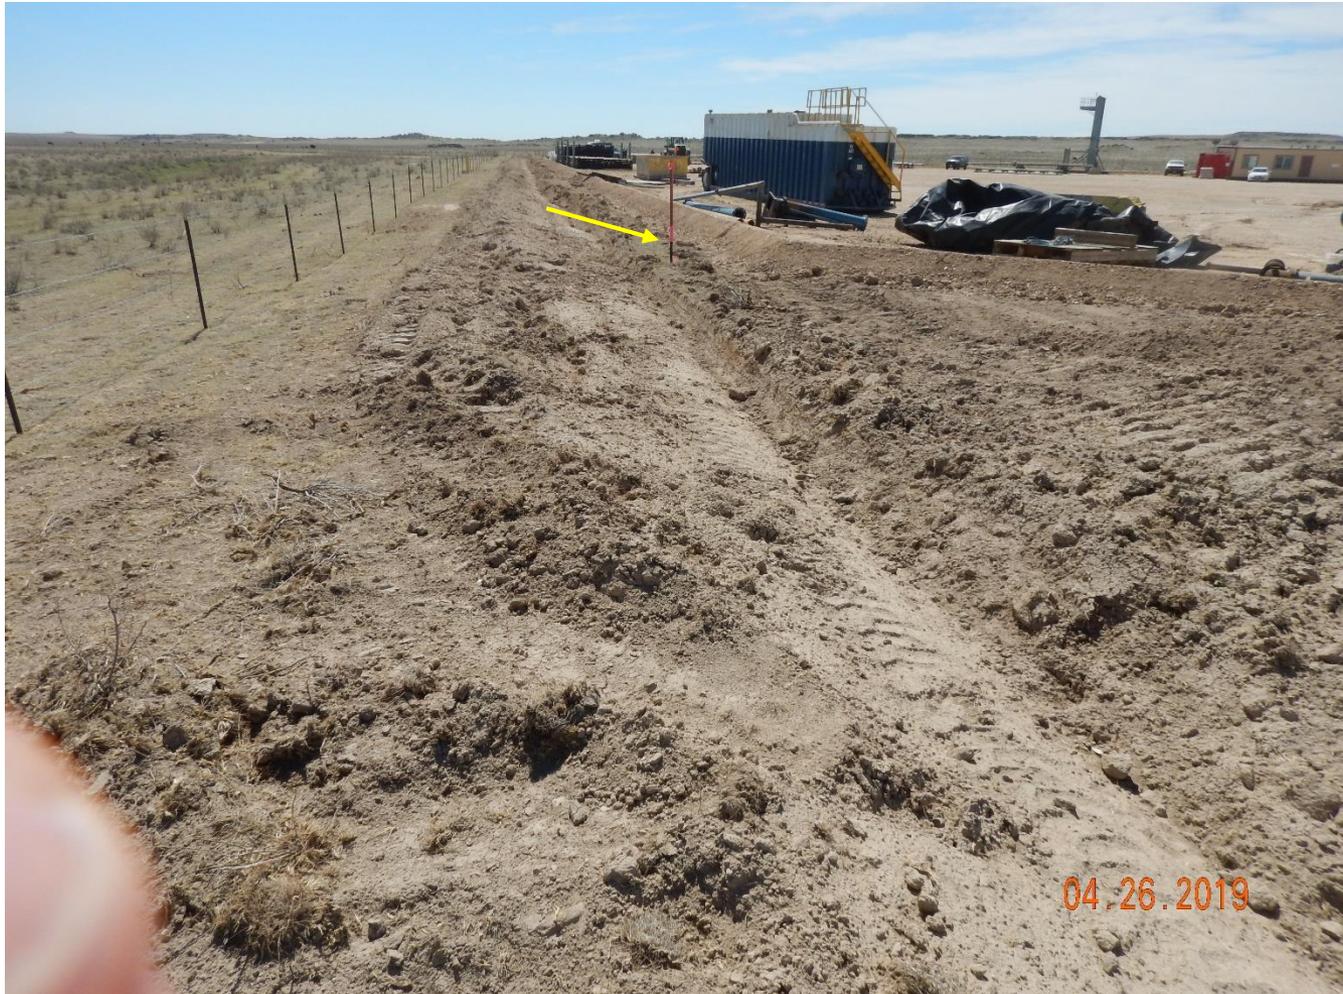
Photo 1: Photo taken from the northeast corner of the location, facing south. Photo shows survey stakes. Operator states within FIRR 401983658 that location was re-surveyed, and that the location has been constructed within the stakes. Photo shows that there area areas of the location's disturbance beyond the survey stakes on the north end of the photo.

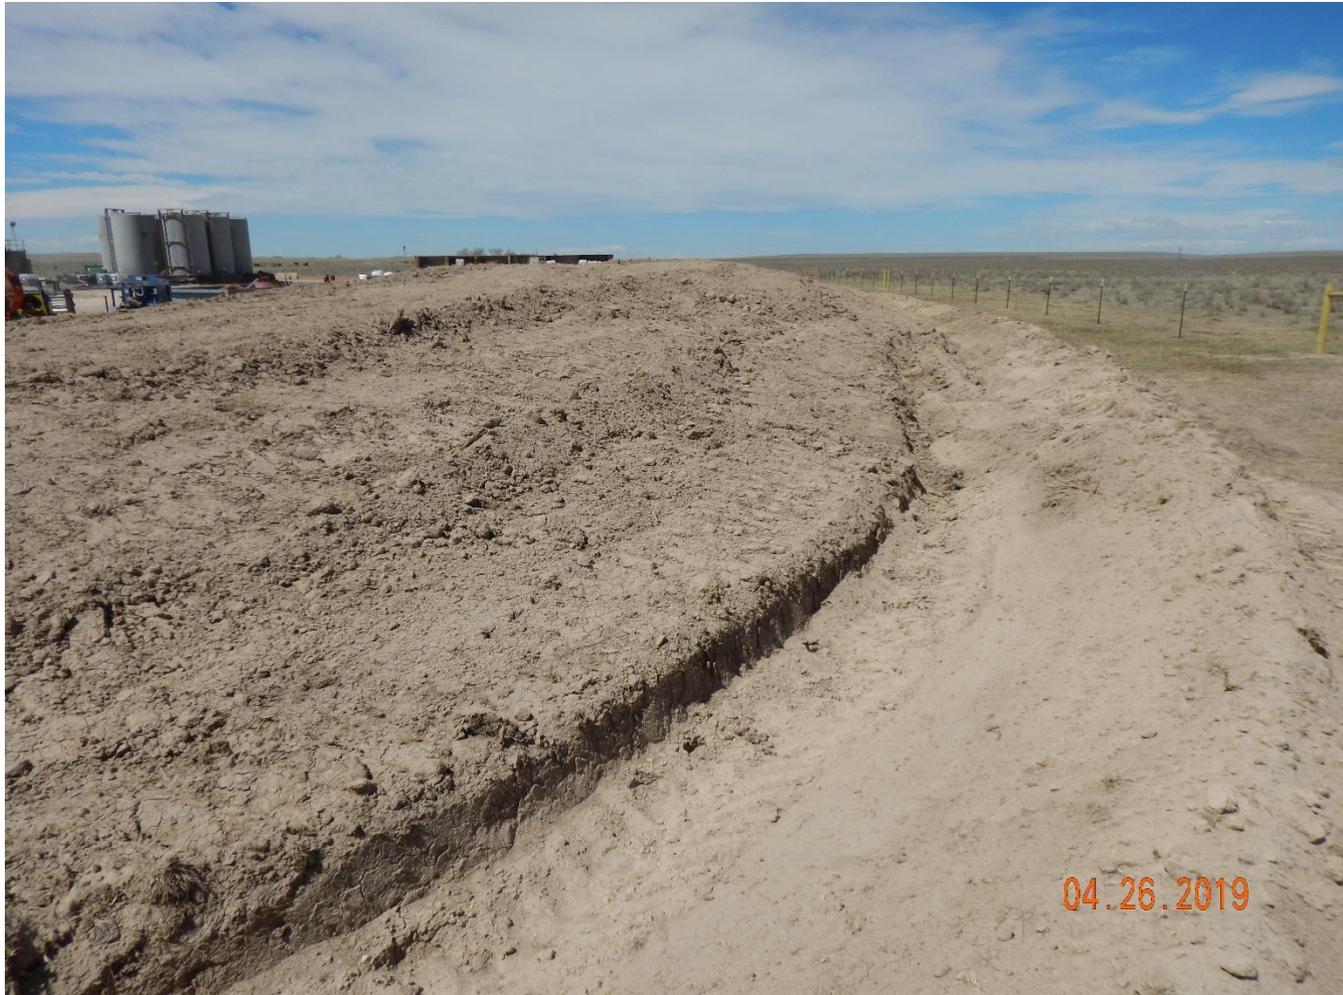
Photo 2: Photo taken from the northeast corner of the location, facing west. Operator states within FIRR 401983658 that location was re-surveyed, and that the location has been constructed within the stakes. Photo shows that there are areas of the location's disturbance beyond the survey stakes on the north end of the location.

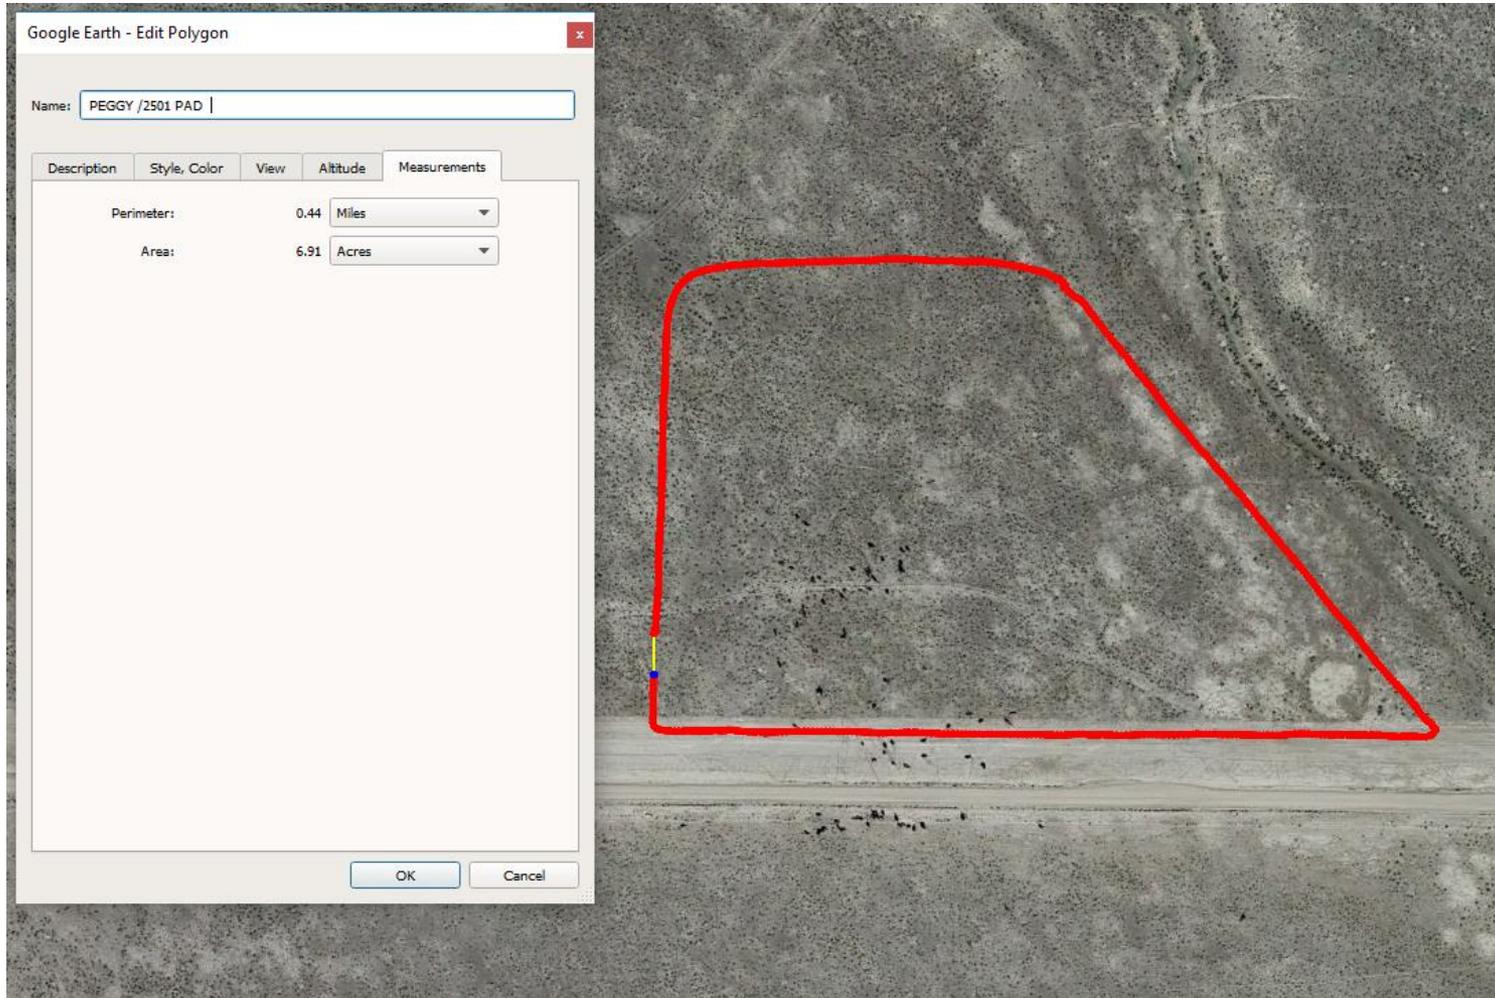
Photo 3: On 4/26/2019, inspector mapped the perimeter disturbance area (stormwater ditch, pad, soil stockpiles), not including the access road, with a Trimble Juno 3B GPS unit. Photo shows a disturbance area of 6.9 acres; this appears to exceed the permitted disturbance area per the approved Form 2A.
