This addresses photos 7, 8 in the COGCC inspection photos document.

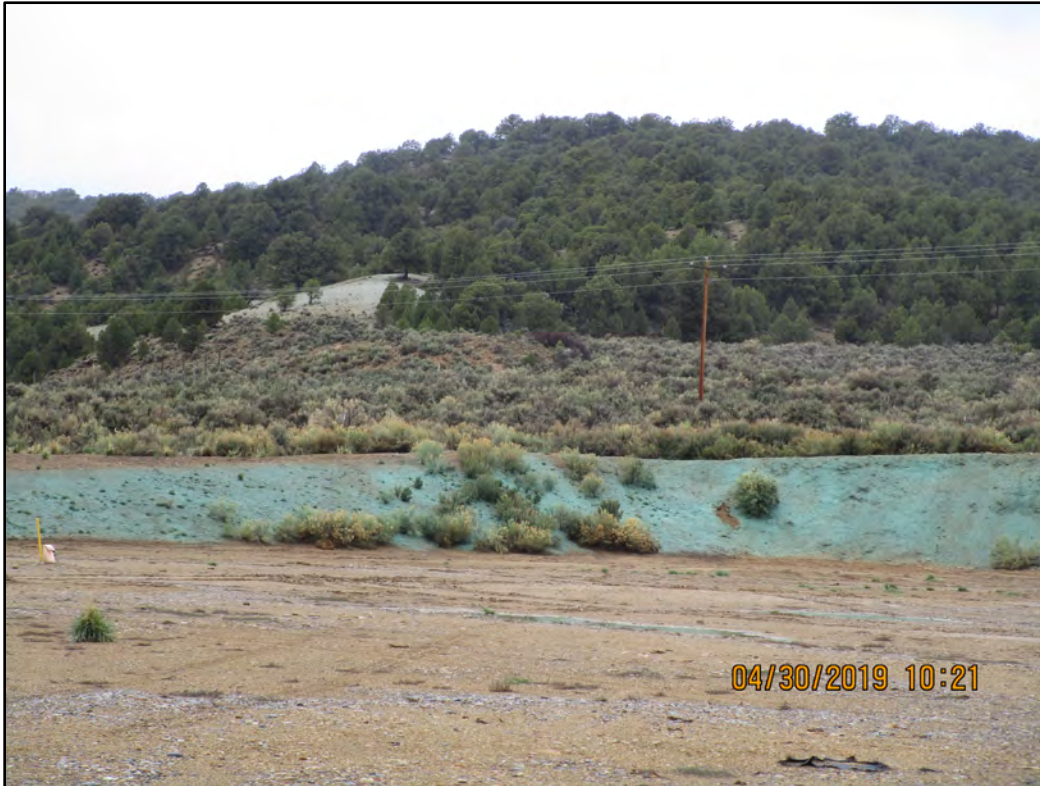
Netting and weed debris were removed once weather conditions allowed.

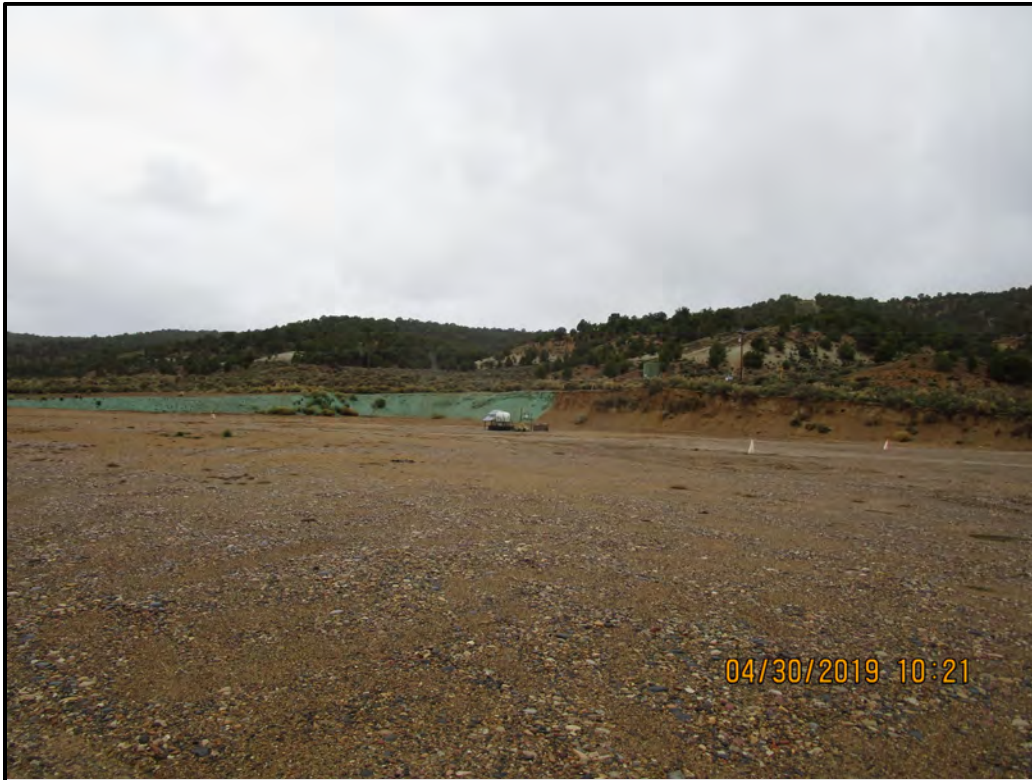
Photo 2

Cut slope (1:2 slope, has been hydro-mulched with Flexterra and seed. The vertical cut slope will be hydro-mulched with Promatrix to stabilize cut from erosion.

Site is saturated at the moment from rain and snow over the last two days. The Promatrix will be applied once pad has dried enough for large equipment to access without damaging pad surface.
