Inspection Photos

Operator: GRAND MESA OPERATING CO #
35080

Location ID: 456610

Inspection Doc. Number: 696200007
Lincoln County, CO

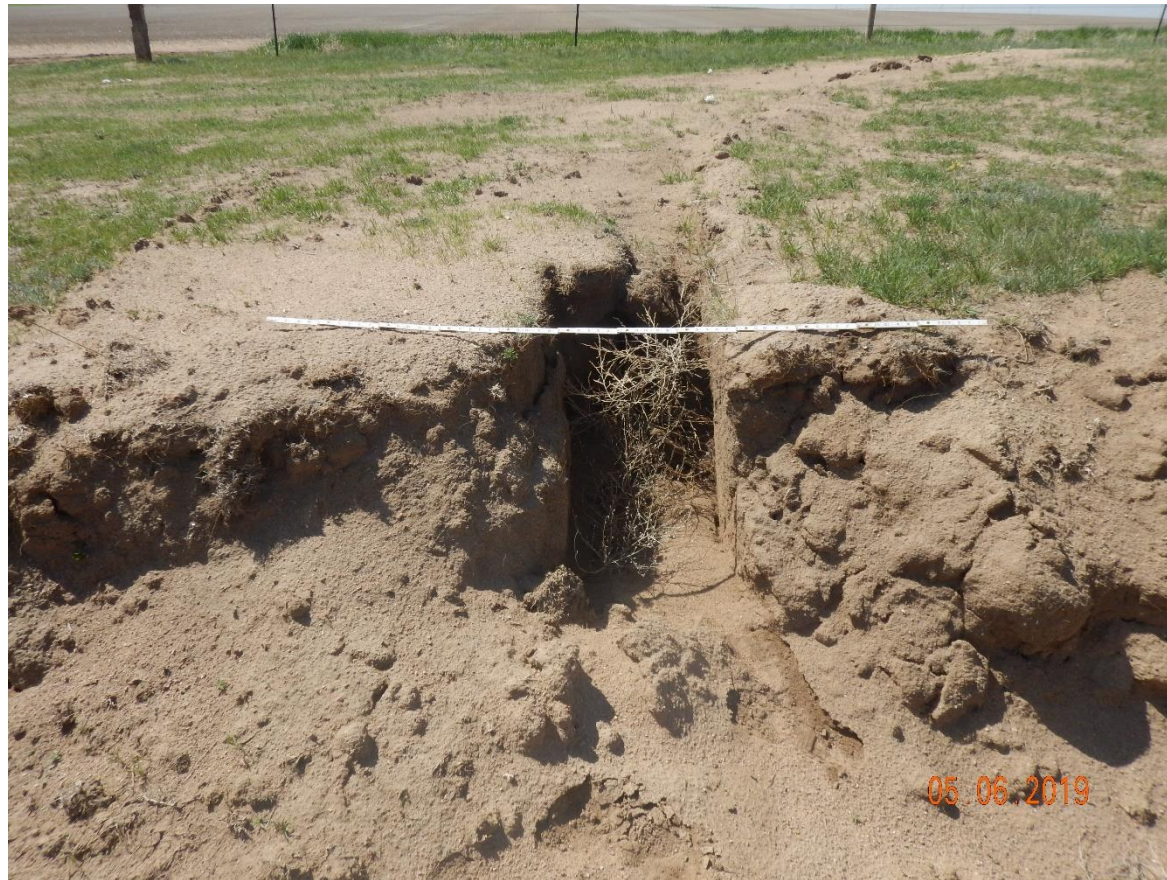
Photo 1: Photo taken from the south end of the location, facing south. Photo shows erosion degradation occurring on the south end of the location. 6 foot measuring stick for reference.

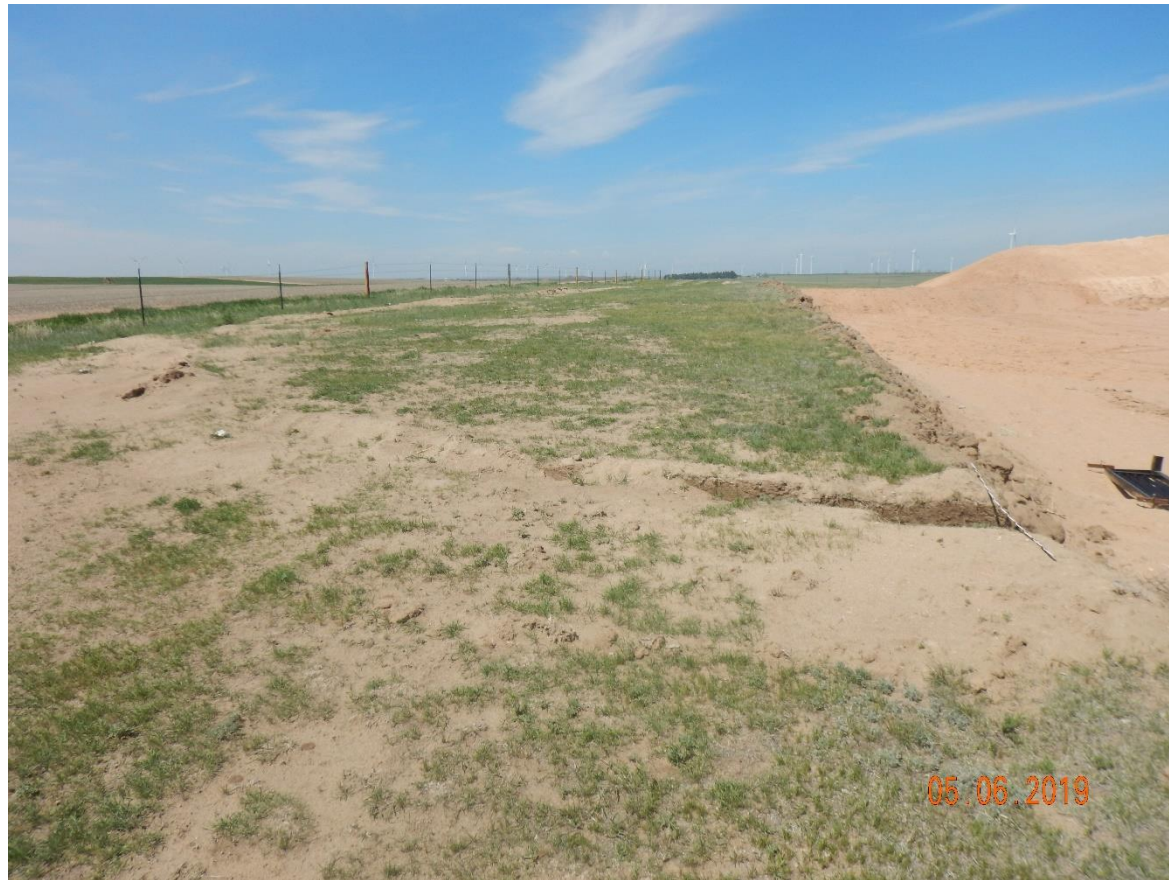
Photo 2: Photo taken from the south end of the location, facing west. Photo shows erosion degradation occurring on the south end of the location. 6 foot measuring stick for reference.

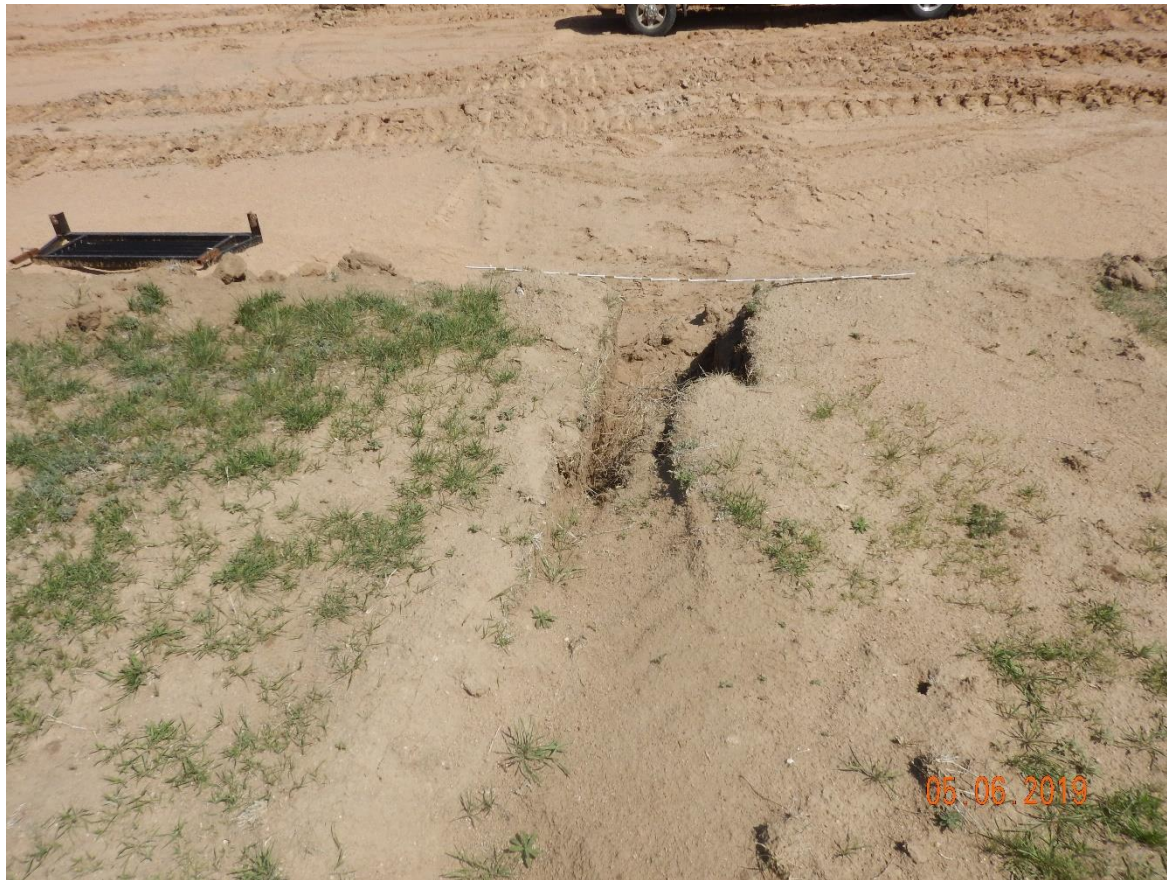
Photo 3: Photo taken from the south end of the location, facing north. Photo shows erosion degradation occurring on the south end of the location. 6 foot measuring stick for reference.

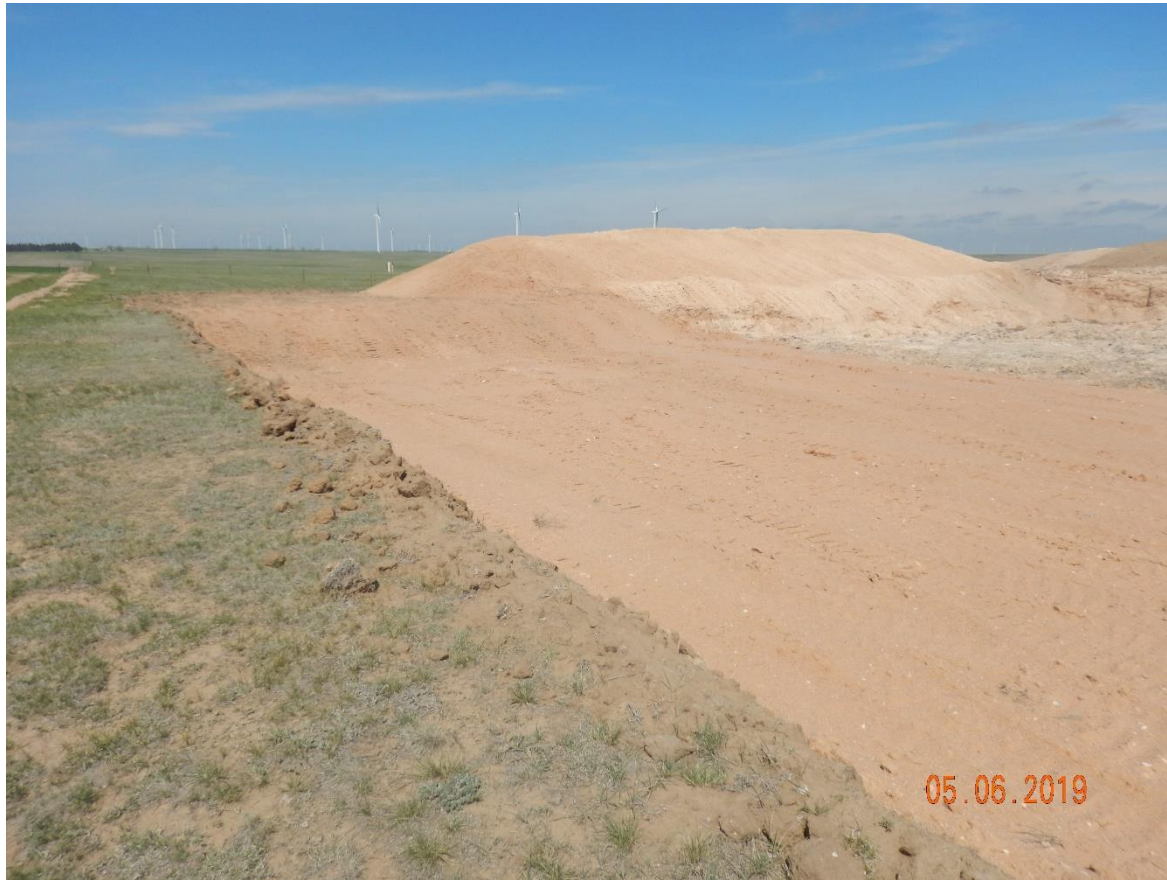
Photo 4: Photo taken from the south end of the location, facing west. Photos 4-7 provide an overview of the location from west, northwest, northeast to east. Photos shows interim reclamation activities do not yet appear to have been conducted on the location.

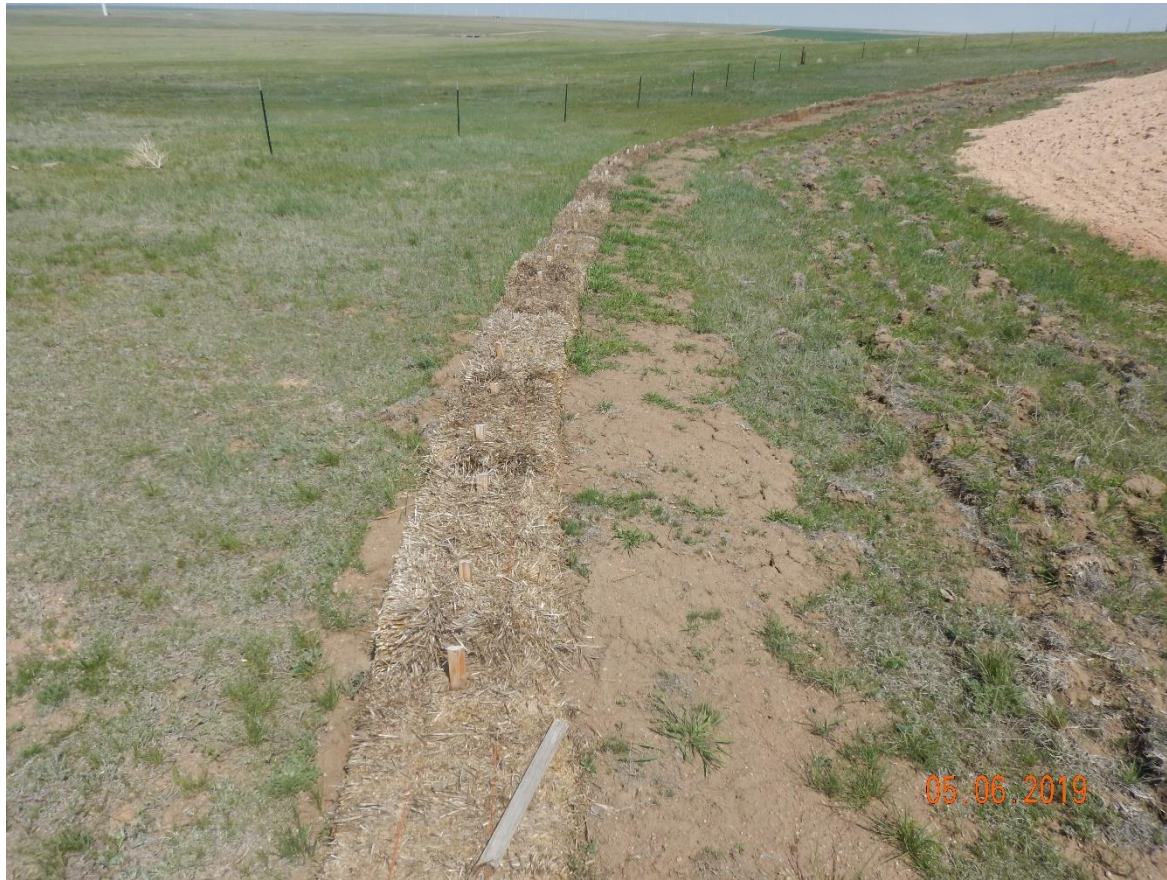
Photo 8: Photo taken from the west end of the location, facing north. Photo shows straw bale wattles. BMPs appear to be in proper functioning condition.

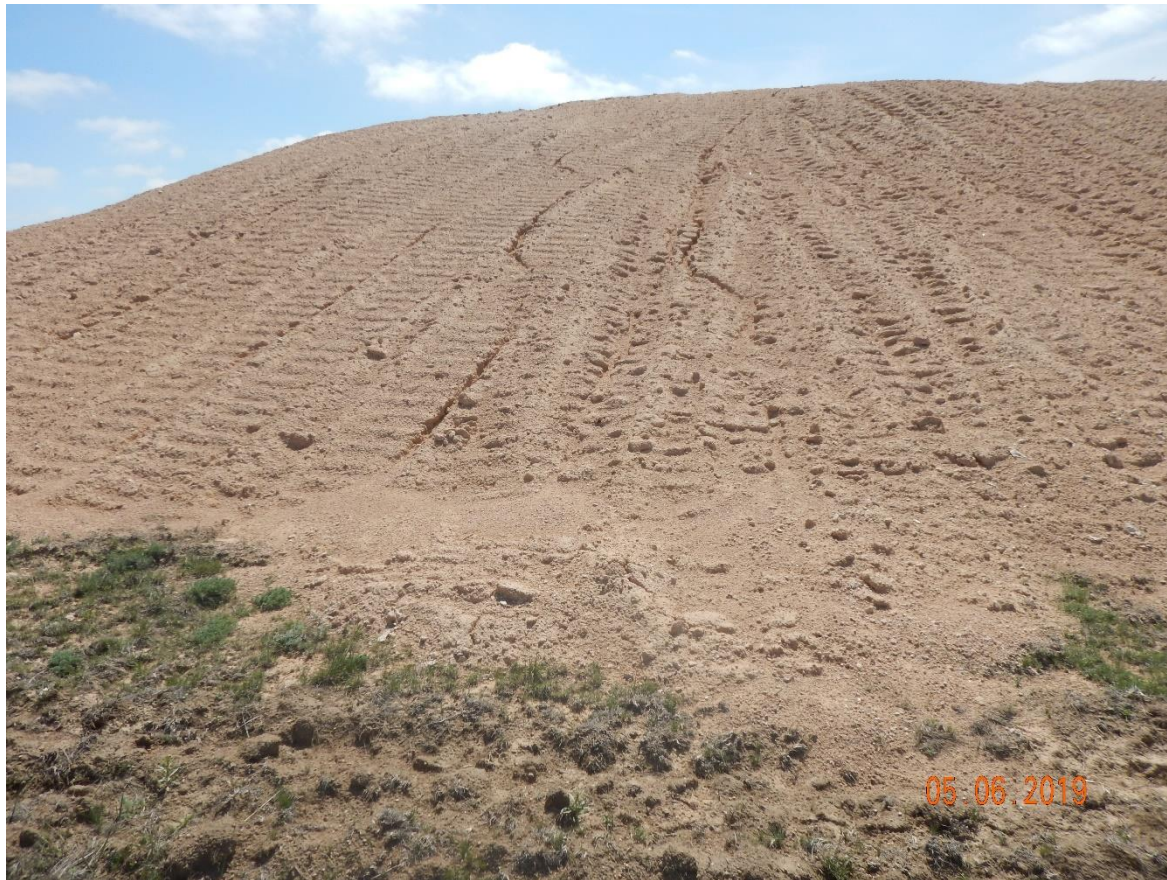
Photo 9: Photo taken from the west end of the location, facing east. Photo shows erosion degradation occurring on slopes of the soil stockpile and sediment deposition.

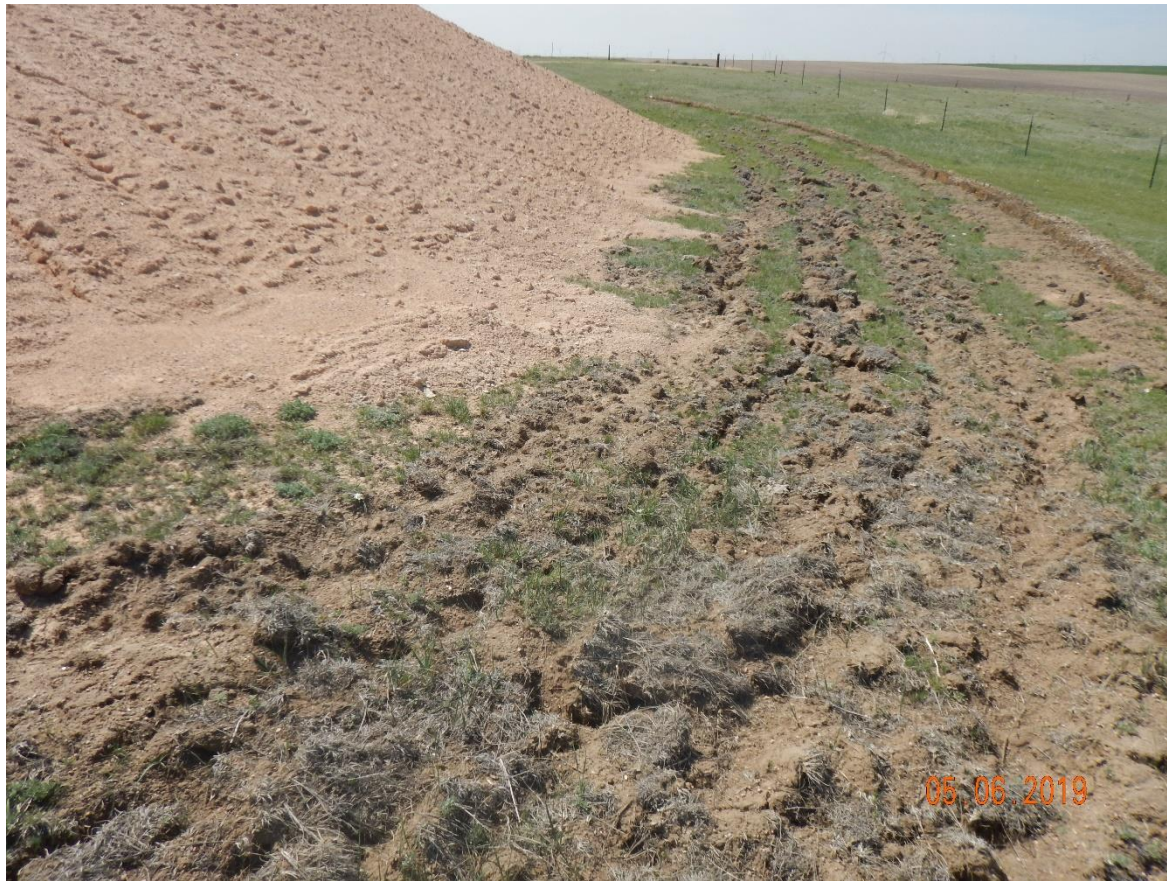
Photo 10: Photo taken from the west end of the location, facing south. Photo shows erosion degradation occurring on slopes of the soil stockpile and sediment deposition. Surface roughening (ripping) appears to be catching the runoff from the stockpile mitigating any sediment transport off-site. Continue to monitor and manage location for stormwater and conduct maintenance as needed.

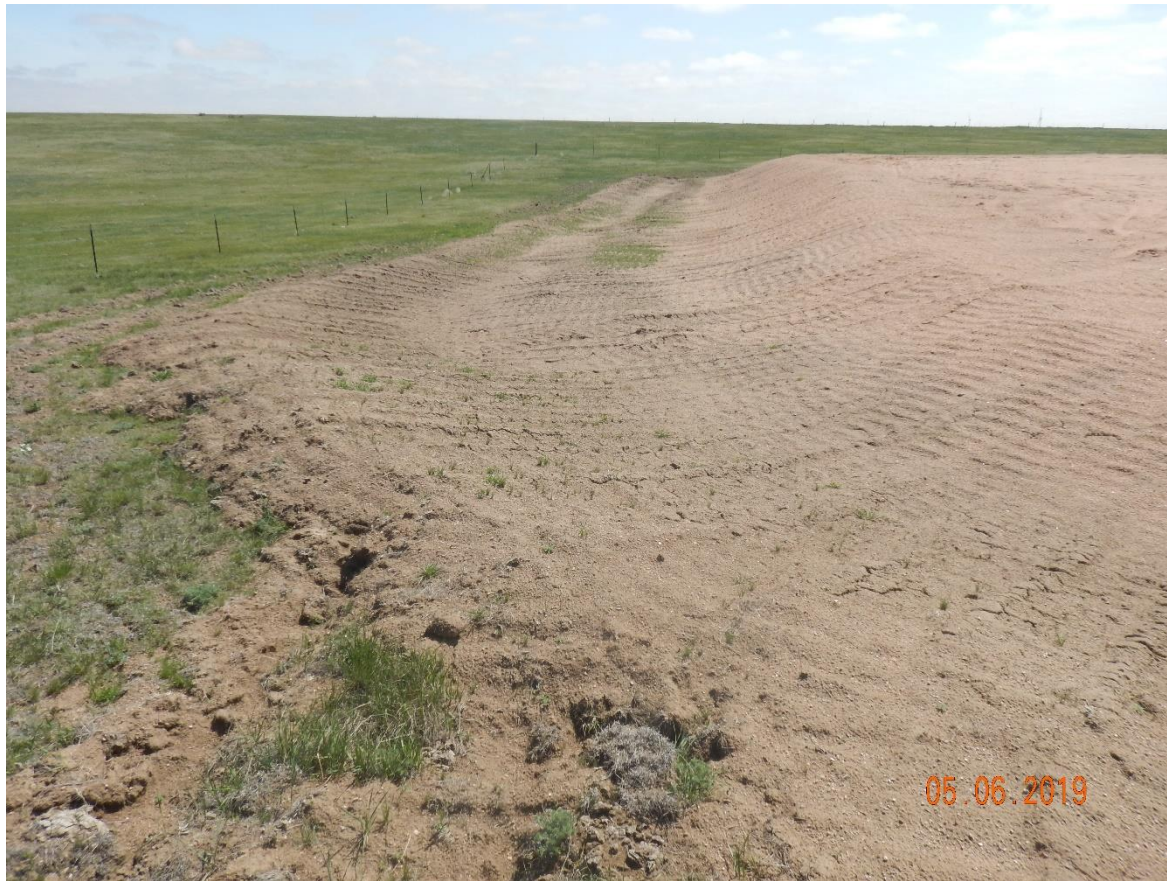
Photo 11: Photo taken from the northwest corner of the location, facing east. Photo shows the berm at the perimeter of the pad, and the ditch/berm at the perimeter of the location. Photo also shows tracking on slopes. BMPs appear to be in proper functioning condition.
