Inspection Photos
Location Name: NEITOS 23-28
API #: 05-071-06514
INSP. #:695100634

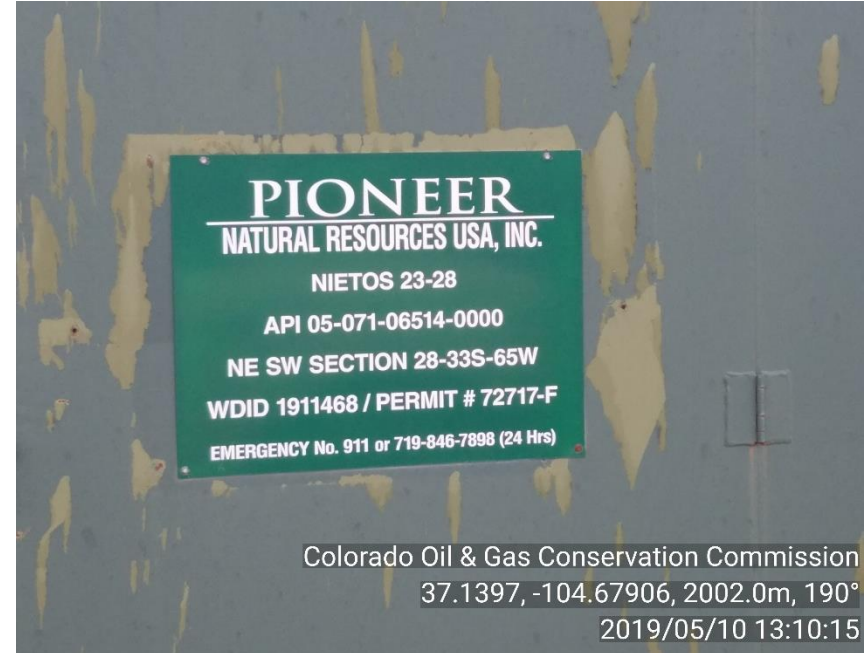
PHOTO 2: WELL SIGN/ OPERATOR ON POSTED WELL SIGN IS
INACCURATE **Install sign to comply with Rule 210.b. CA DUE DATE
7/10/19**
