**Inspection Photos**  
**Location: Craig #1-7**  
**Inspection Date: 5/8/19**  
**All Photos taken by COGCC staff Kris Neidel**

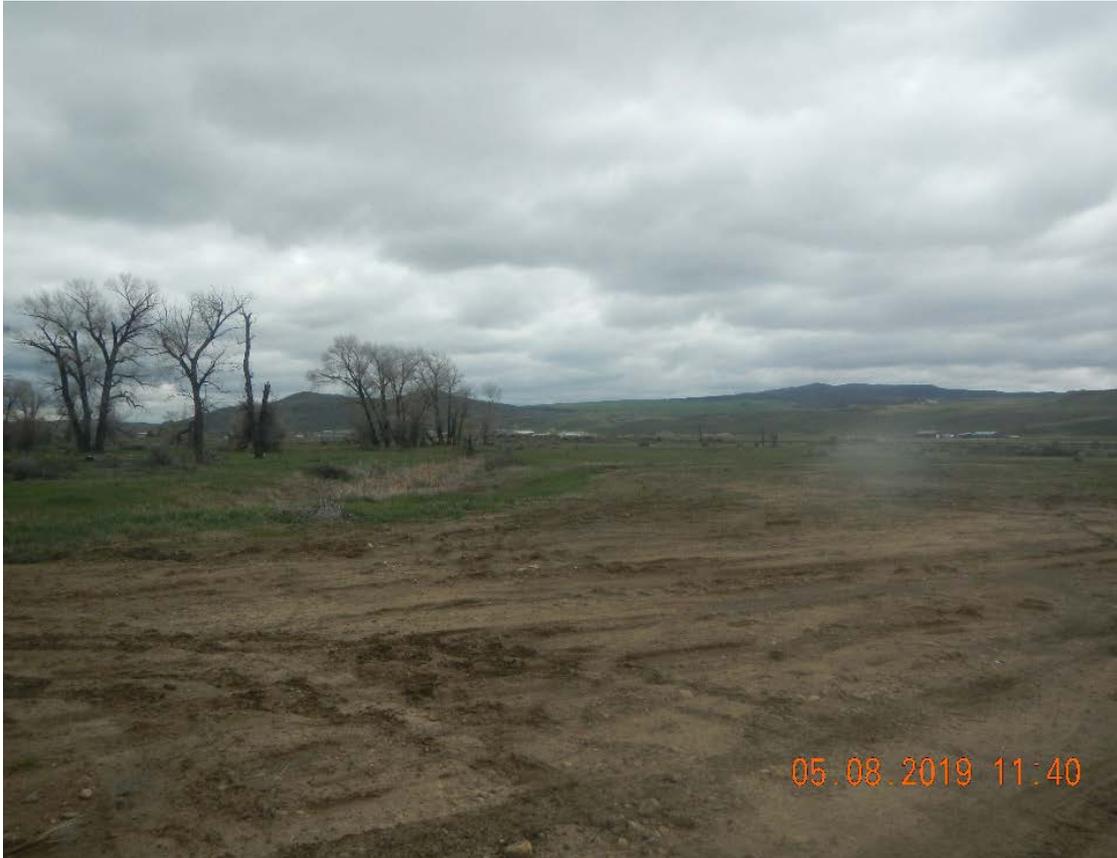
**Photo 1 – looking south-east. Foreground shows access road. The area just past the access road is where the tank battery was. Some trash was observed on the location; gloves, bottles, cans.**

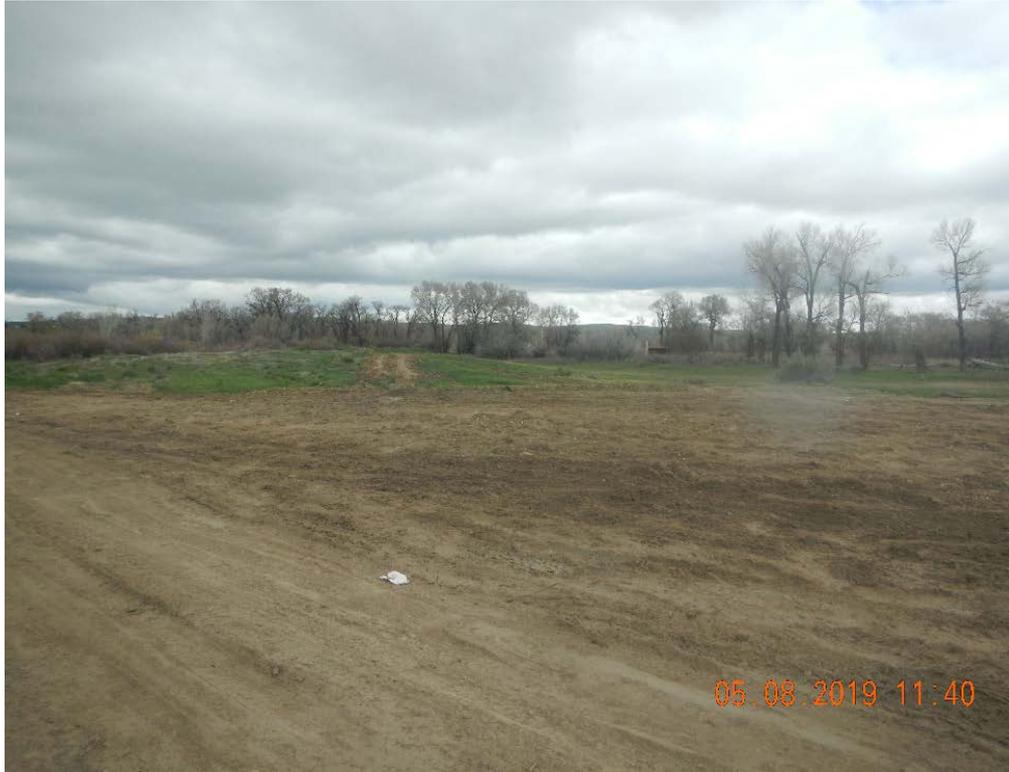
**Photo 2 – looking north-northeast. This is where the well and pumpjack were. In the foreground is the access road that goes to the Yampa River. A piece of cable was observed in the grassy area north of well, per rule 603.f remove all trash. A deadman anchor was observed to the east of the well.**
