# Inspection Photos

Operator: PCR OPERATING LLC - 10657

Location ID: 313705

Inspection Doc. Number: 696200044

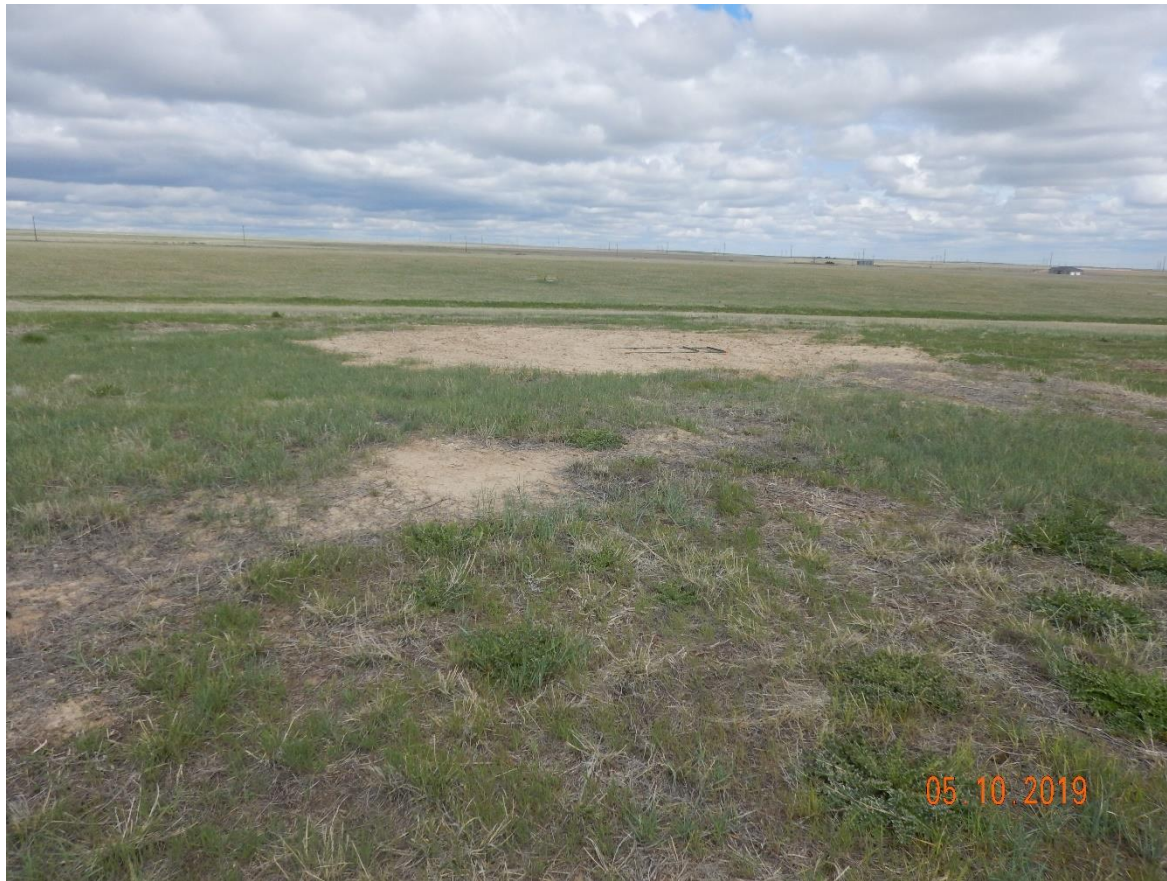
**Photo 1:** Photo taken from the southeast end of the location, facing northwest. Previous inspection documented a pump base remaining on the location, and that location remained predominantly undesirable weedy plant species. Inspection required operator to conduct reclamation in accordance with 1004.a. Photo shows concrete base has been removed. However, unable to find evidence that reclamation work beyond the removal of the base has been conducted.

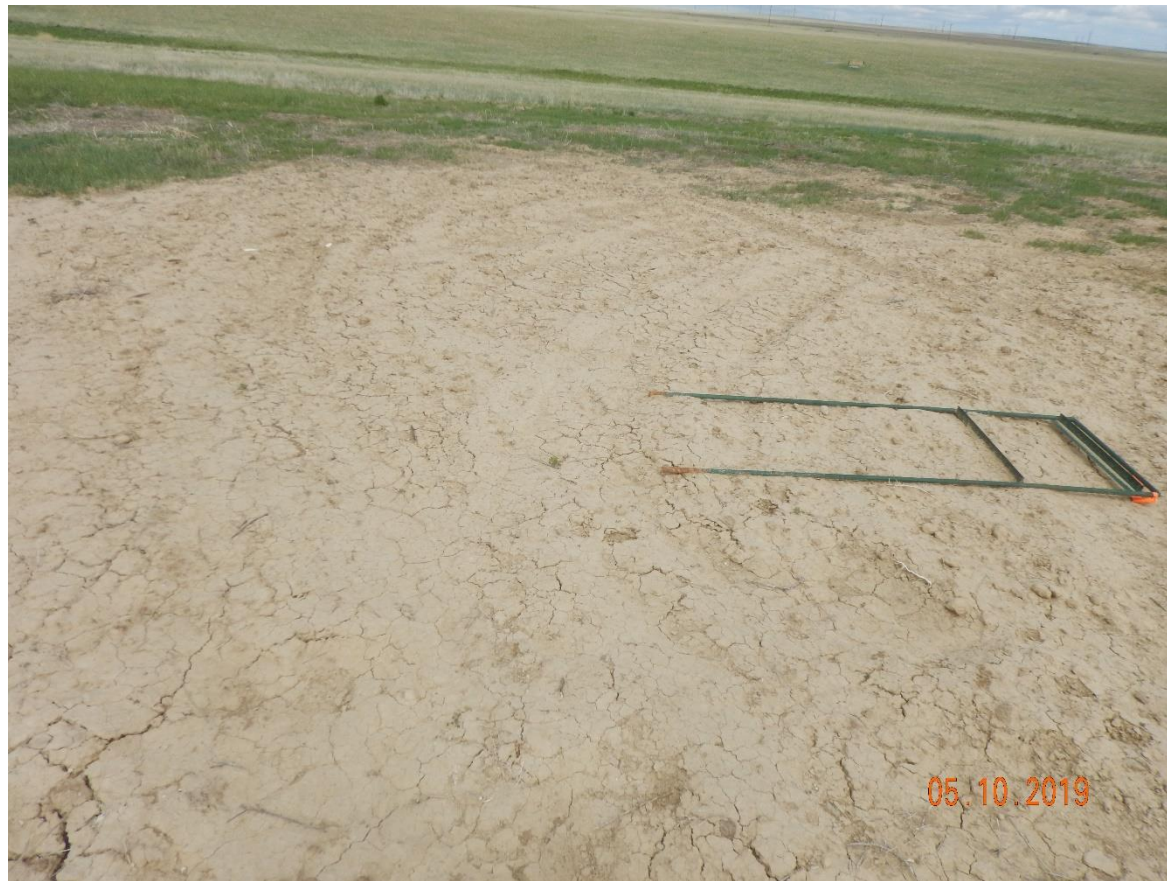
**Photo 2:** Photo shows concrete base has been removed. Photo also show no other reclamation activities appear to have been conducted on the location; unable to find evidence that revegetation/seeding activities have been conducted, or stabilization BMPs installed. Location remains predominantly exposed soil or undesirable weedy plant species. Photo also shows metal sign holder has been left at well site. This needs to be removed.

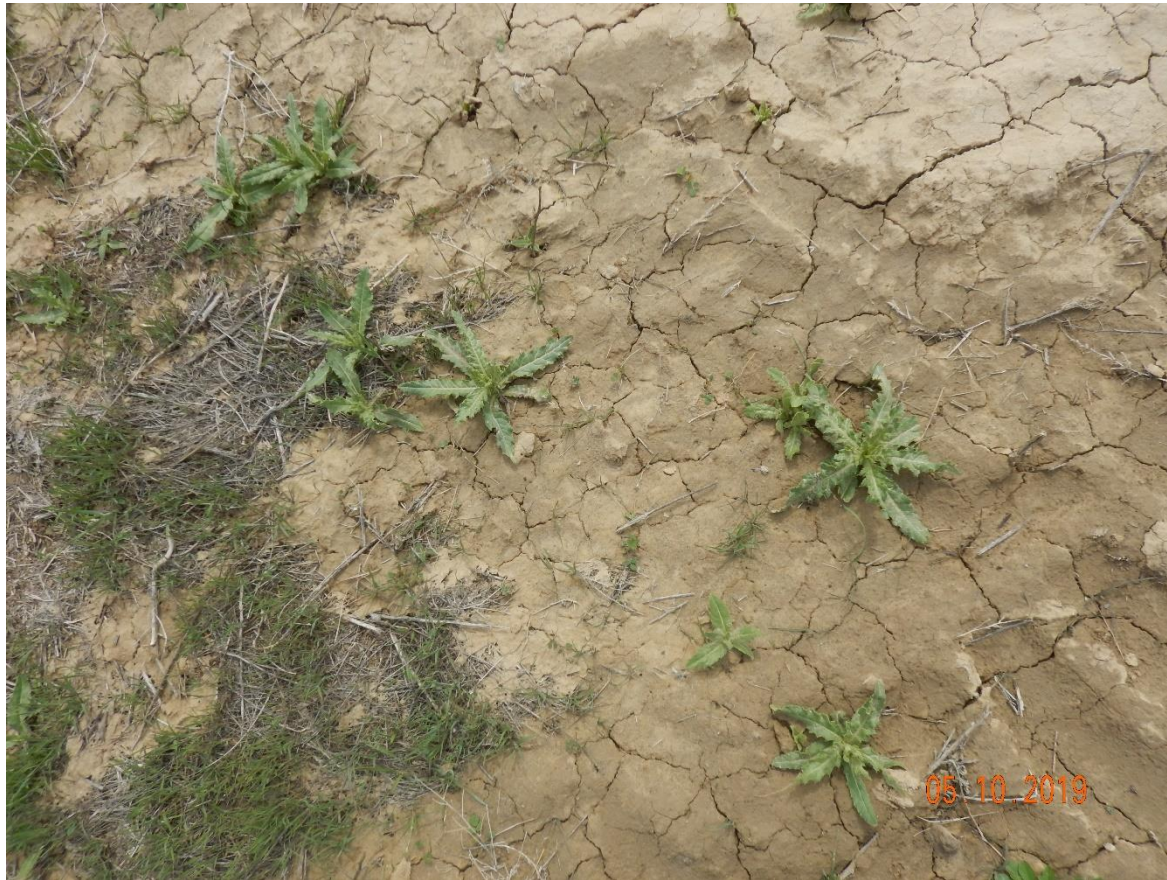
**Photo 3:** Photo taken from the location. Photo shows Canada Thistle (*Cirsium arvense*) establishing on the location. This is a Colorado State listed noxious weed and needs to be managed

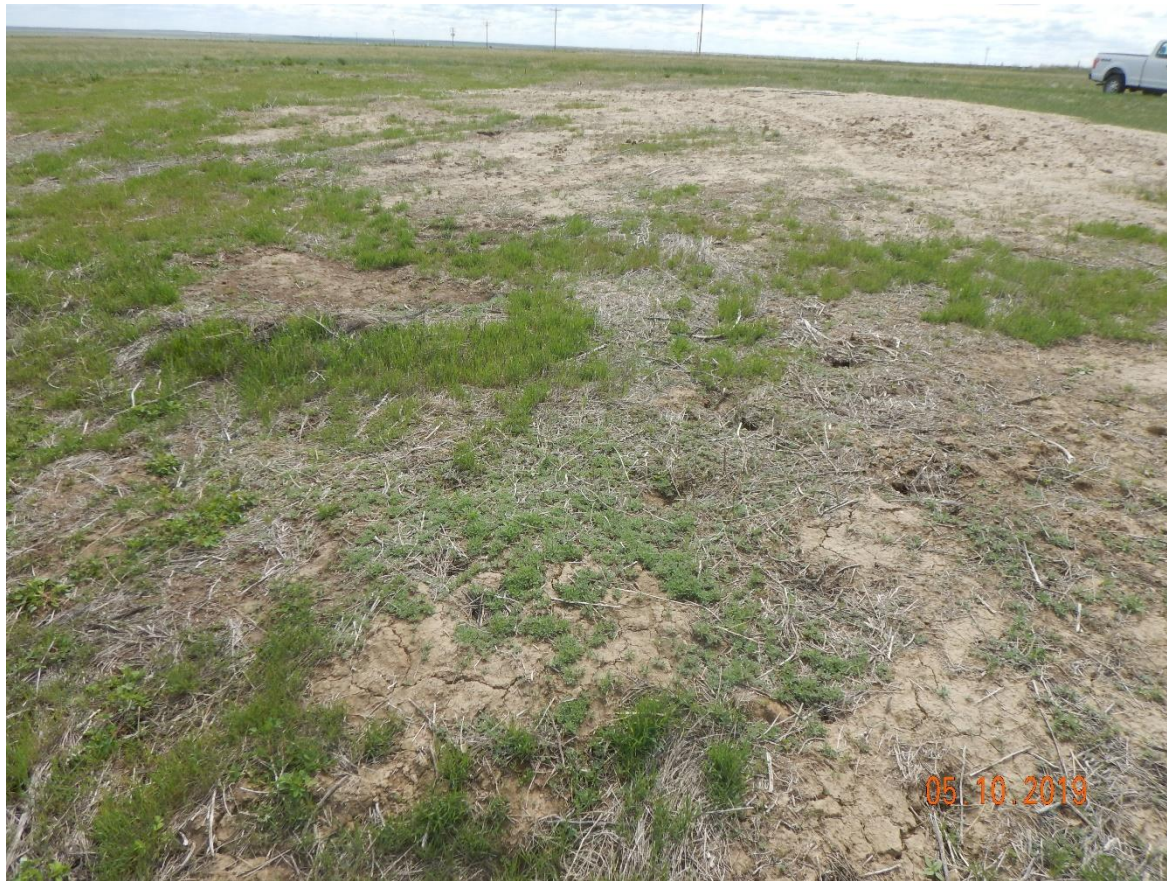
**Photo 4:** Photo taken from the northwest corner of the location, facing southeast. Photo shows reclamation on the entire location does not appear to have been conducted in accordance with 1004.a. Location remains exposed soil or predominantly undesirable weedy plant species.

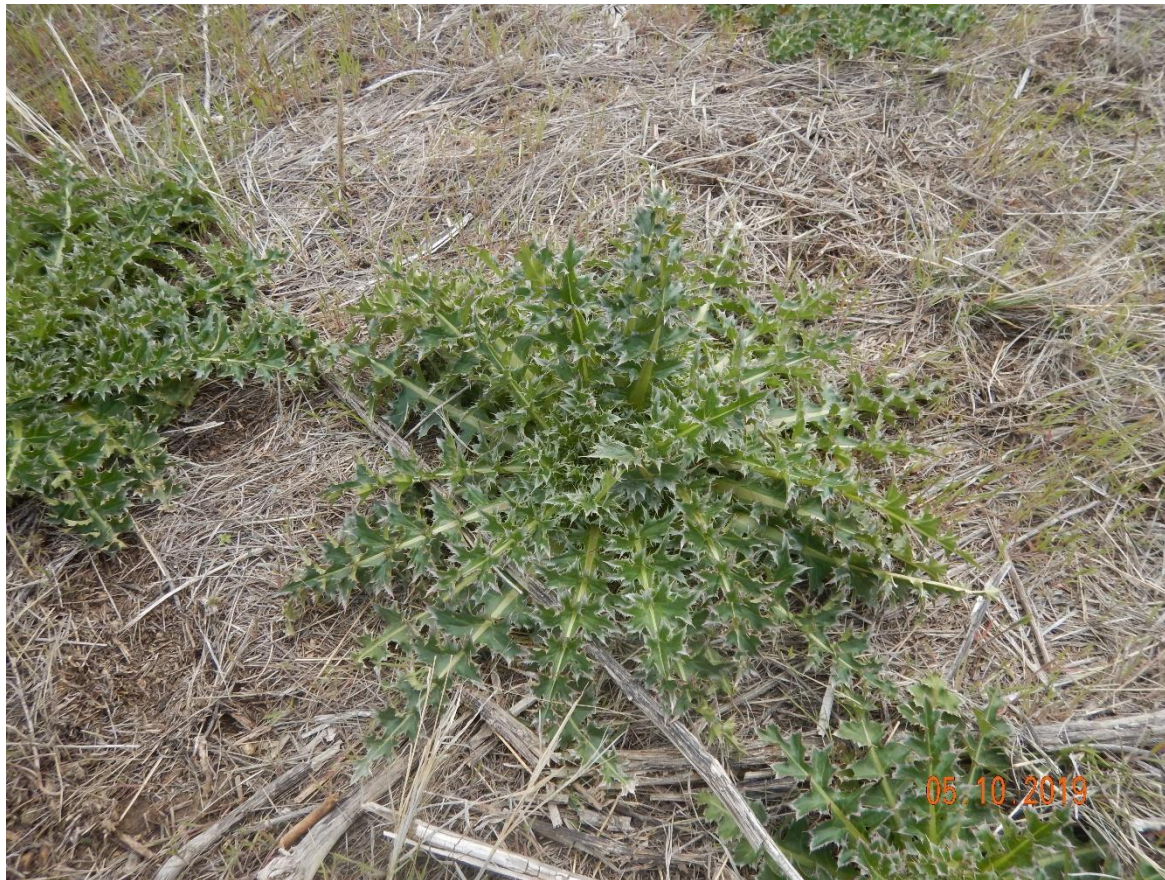
**Photo 5:** Photo taken from the of the location. Photo shows Scotch Thistle (*Onopordum acanthium*) establishing on the location. This is a Colorado State listed noxious weed and needs to be managed.

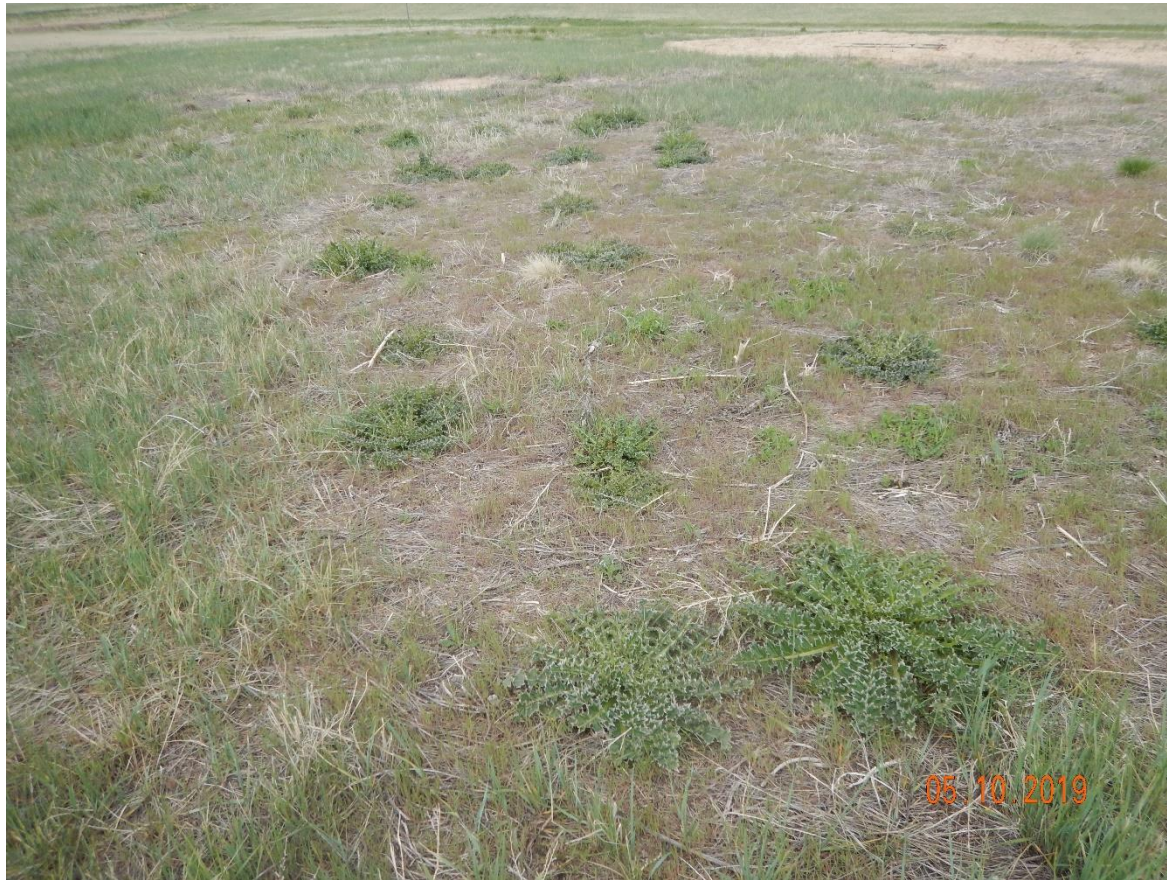
**Photo 6:** Photo taken from the east end of the location, facing west. Photo shows location remains predominantly undesirable weedy plant species such as Cheat grass, Kochia, Scotch and Canada thistle. Unable to find evidence that reclamation has been conducted on the location in accordance with 1004.a

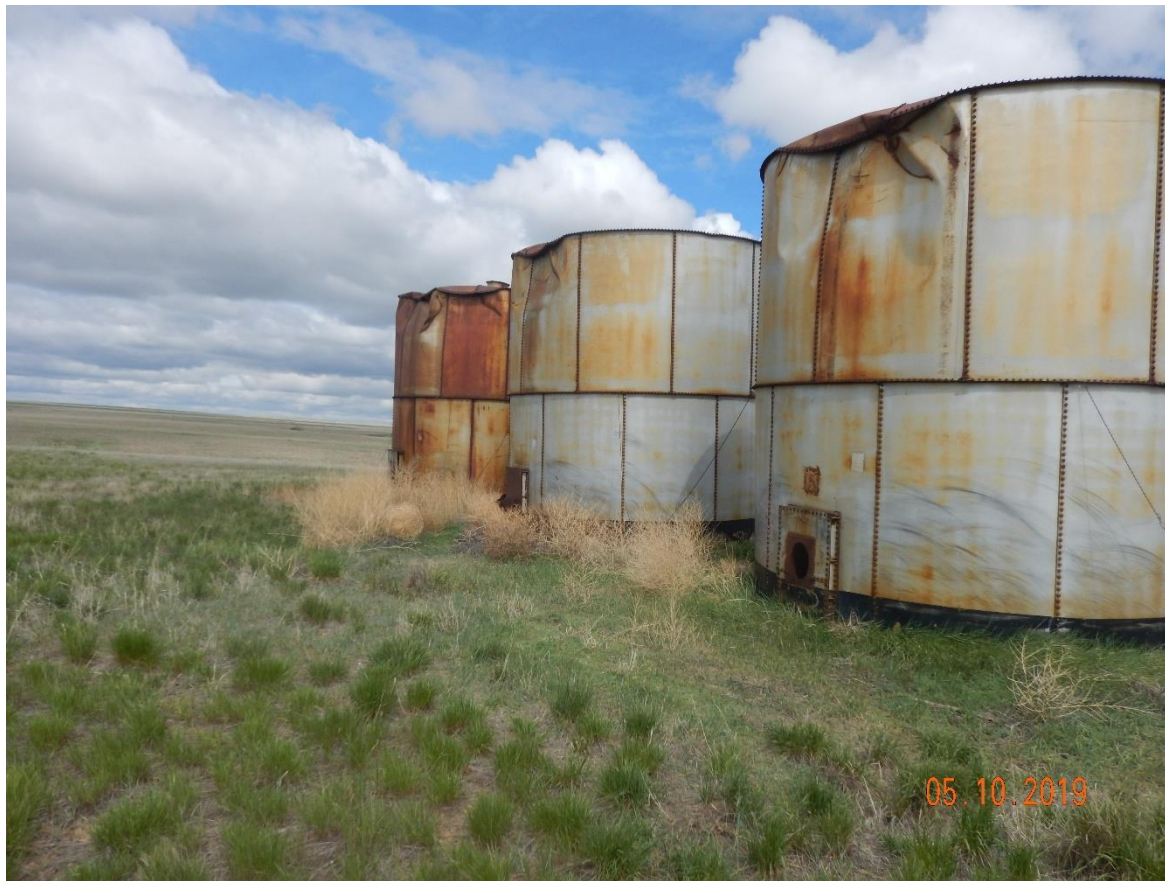
**Photo 7:** Previous inspection documented three (3) above ground steel tanks north of the location and required operator to remove in accordance with 1004.a. Photo shows tanks remain.

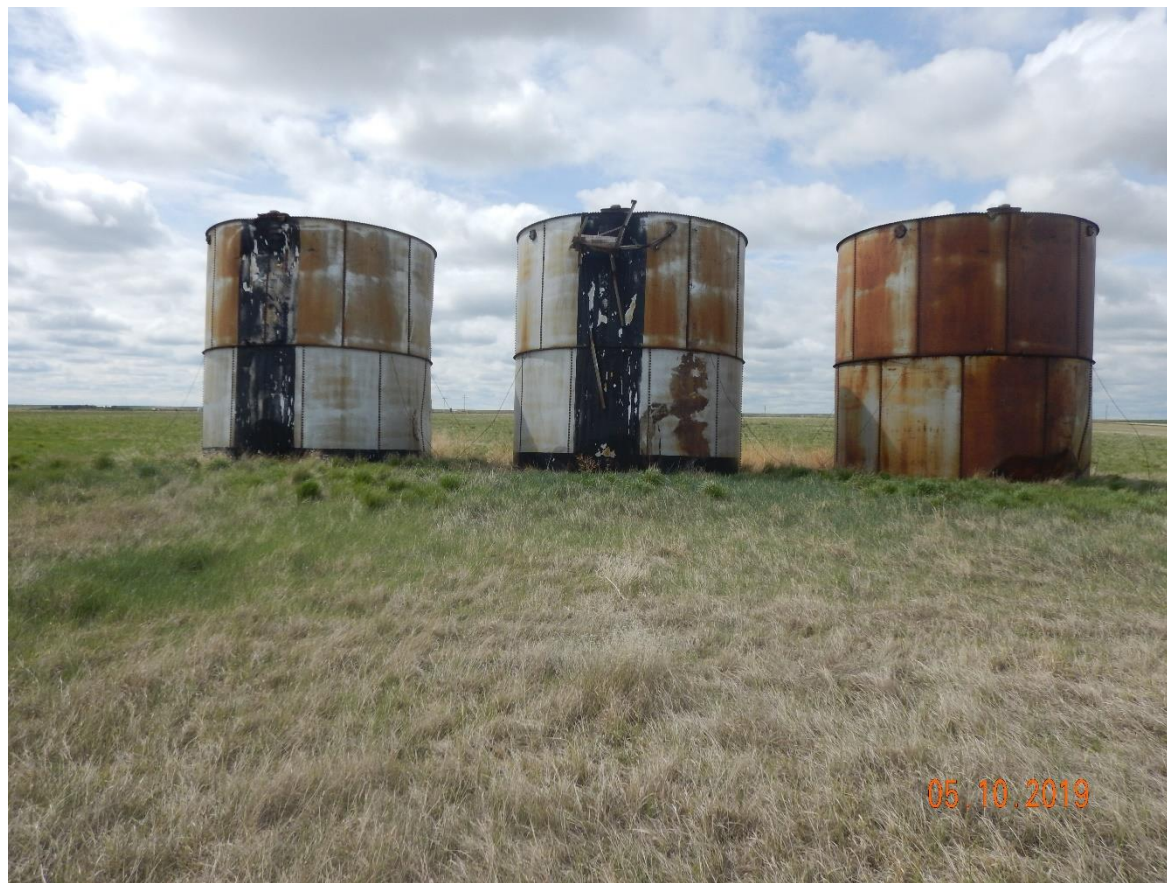
**Photo 8:** Previous inspection documented three (3) above ground steel tanks north of the location and required operator to remove in accordance with 1004.a. Photo shows tanks remain.
