Interim Reclamation and Stormwater Inspection

May 13, 2019

Operator: GREAT WESTERN OPERATING COMPANY LLC- #10110

Location ID: 434399

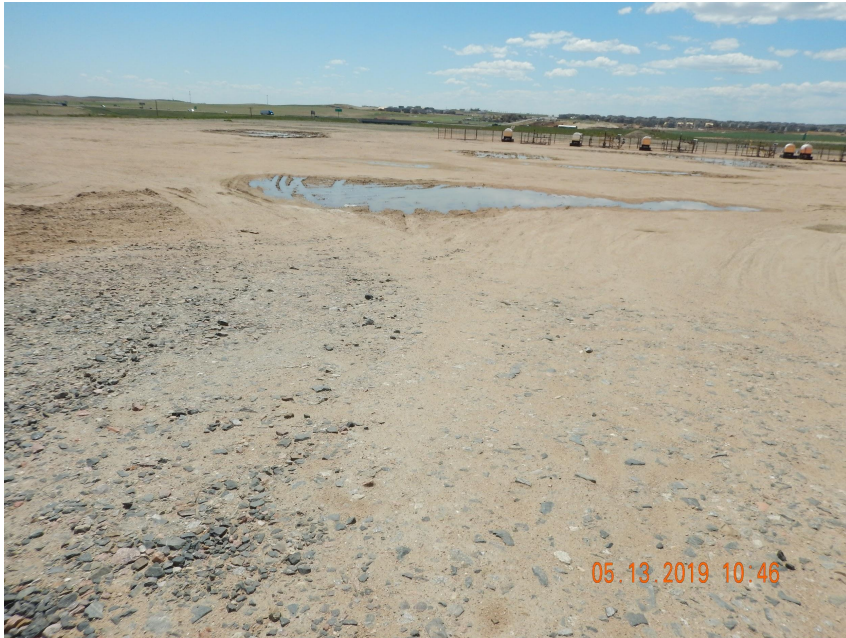
Photo 1. Photo taken from the entrance of location, facing Southeast. Photo illustrates that interim reclamation has not been performed. This location is not in compliance with Rule 1003 standards.

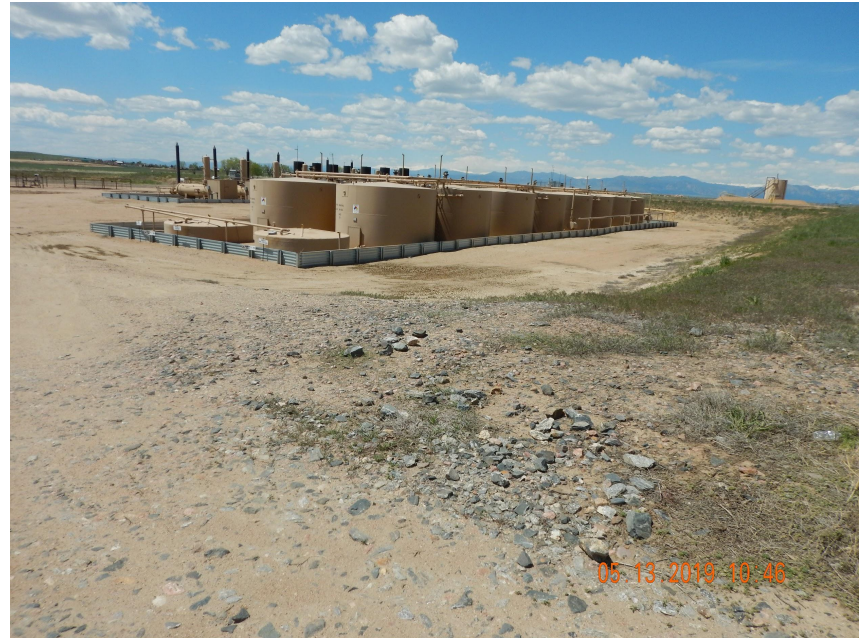
Photo 2. Photo taken from the entrance of location, facing Southwest. Photo illustrates production equipment associated with the location.

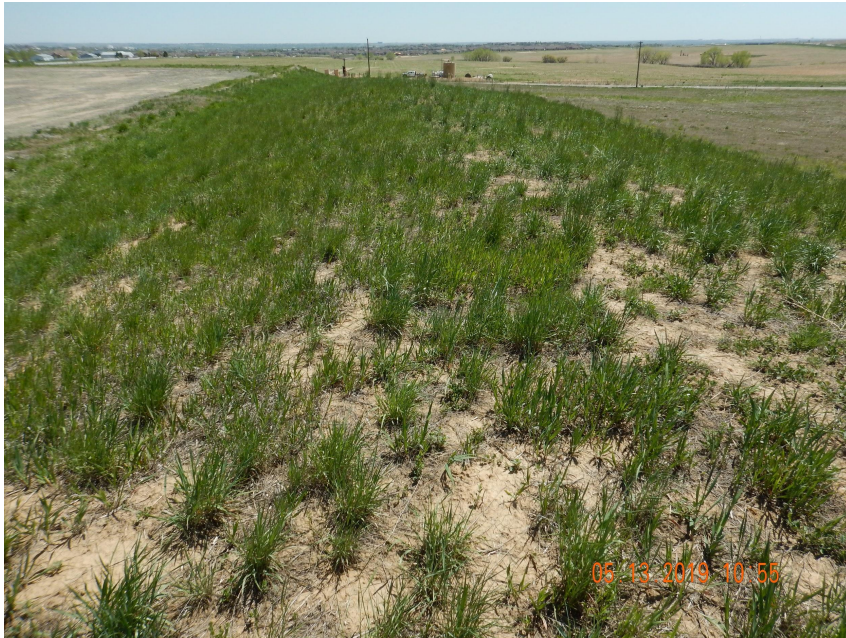
Photo 3. Photo taken from southern location, facing East. Photo illustrates the topsoil stockpile which appears to be in compliance with Rule 1002.c.

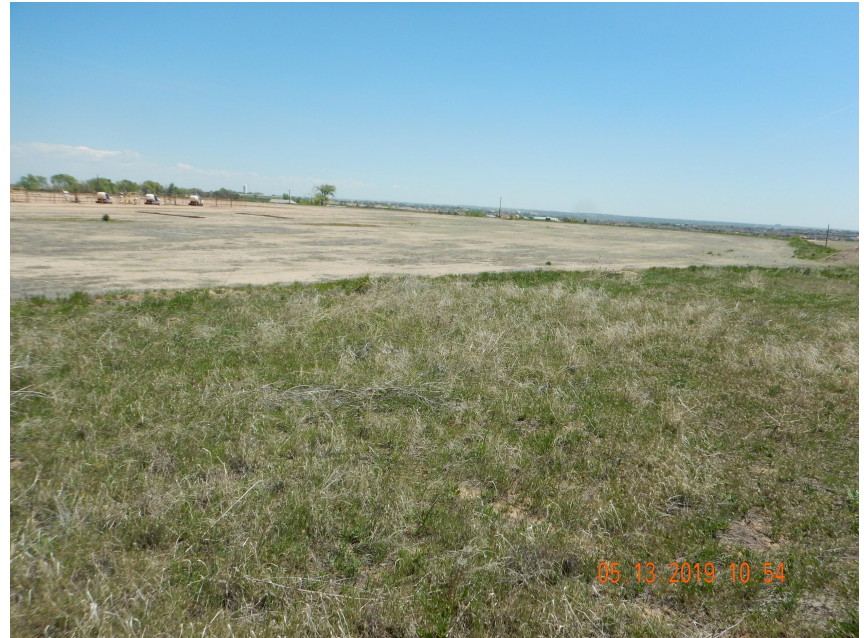
Photo 4. Photo taken from the southern location, facing North. See comments under Photo 1.

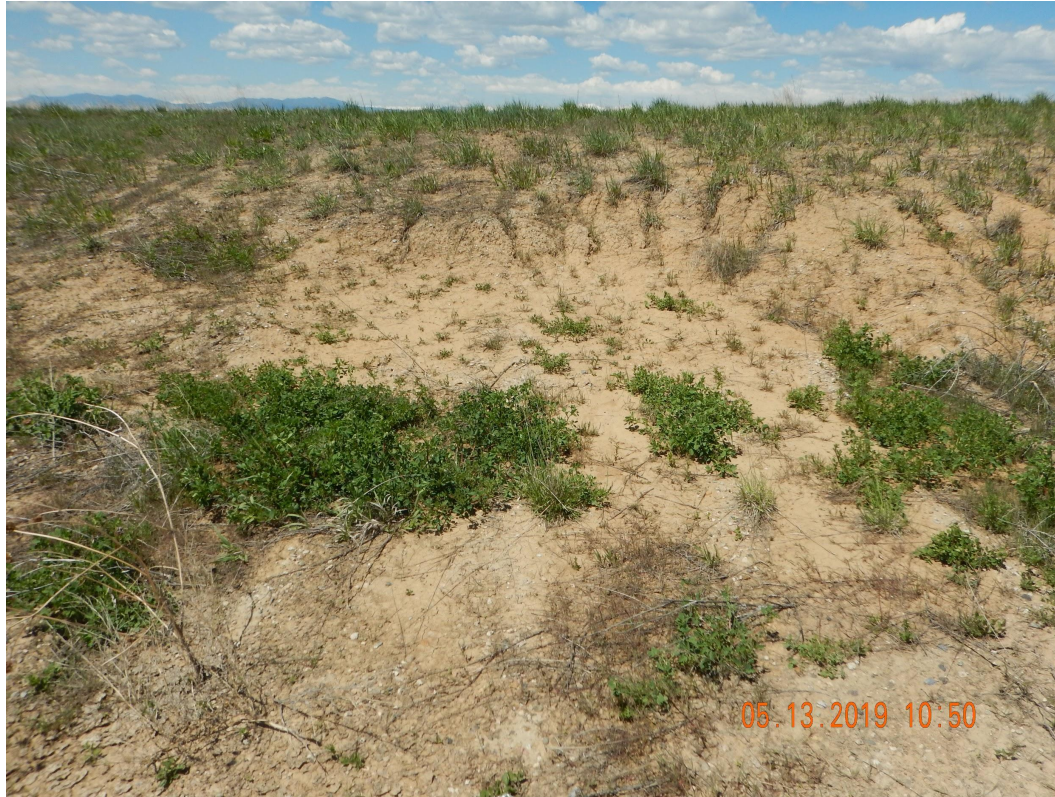
Photo 5. Photo taken from the southwestern location, facing West. Photo illustrates stormwater erosion. Operator has failed to properly stabilize cut slopes to minimize erosion and site degradation.

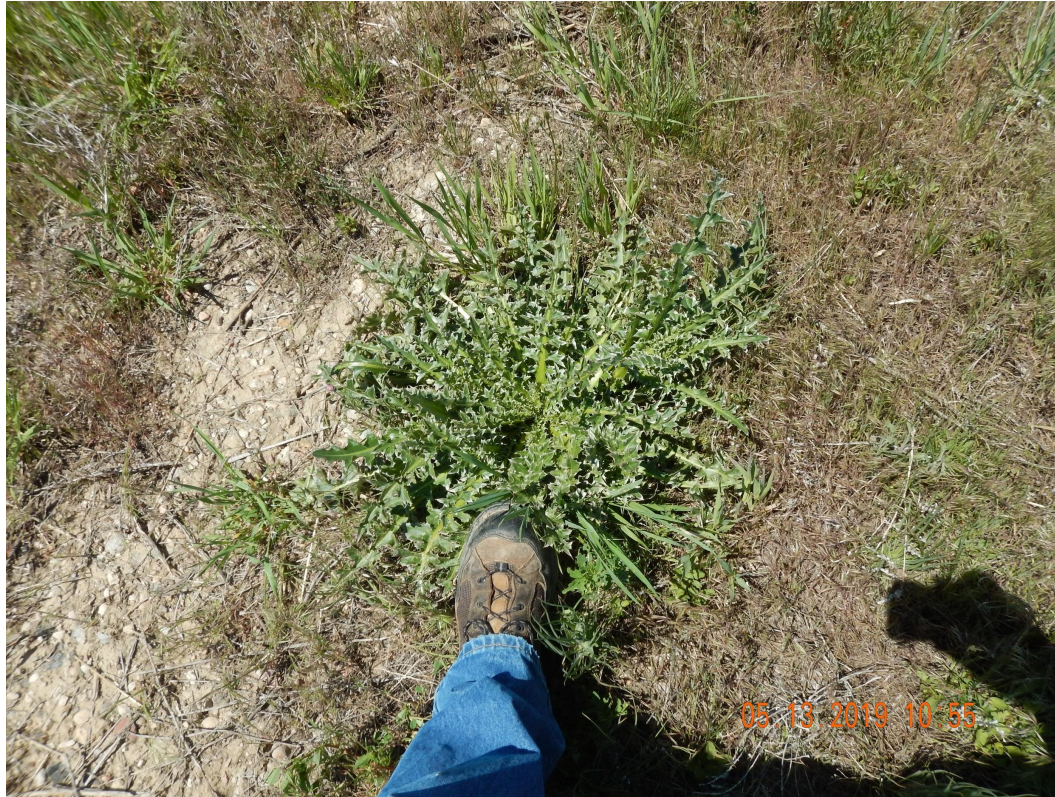
Photo 6. Photo taken from a portion of the location. Photo illustrates a List B Colorado noxious weed, Musk thistle.

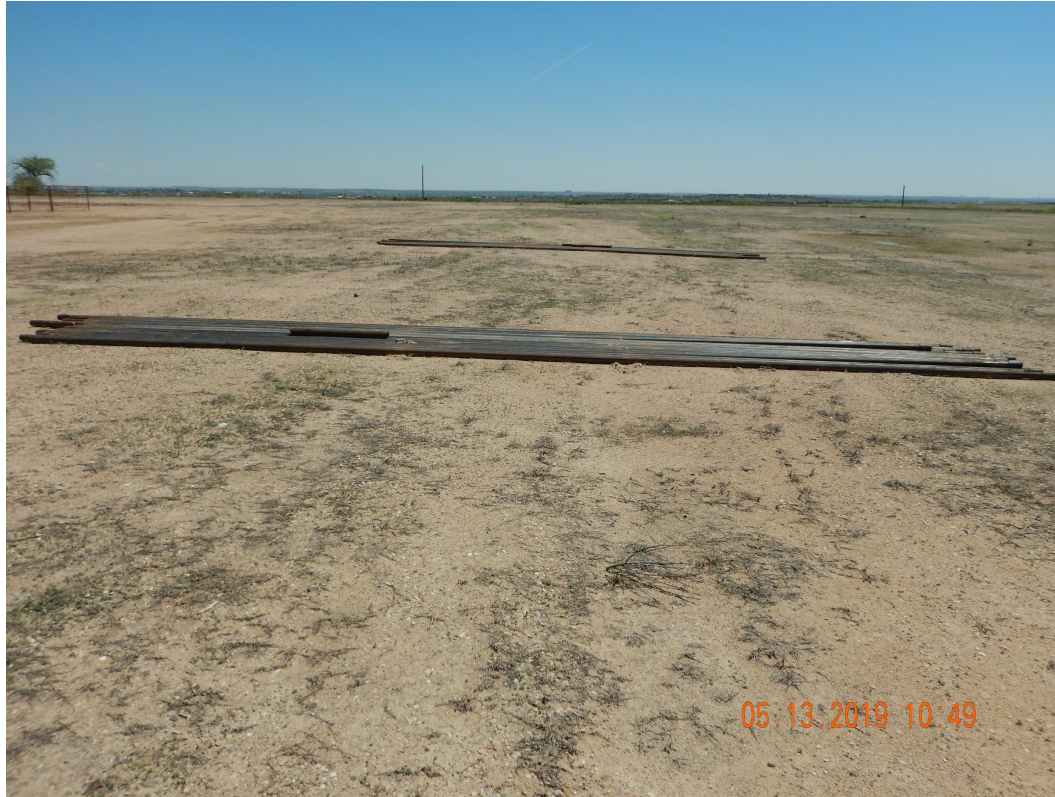
Photo 7. Photo taken from location, facing East. Photo illustrates unused equipment.

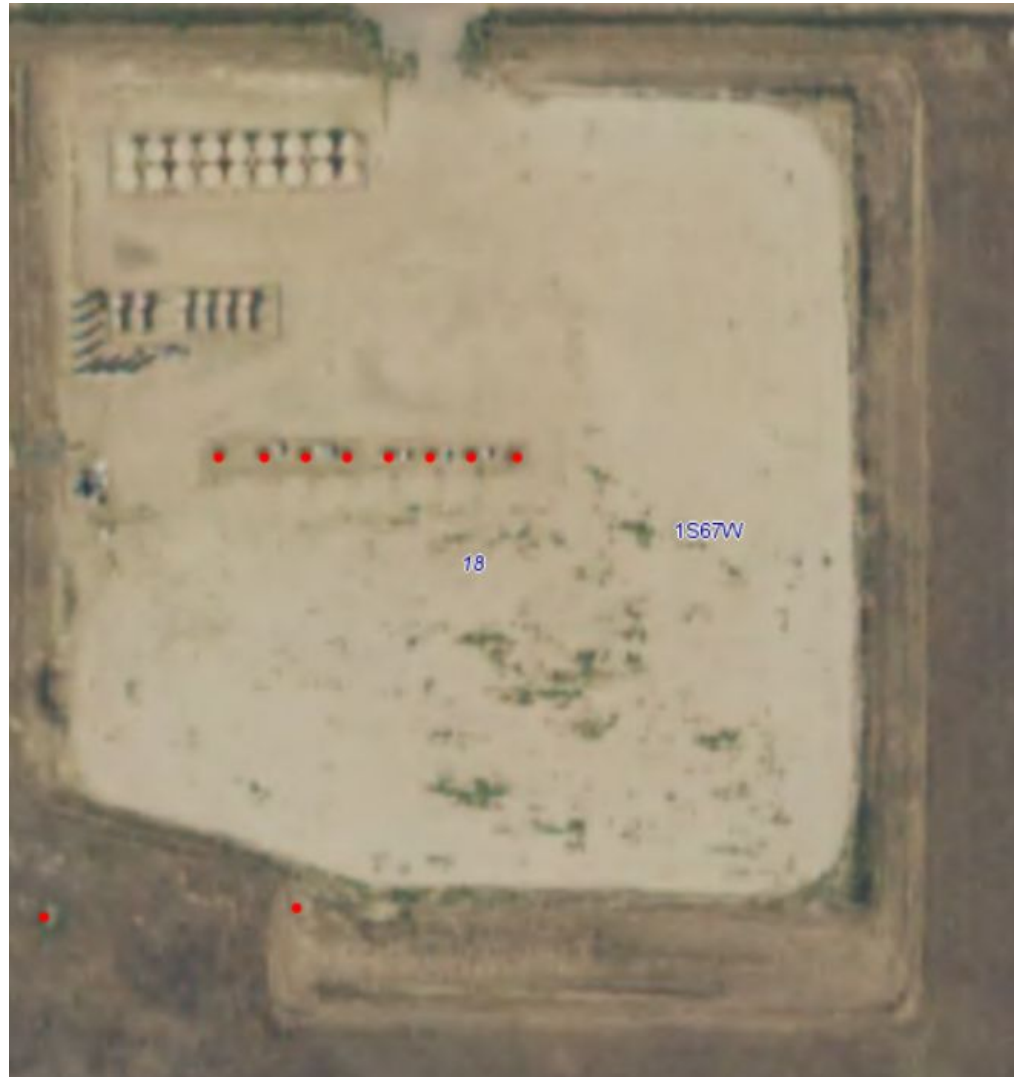
Aerial photo taken from 2017. This is the current state as of 5/13/2019 which is not in compliance with Rule 1003.
