Final Reclamation Inspection

Operator: K P KAUFFMAN COMPANY INC- #46290

API: 05-001-07569

Inspection Photos
Location Name: EDSTROM #3
API: 05-001-07569

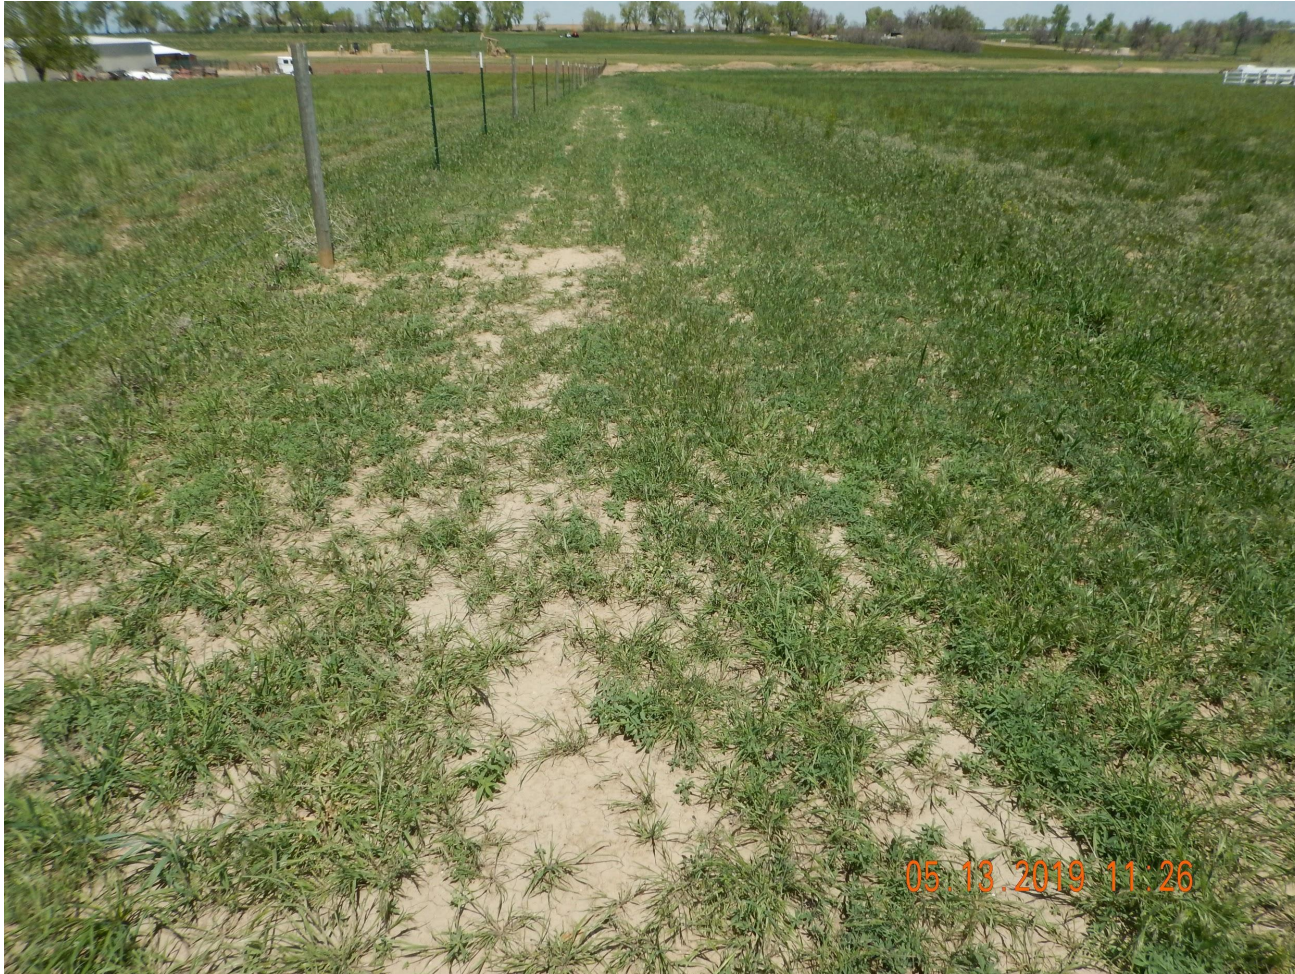
Photo 1. Photo taken from a portion of the access road, facing North. Photo illustrates undesirable weedy annual vegetation, Cheatgrass and Kochia, throughout the access road.

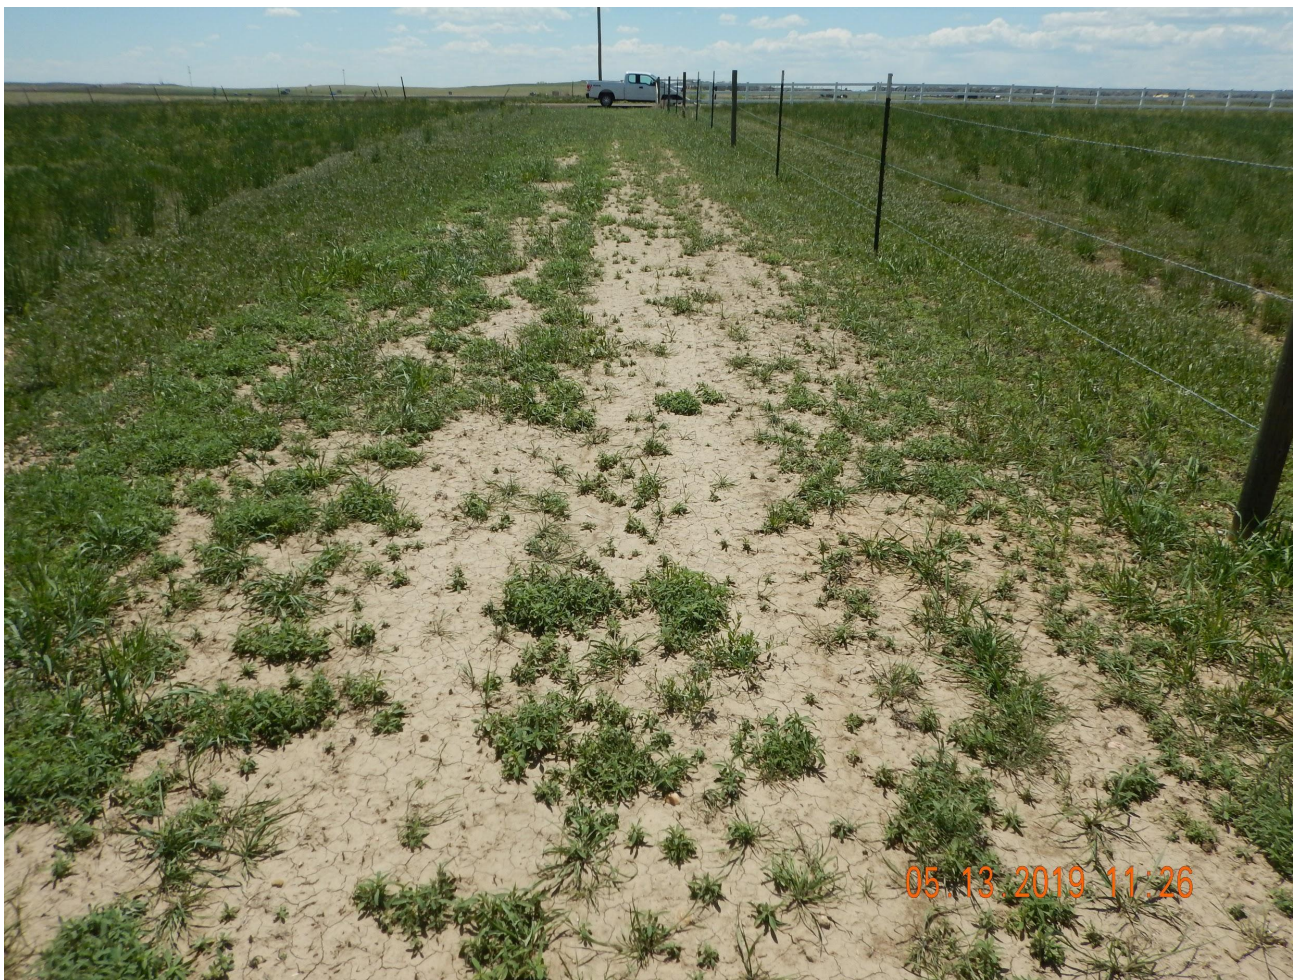
Photo 2. Photo taken from a portion of the access road, facing South. Photo illustrates bare ground and undesirable weedy annual vegetation, Kochia and Cheatgrass.

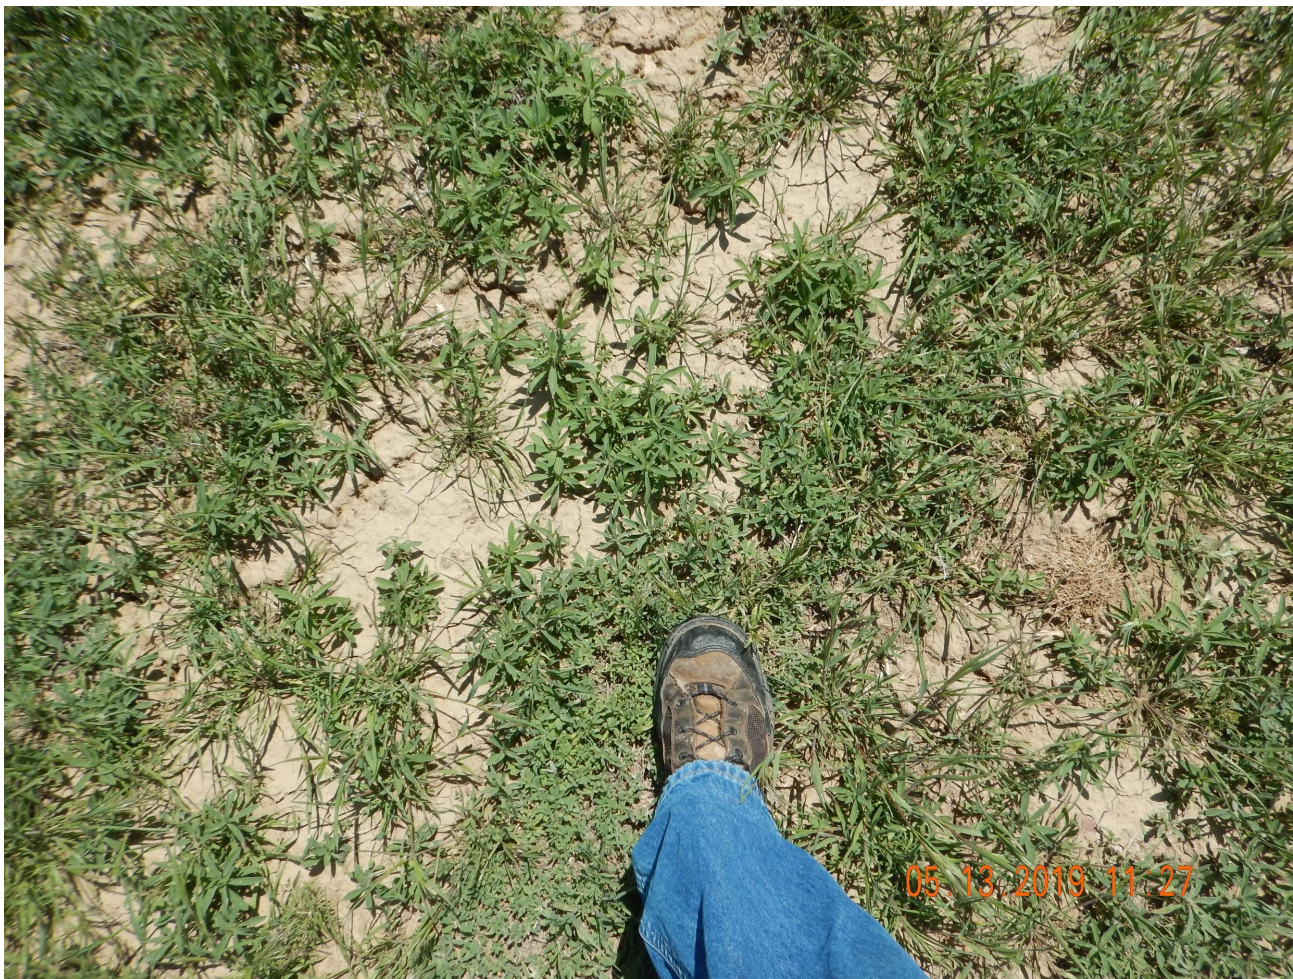
Photo 3. Close up photo taken from a portion of the access road. Photo illustrates undesirable weedy annual vegetation, Kochia and Cheatgrass.

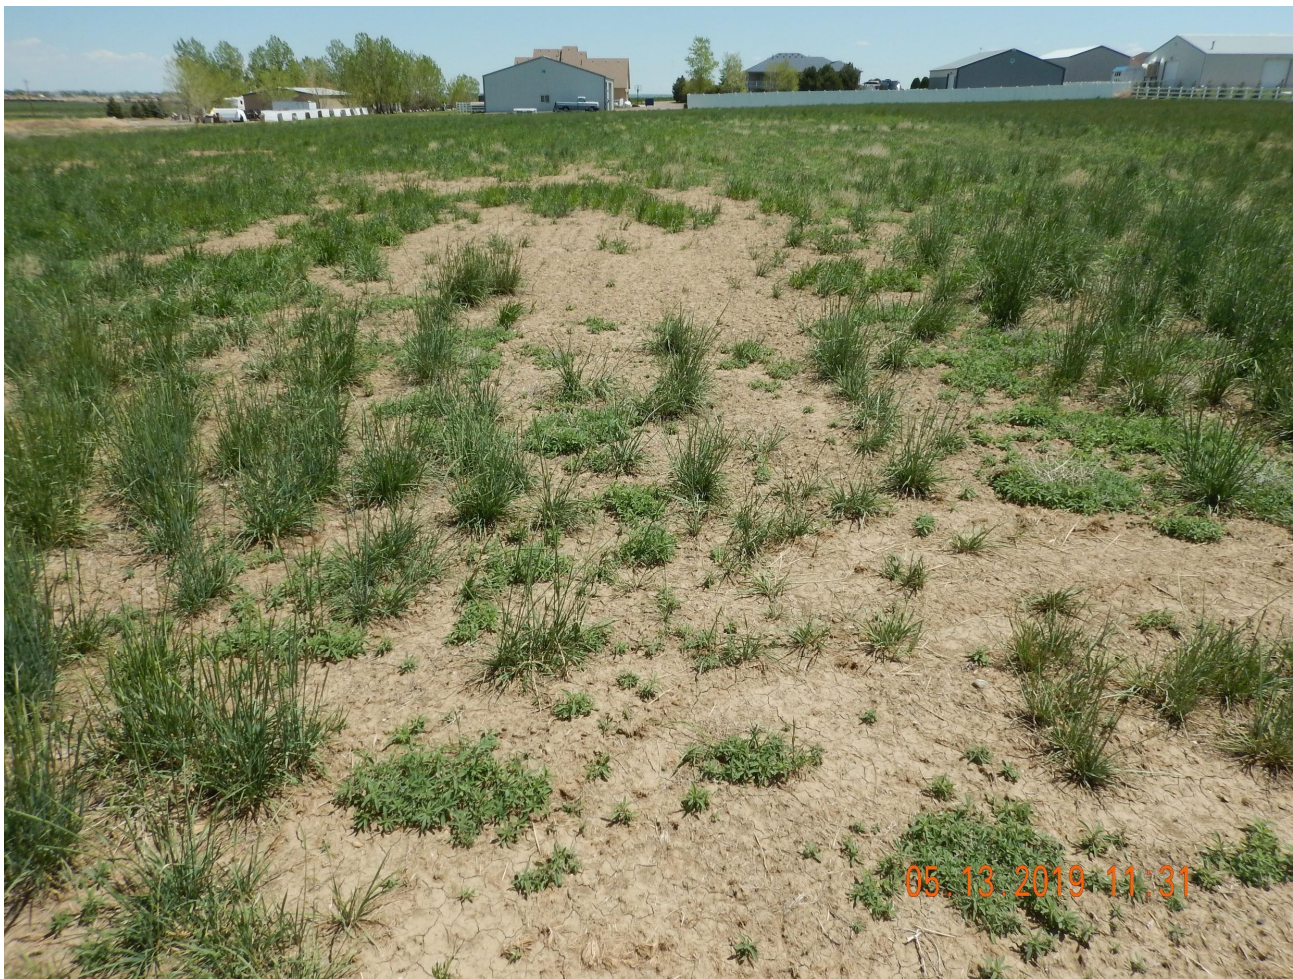
Photo 4. Photo taken from the well location, facing East. Photo illustrates bare ground and undesirable weedy annual vegetation, Kochia and Cheatgrass.

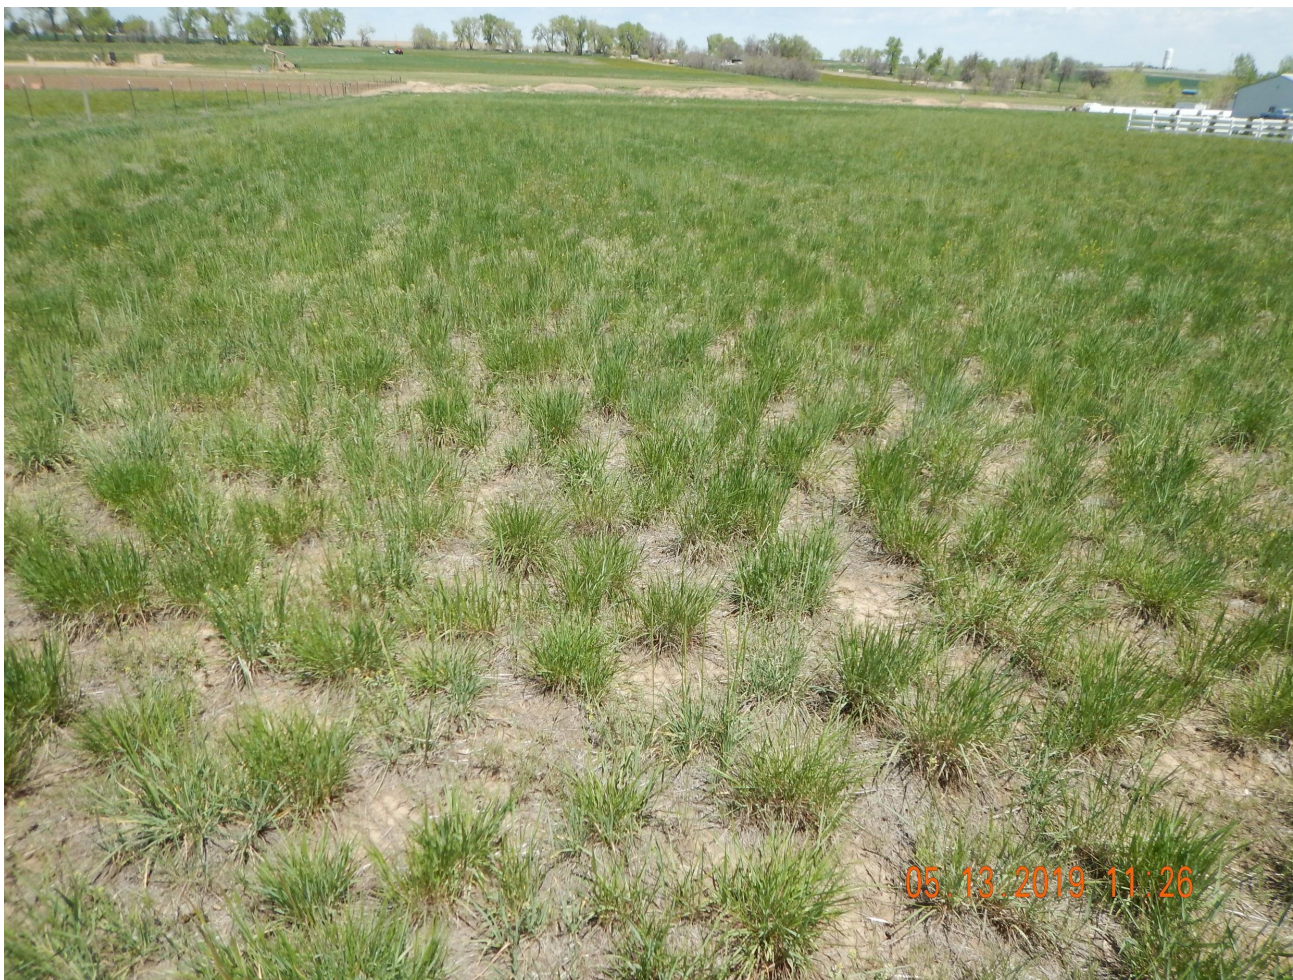
Photo 5. Reference photo taken east of the access road, facing North. Photo illustrates perennial vegetation which is not reflective throughout the disturbance area.
