Inspection Photos

API: 05-061-06365

Operator: STRACHAN EXPLORATION INC

Inspection Date: 5/15/2019

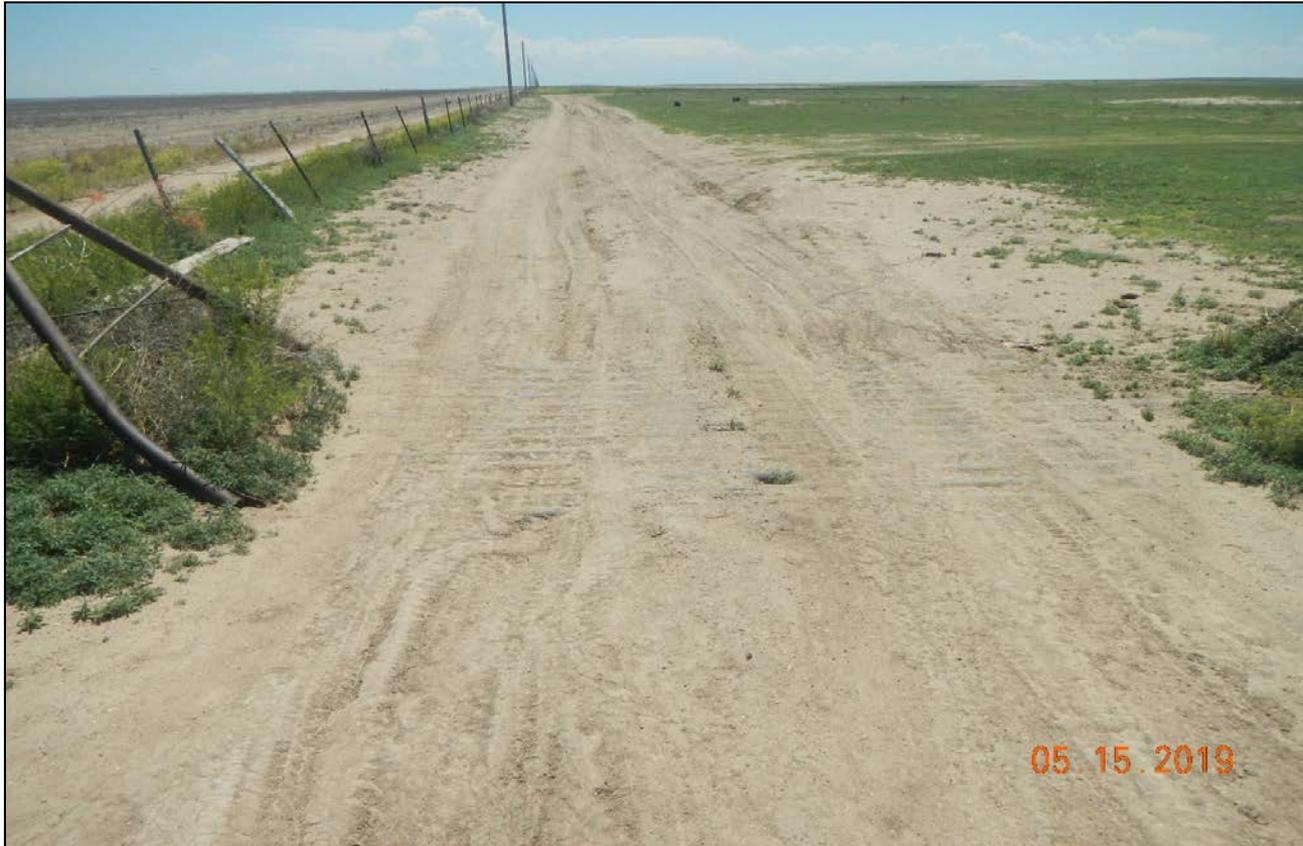
Photo 1. Facing south at the beginning of the access road. The cattle guard is filled in with sediment. There is also another cattle guard further down the road that is filled in with sediment.

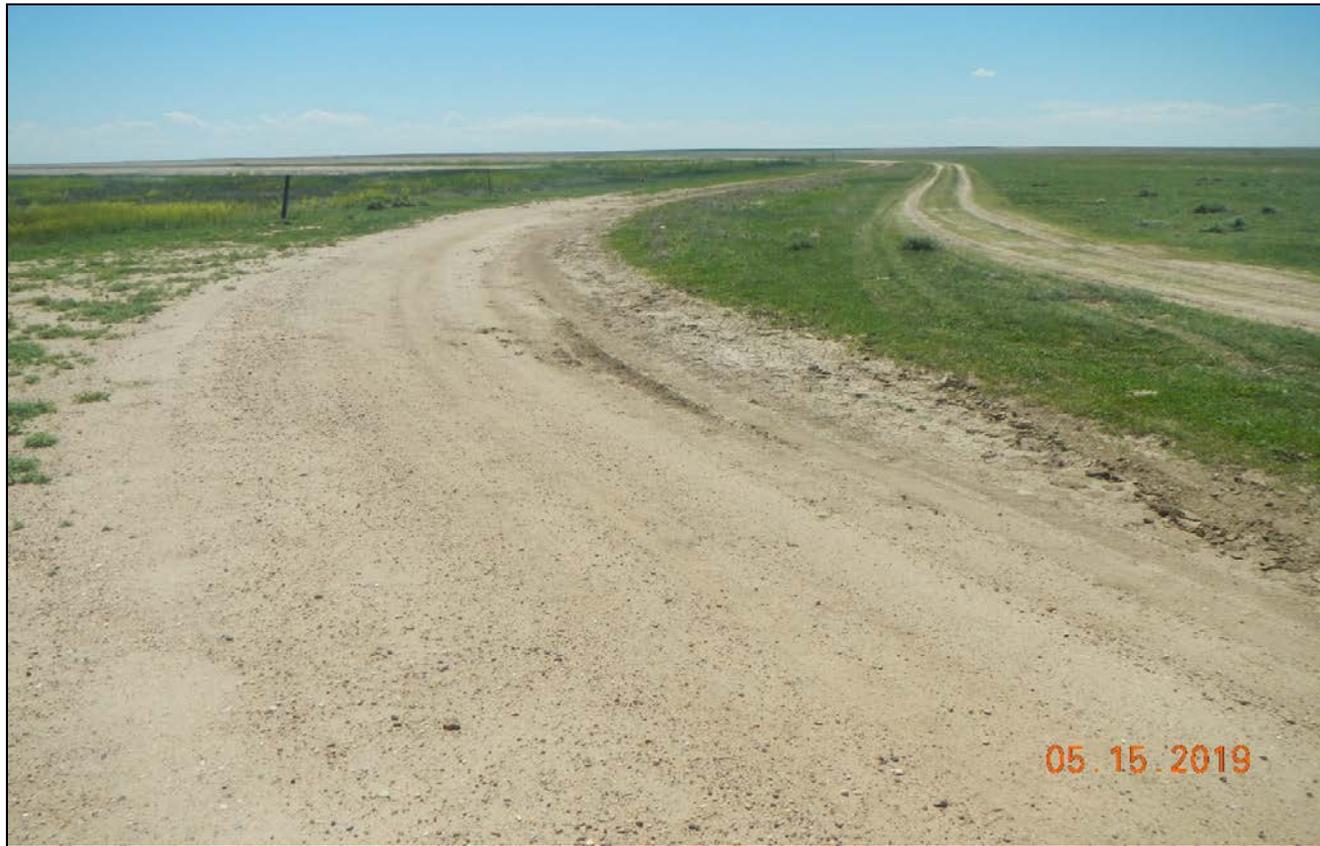
Photo 2. It appears water pools onto the access road. A new road has been made by vehicles avoiding this area when wet causing additional disturbance that needs to be reclaimed and prevented.

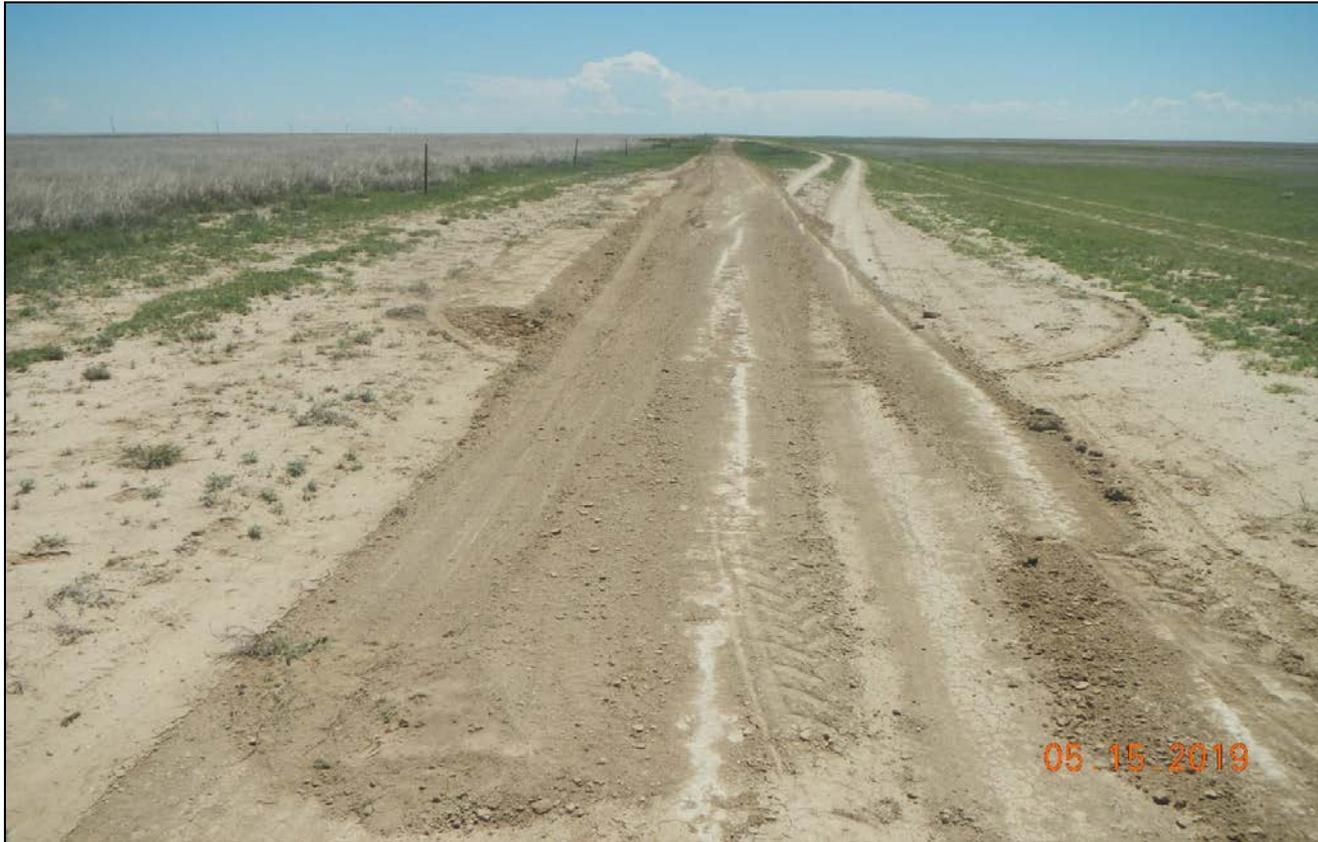
Photo 3. It appears water pools onto the access road. A new road has been made by vehicles avoiding this area when wet causing additional disturbance that needs to be reclaimed and prevented.

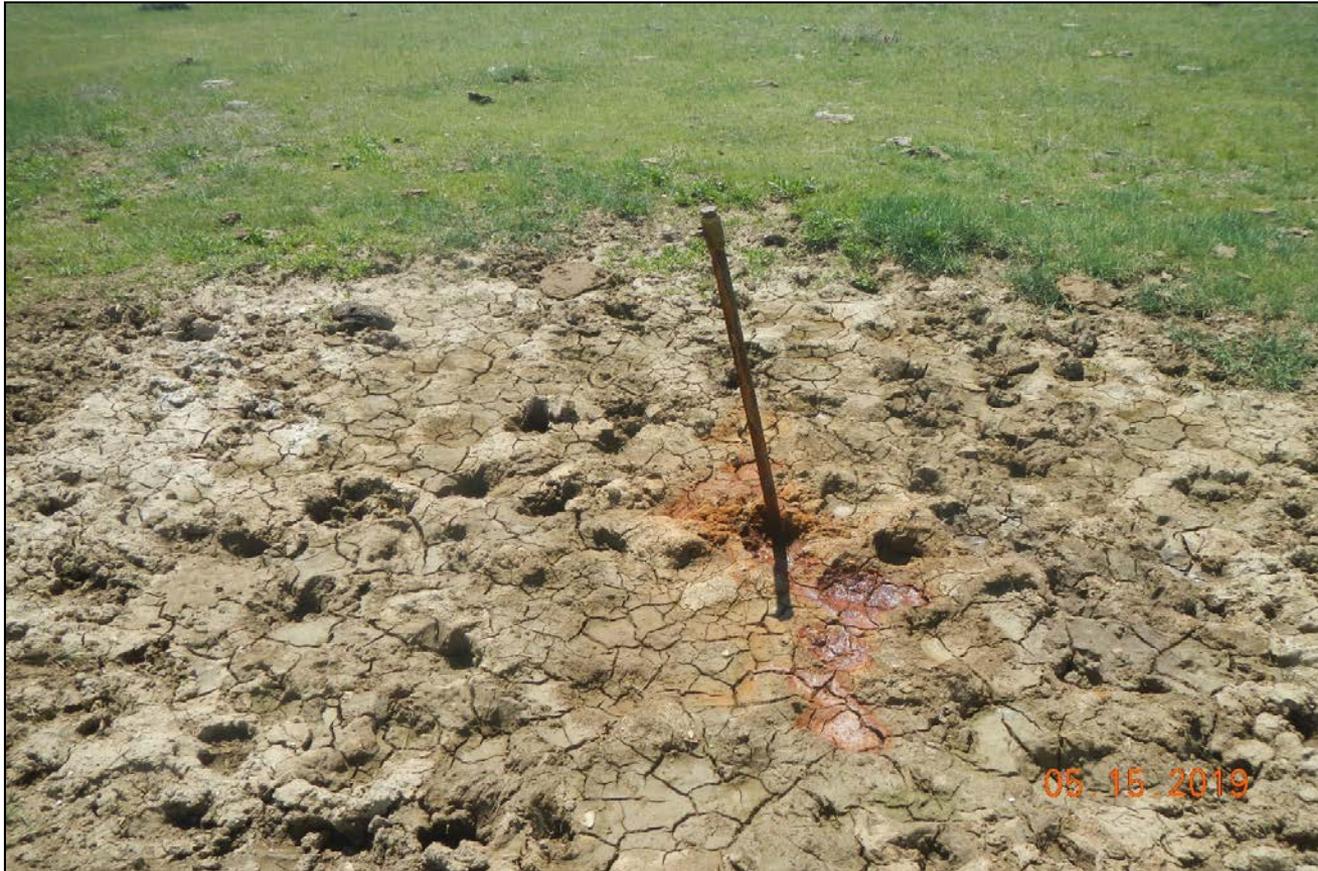
Photo 4. There is an unknown pipe riser along the access road that is rusted with possible leakage. Lat/Long: 38.44139, -103.06295

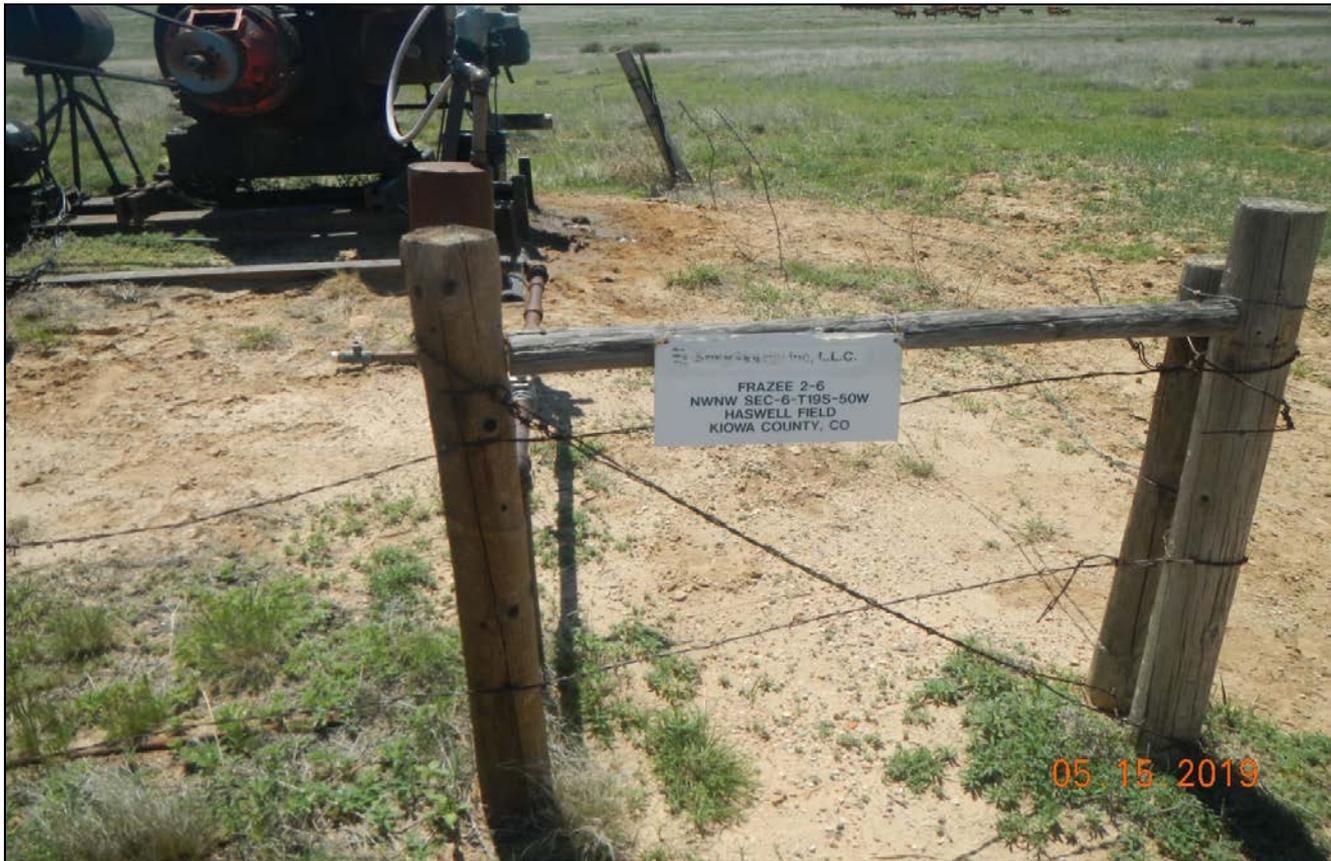
Photo 5. Well sign is posted at the pump jack.

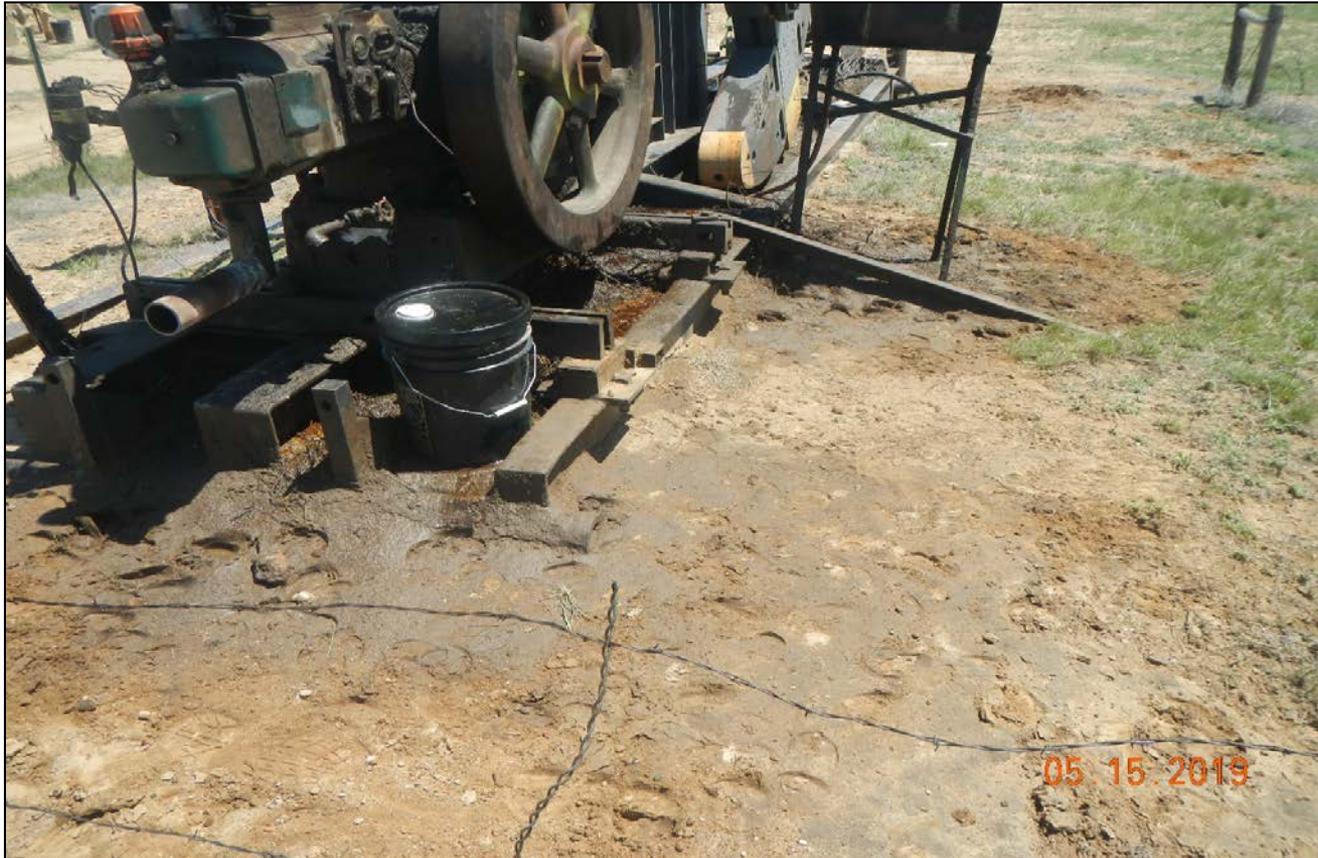
Photo 6. There is oil stain soil around the pump jack. There is a 5 gallon bucket with no labels or secondary containment.

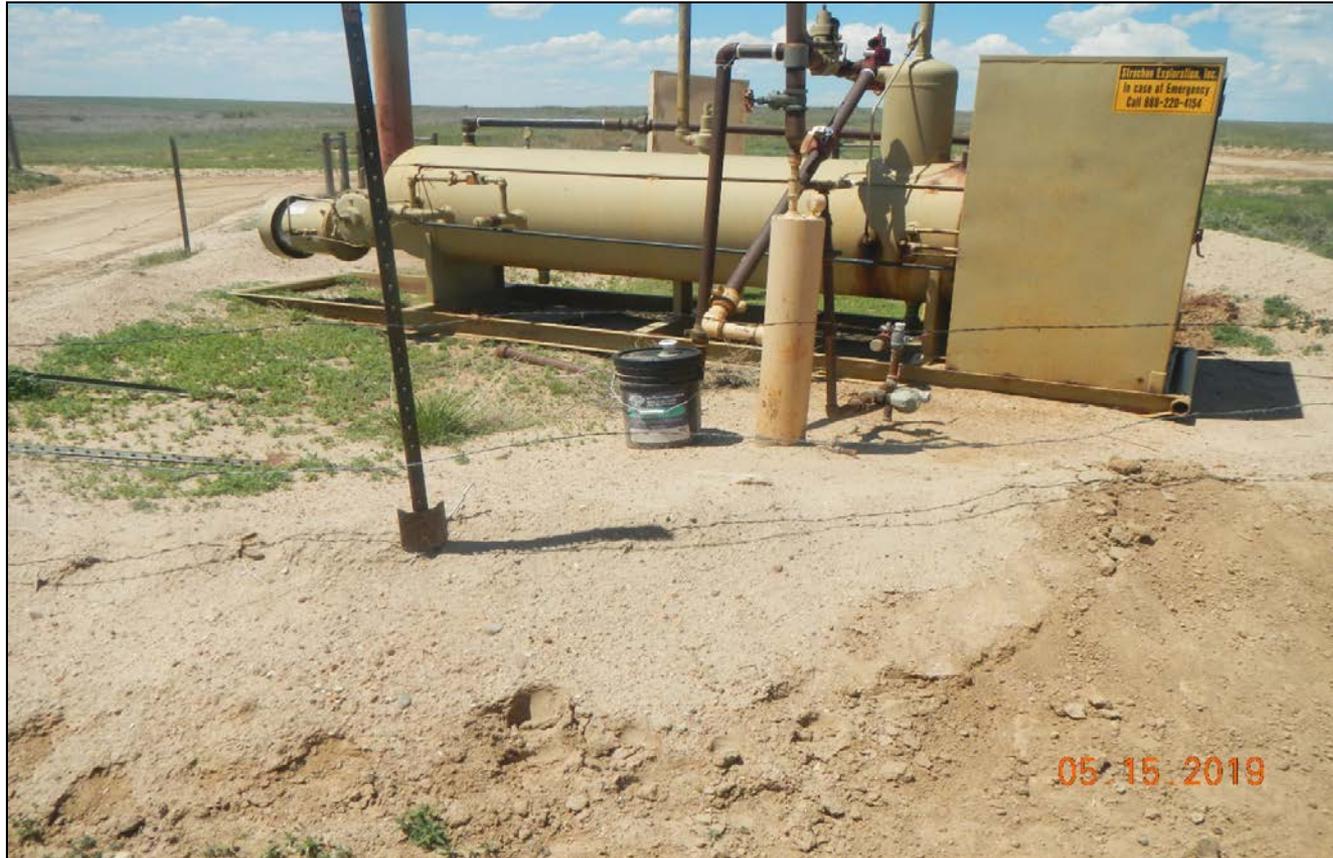
Photo 7. The berms are not sufficient the fencing around the equipment is not sufficient to prevent livestock entry. Unknown 5 gal container is stored near equipment.

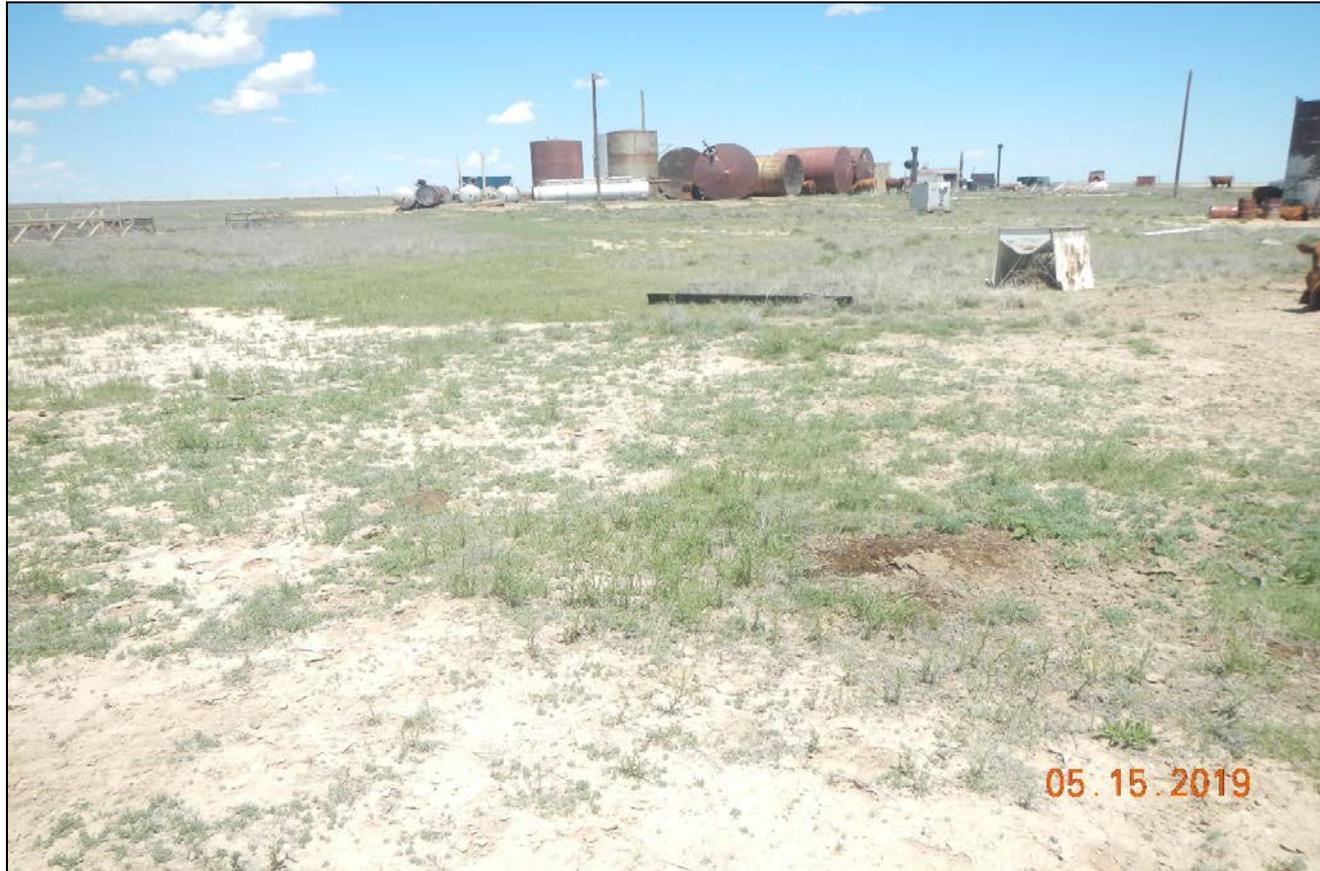
Photo 8. There is various junk rusted equipment stored to the north of the site.

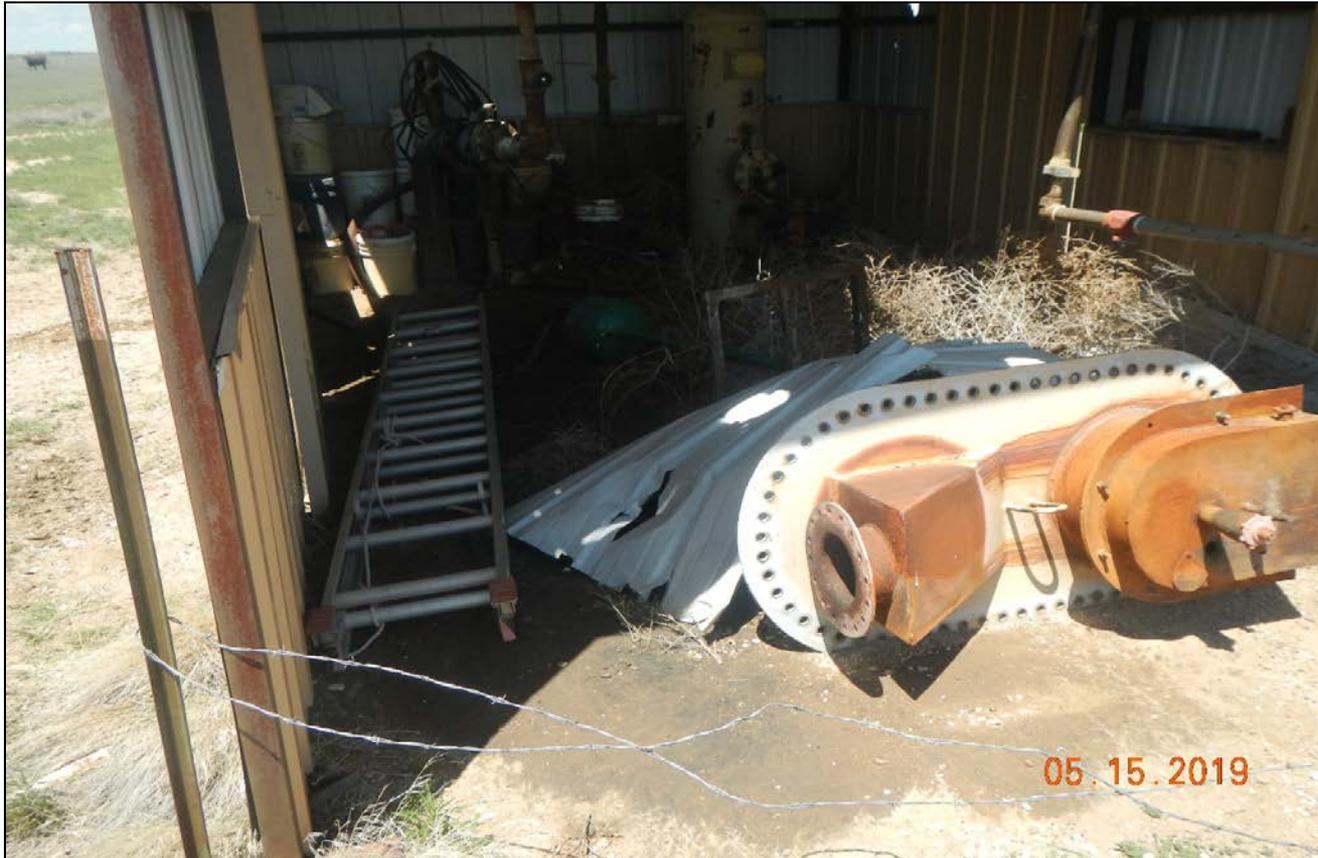
Photo 9. There is a shed with various junk equipment inside. There is oil stained soil that can be seen in the photo. Extent is unknown.

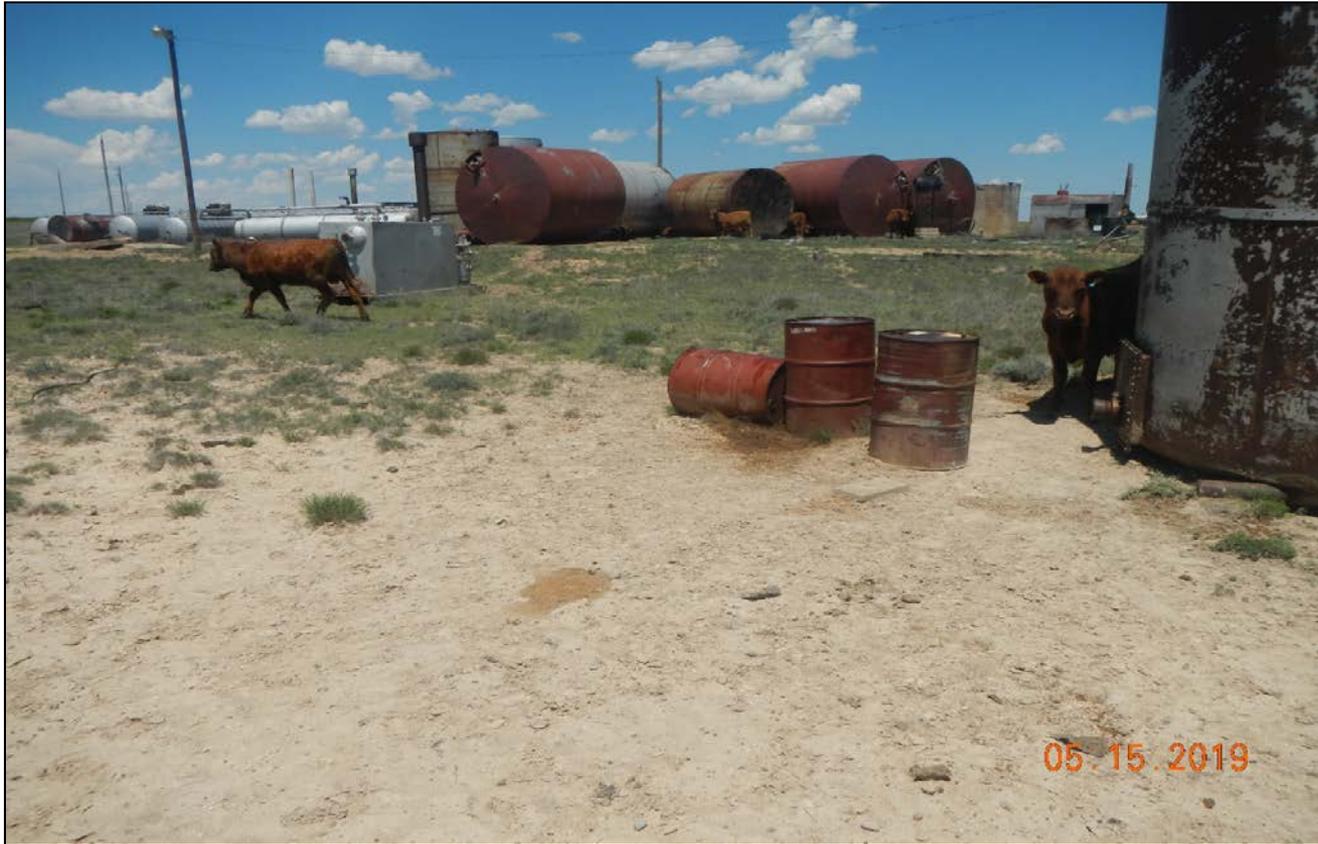
Photo 10. Facing toward the unused equipment. There are barrels with what appears to be oil with no labeling or containment. One barrel is tipped over with oil stained soil from spillage.

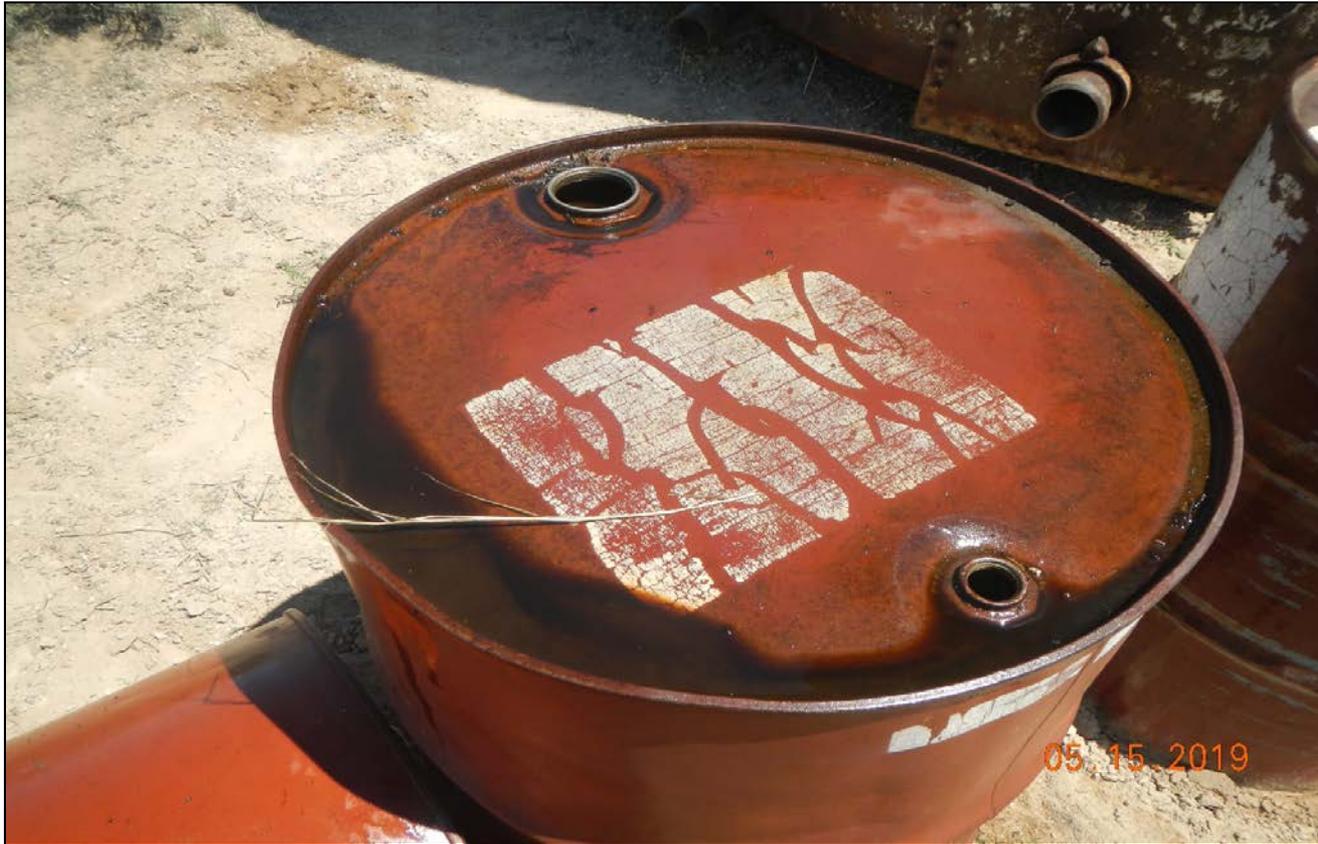
Photo 11. The barrels appear to full of oil with no cap and there is oil on the top surface.

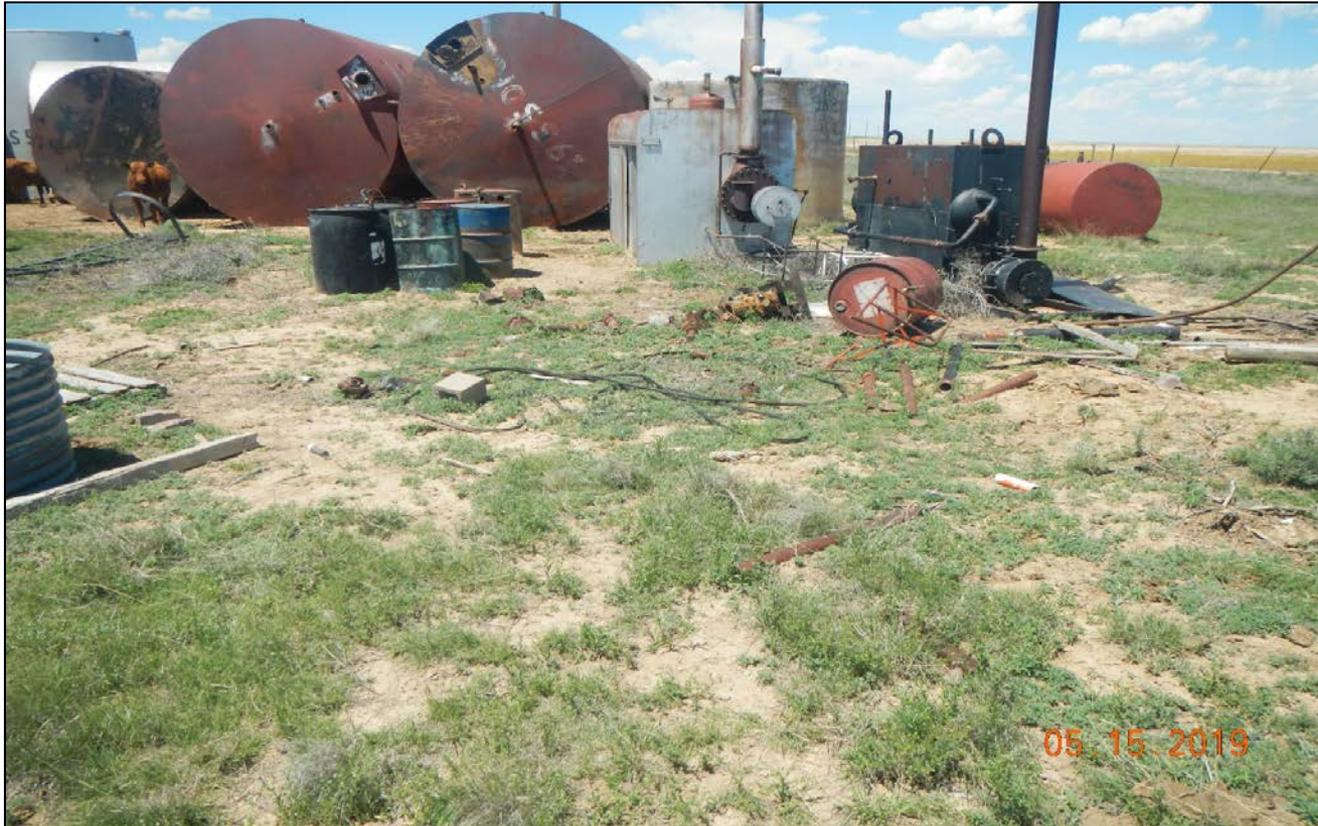
Photo 12. There is various junk debris scattered on the ground. Barrels with no labels or containment.

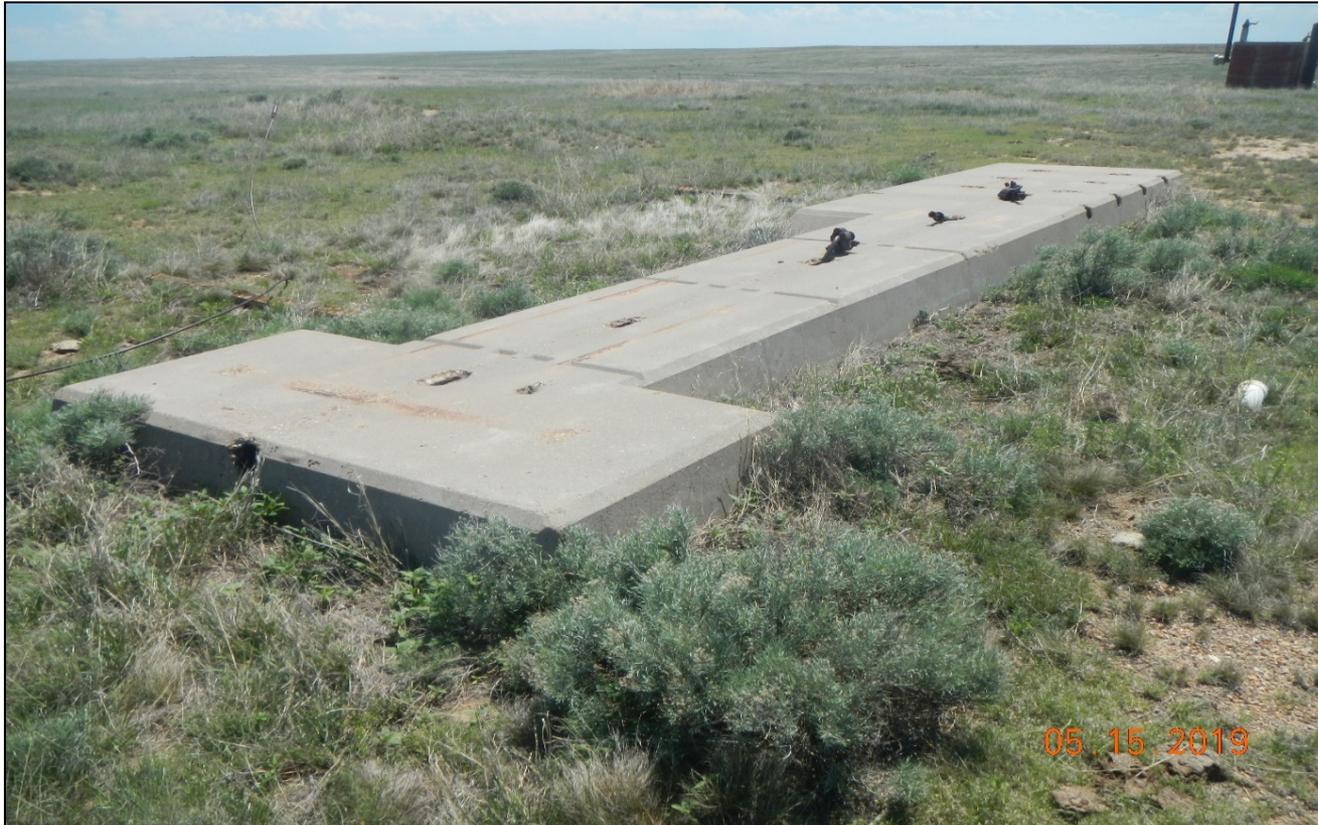
Photo 13. There is a cement pad at the north side of the location which is unused equipment or debris.

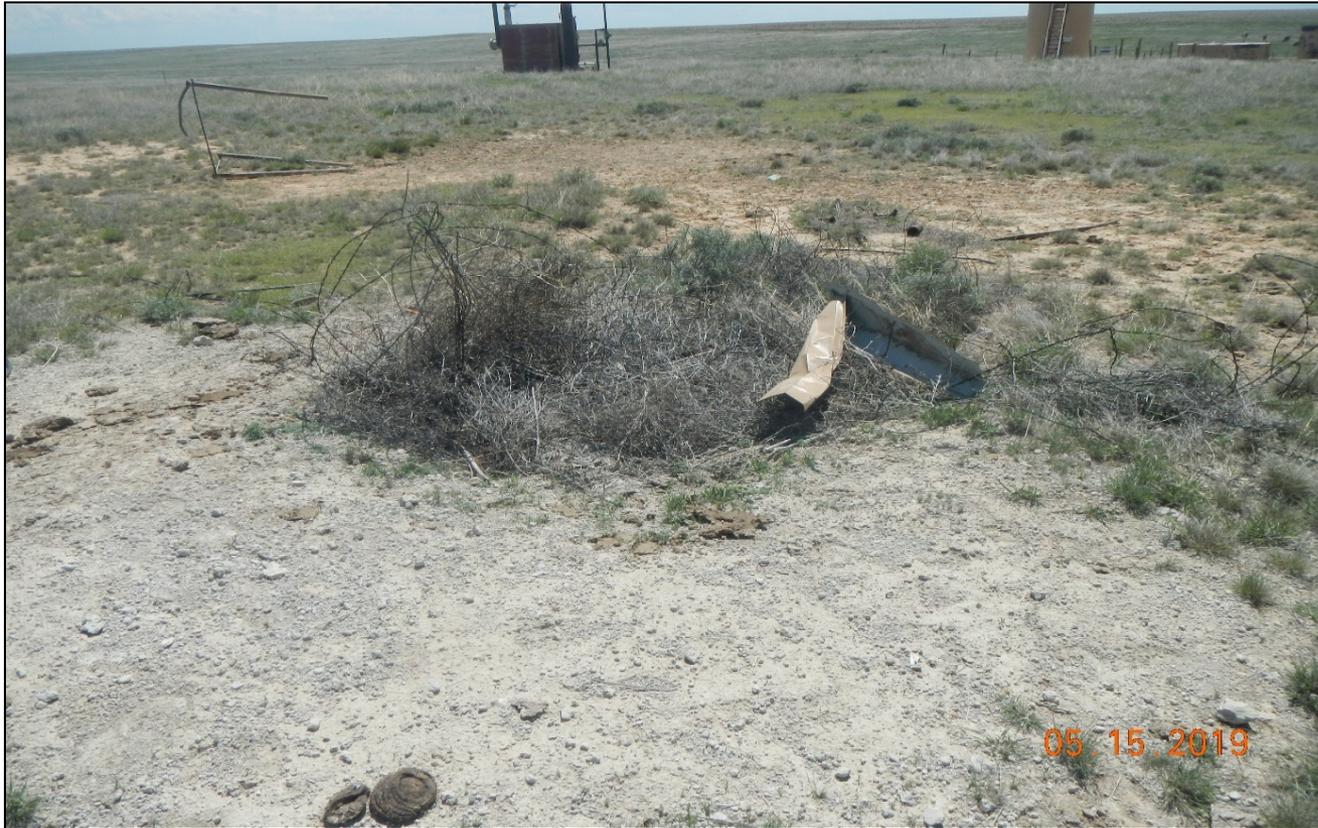
Photo 14. There is barbed wire in piles which poses a risk to livestock in the area. There is a grey pile of what appears to be cement debris. This picture was taken at the north side of the location.
