Inspection Photos

Operator: Logos Operating
Location/API #: 067-05367
Date: 5-9-2019

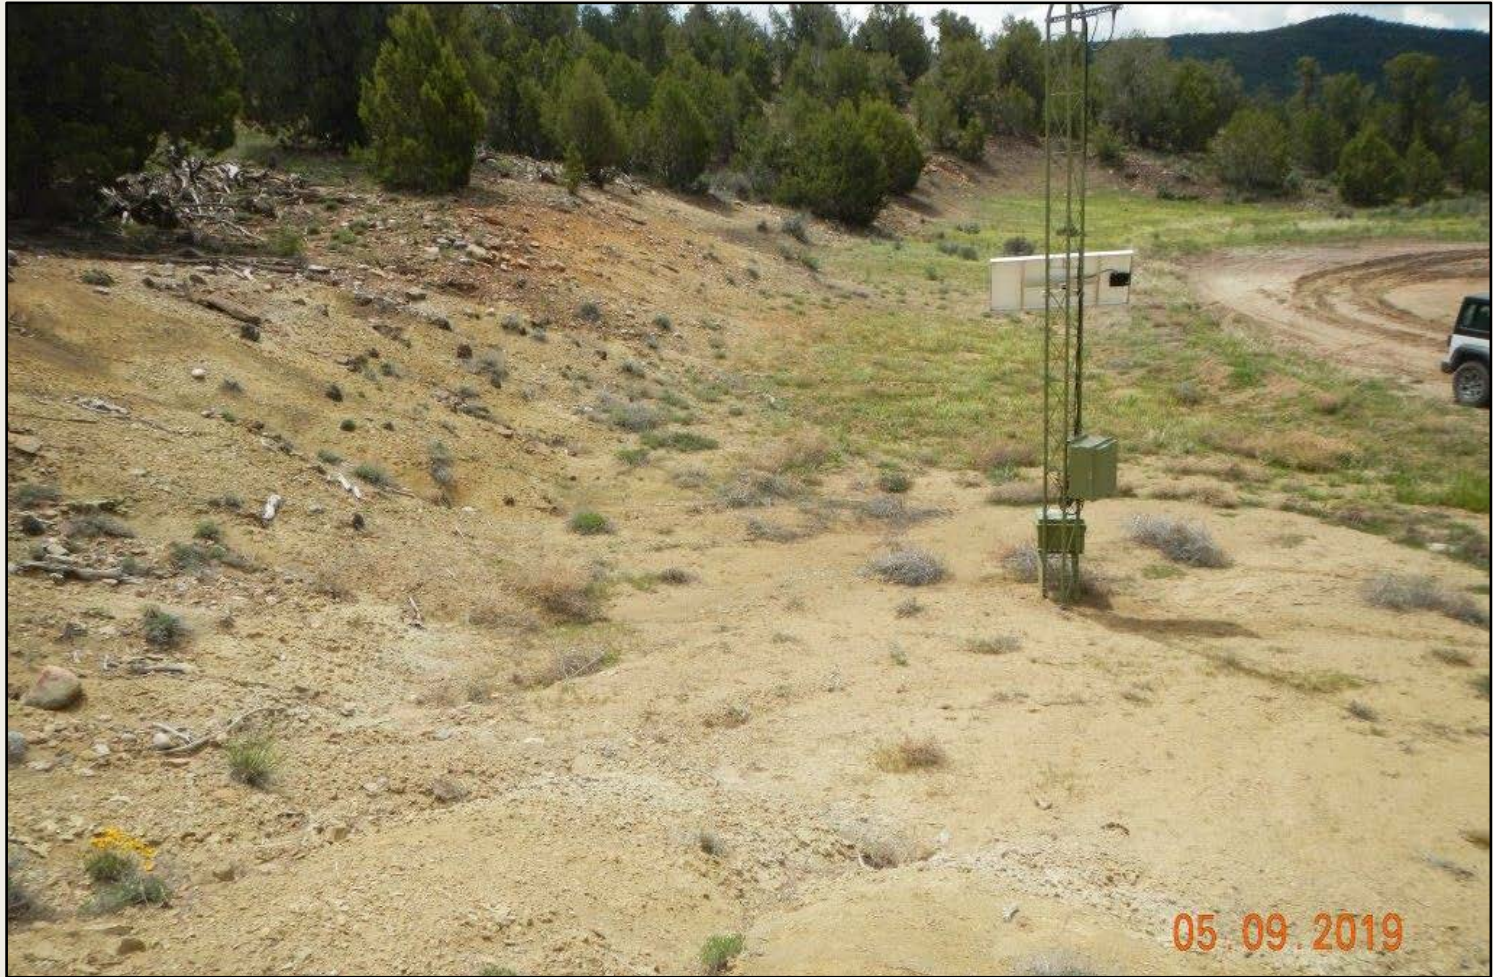
Photo 1. View of the eastern project area from the northeastern corner facing southward. Cut slopes are eroding.

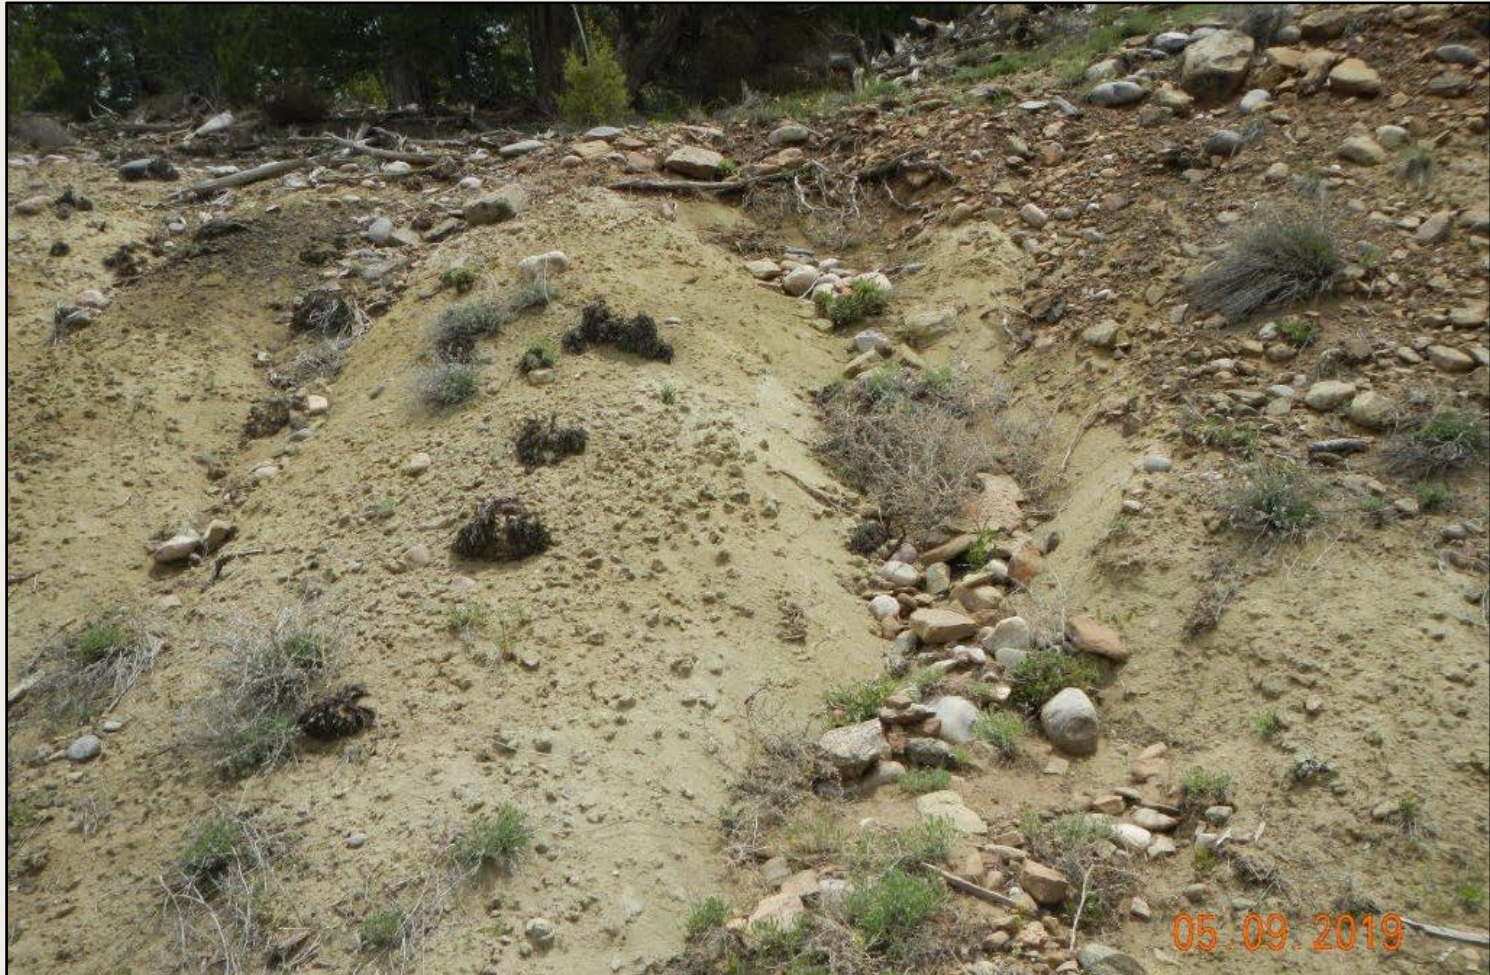
Photo 2. View of erosional channeling in the well pad cut-slope. Exposed roots, scouring, and sediment deposition indicate erosion.

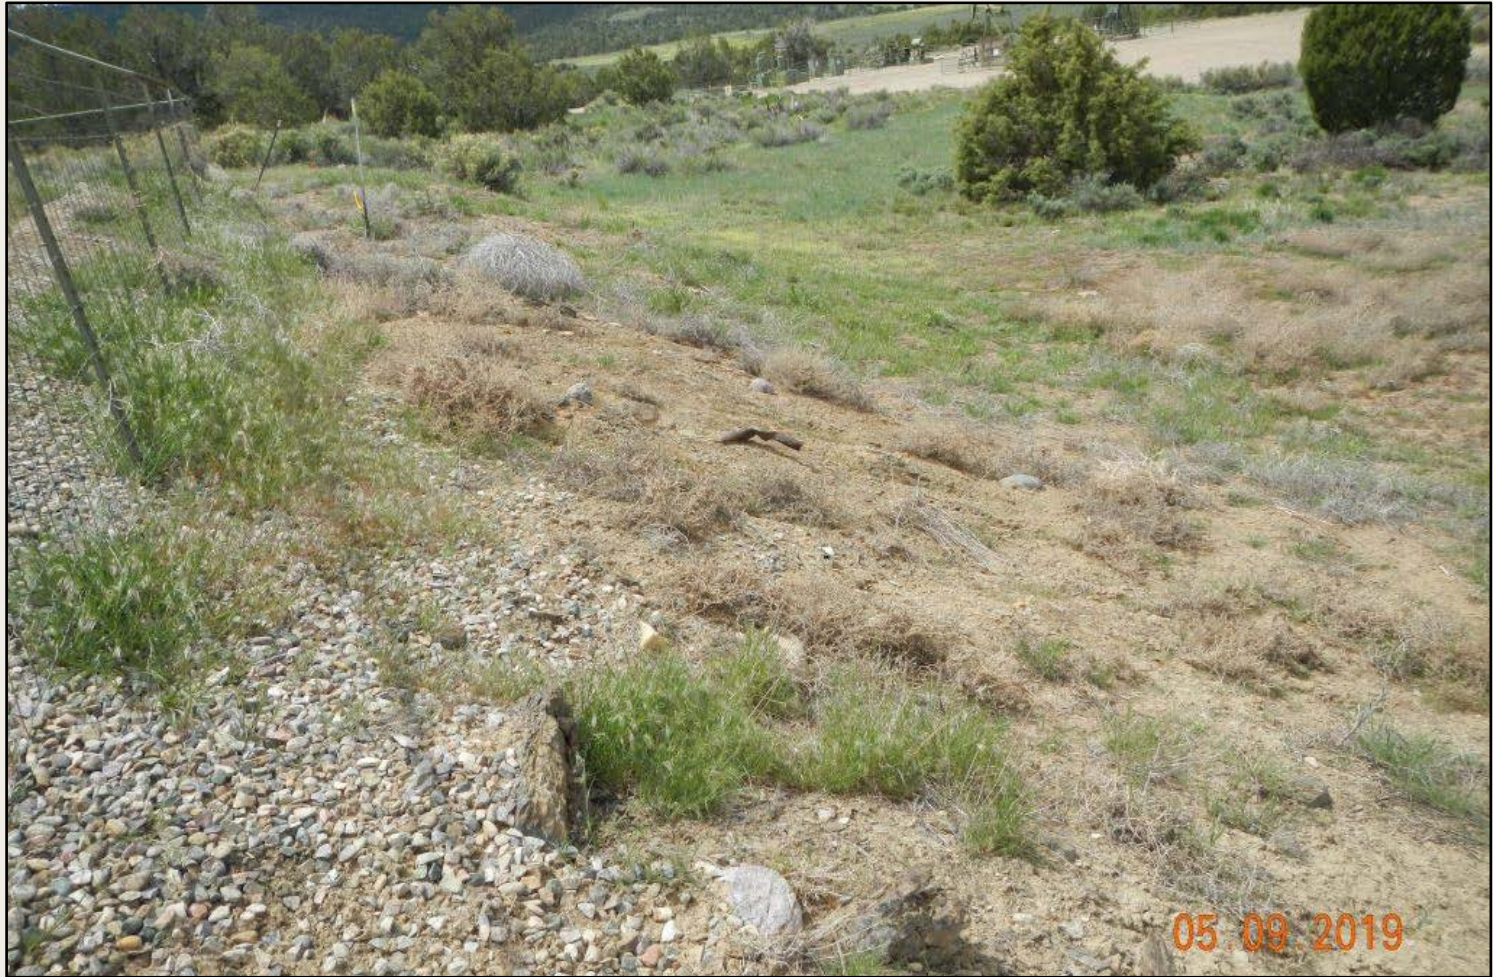
Photo 3. View of the western project area from the western edge facing southward. Vegetation is sparse and erosion is occurring.

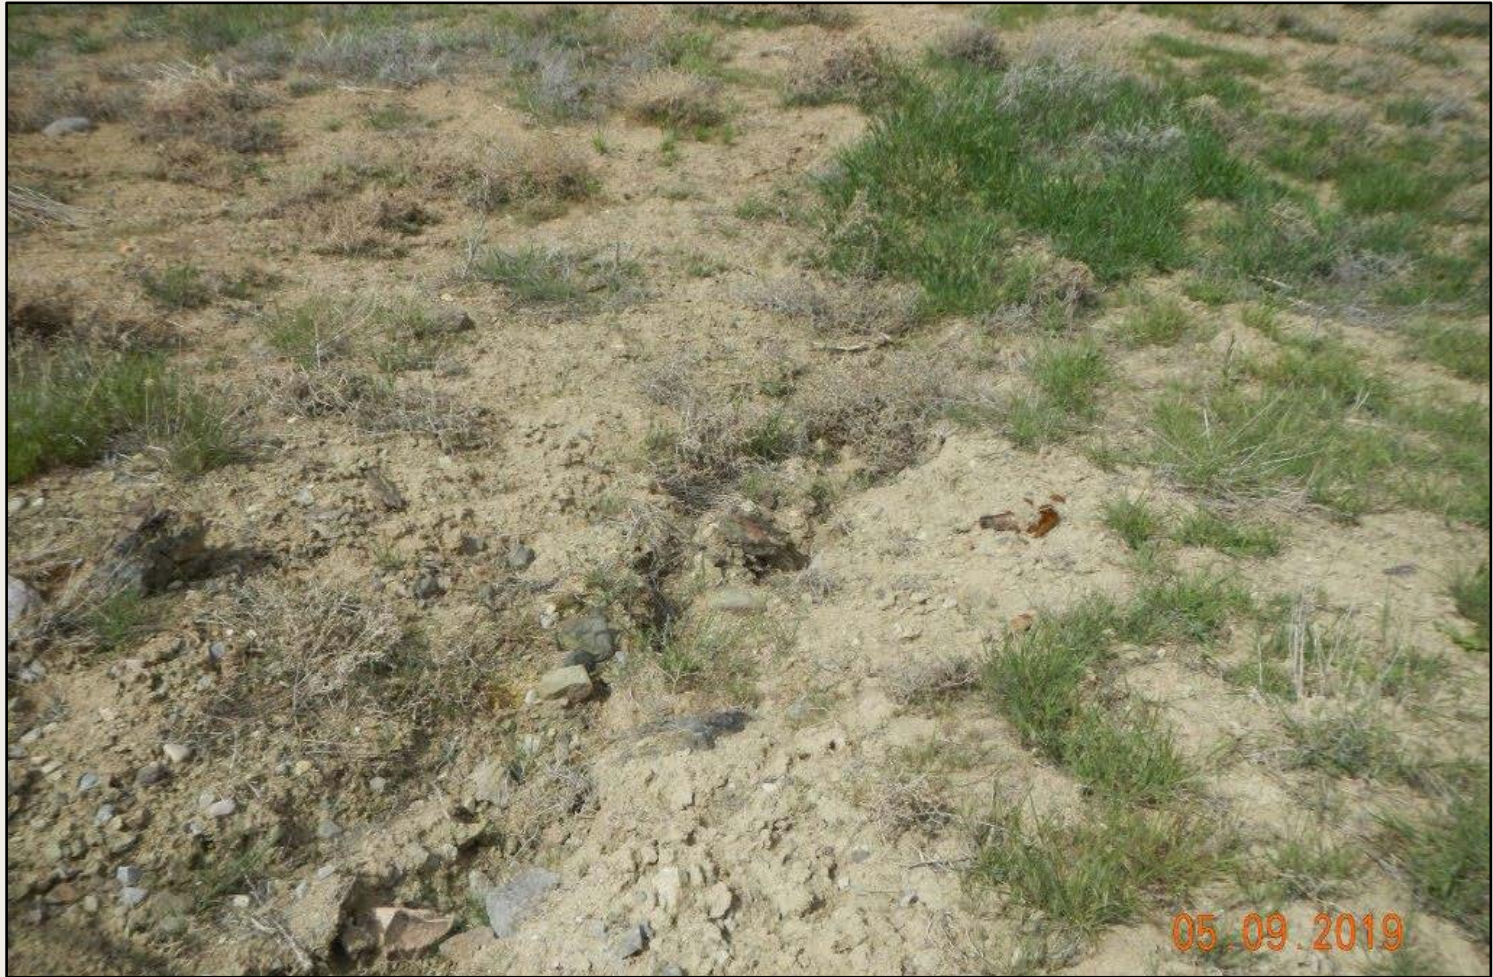
Photo 4. View of erosional channel approximately 2 feet wide and 1 foot deep within the western project area.
