Construction and Stormwater Inspection

Operator: CUB CREEK ENERGY- #10542

Location ID: 456537

Inspection Photos
Location Name: OLANDER PAD
Location ID: 456537

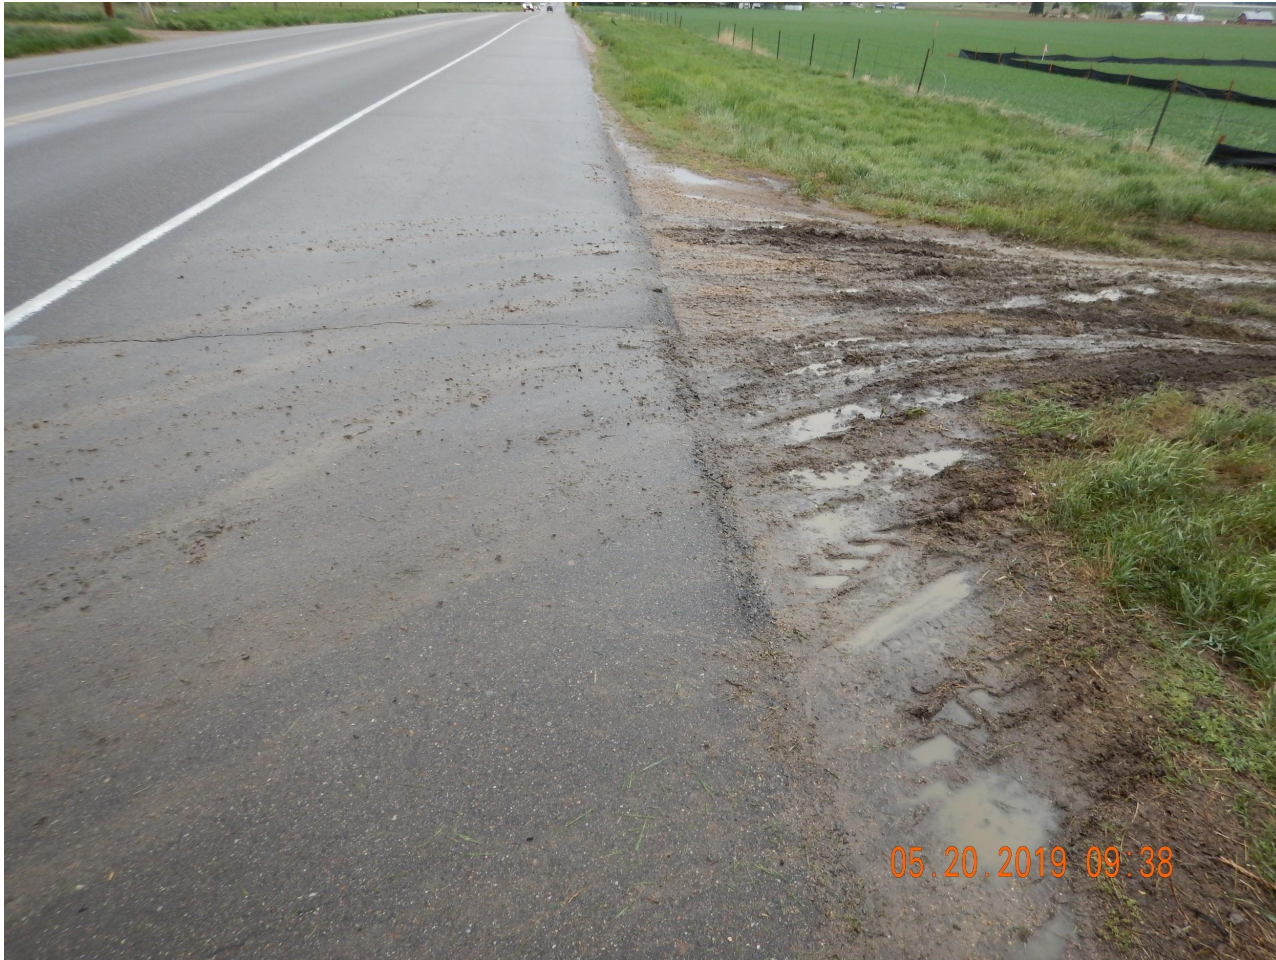
Photo 1. Photo taken from the entrance to location, facing East. Operator has failed to install a vehicle tracking device BMP. Operator is tracking out sediment and rutting up the entrance.

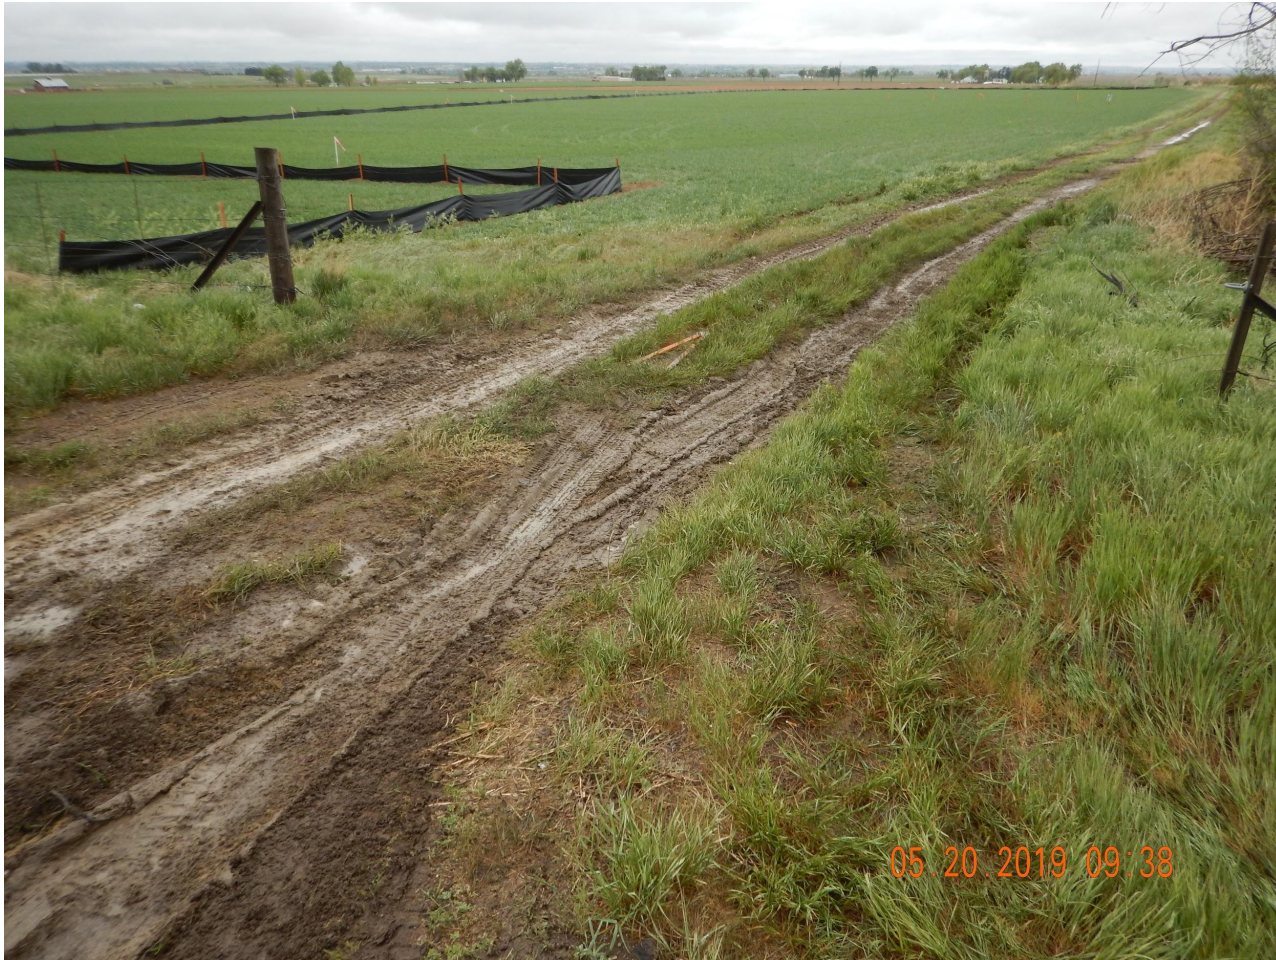
Photo 2. Photo taken from the entrance to location, facing South. See comments under Photo 1.

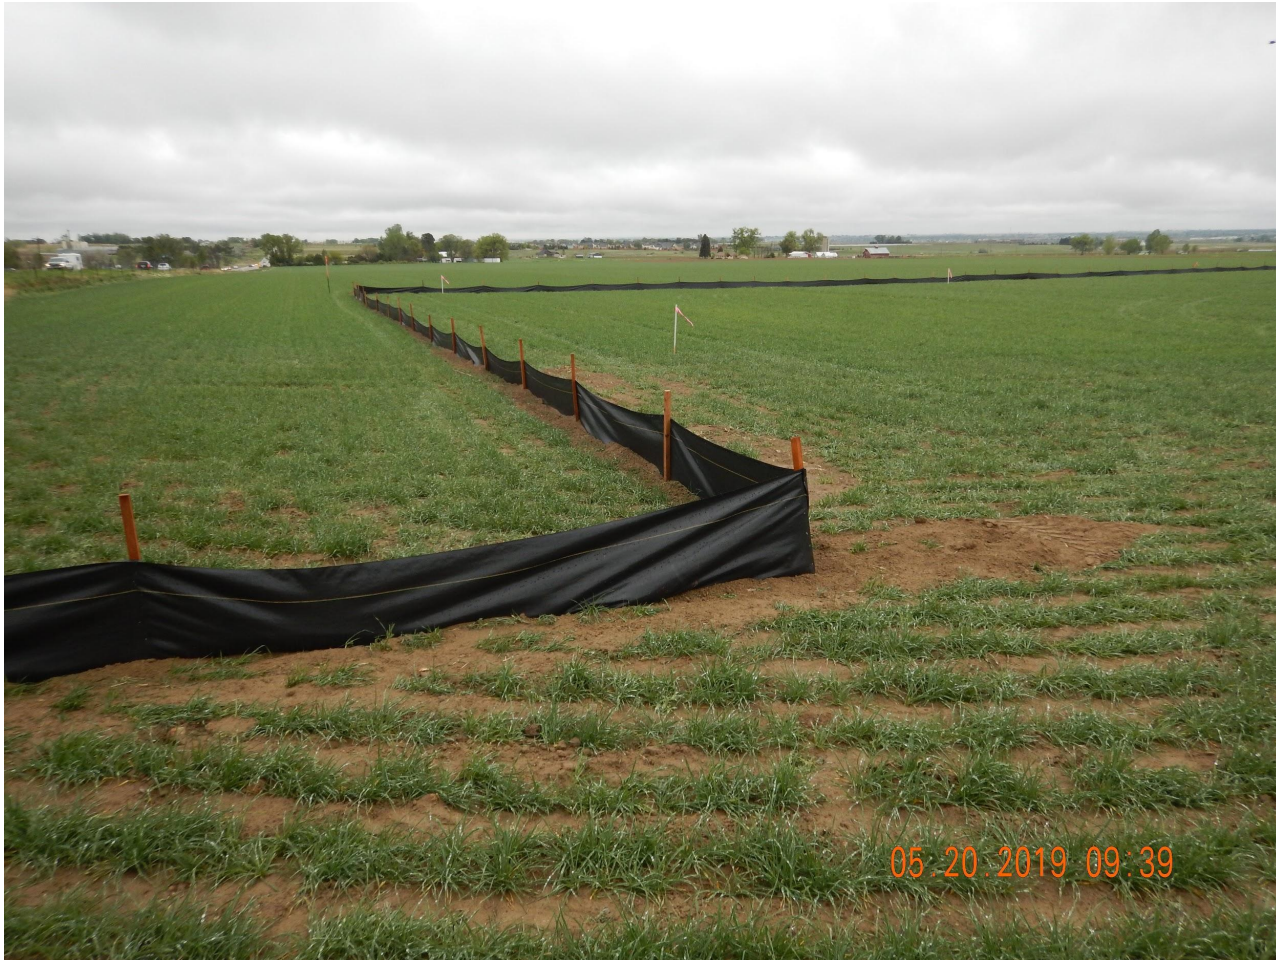
Photo 3. Photo taken from the northern location, facing East. Operator has install initial stormwater BMPs prior to the start of construction per Rule 1002.f. Note: It appears silt fence stakes have been installed too far apart. Per Rule 1002.f., Operator shall install stormwater BMPs per good engineering practices.
