# Inspection Photos

Operator: ALLISON DRILLING COMPANY INC -  
1350

Location ID: 402112

Inspection Doc. Number: 696200102  
Washington County, CO

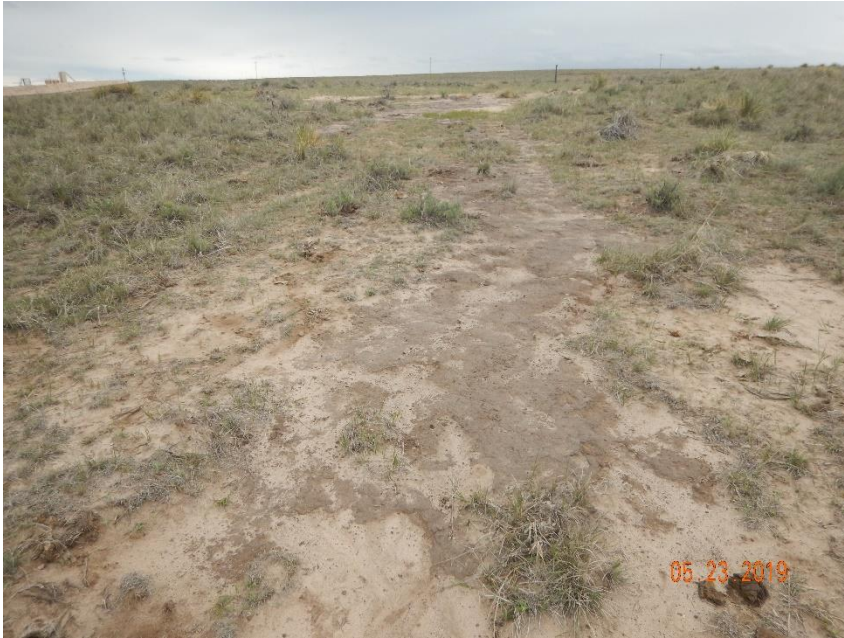
**Photo 1:** Photo taken from access road, west of the location, facing east. Photo show stained soils.

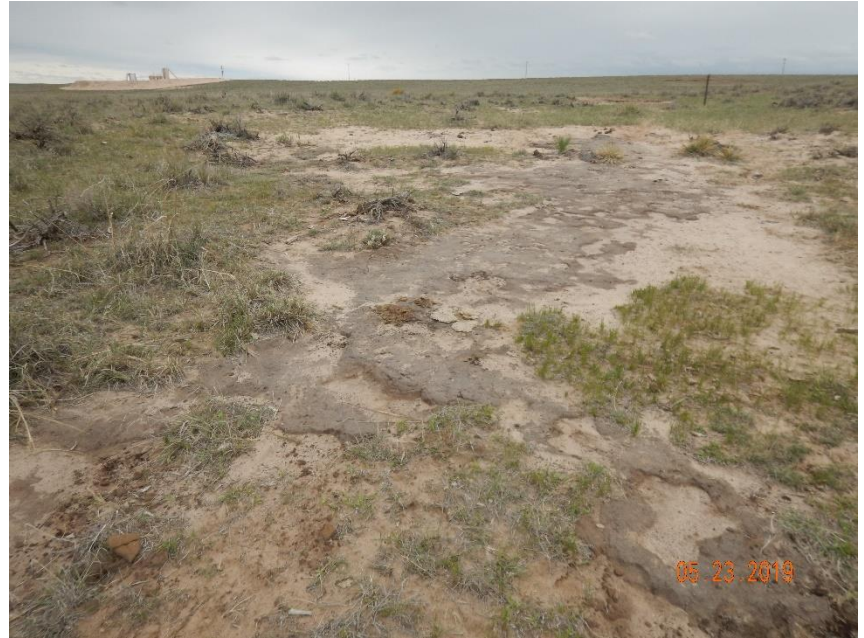
**Photo 2:** Photo taken from the well location, facing east. Photo shows stained and contaminated soils on the location.

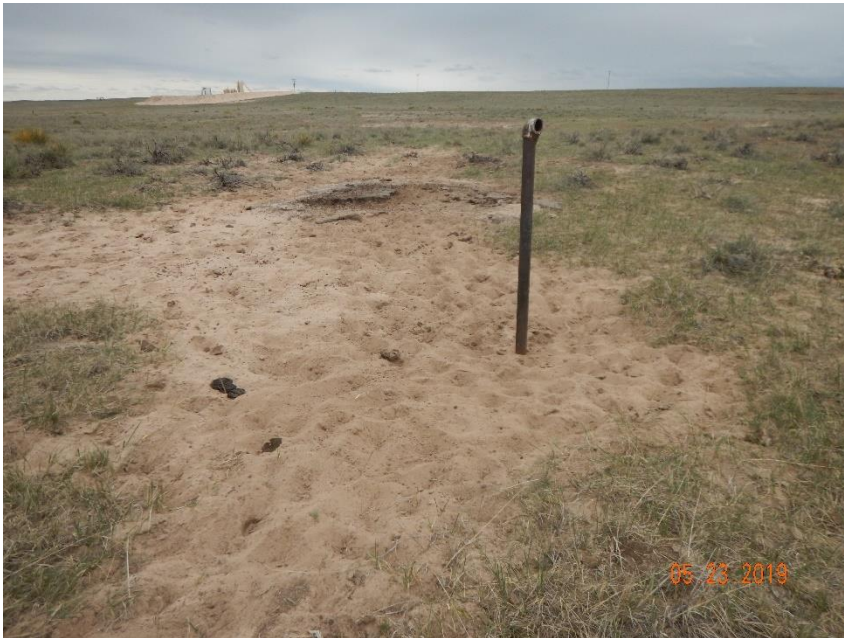
**Photo 3:** Photo taken from the south end of the location, facing north. Photo shows pipe riser remaining on location.

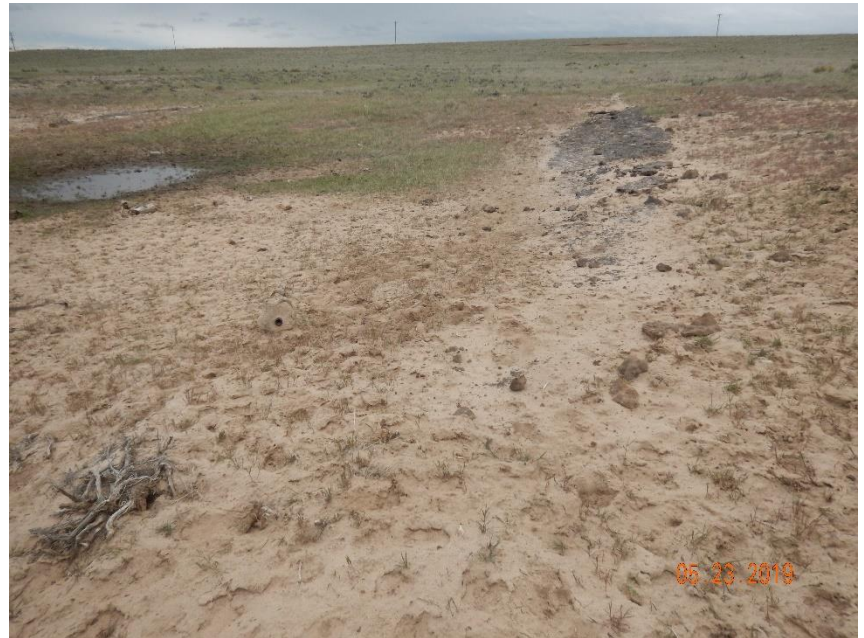
**Photo 4:** Photo taken from the southwest end of the pit, facing east. Photo shows pit has not been closer and stained/contaminated soils remain.

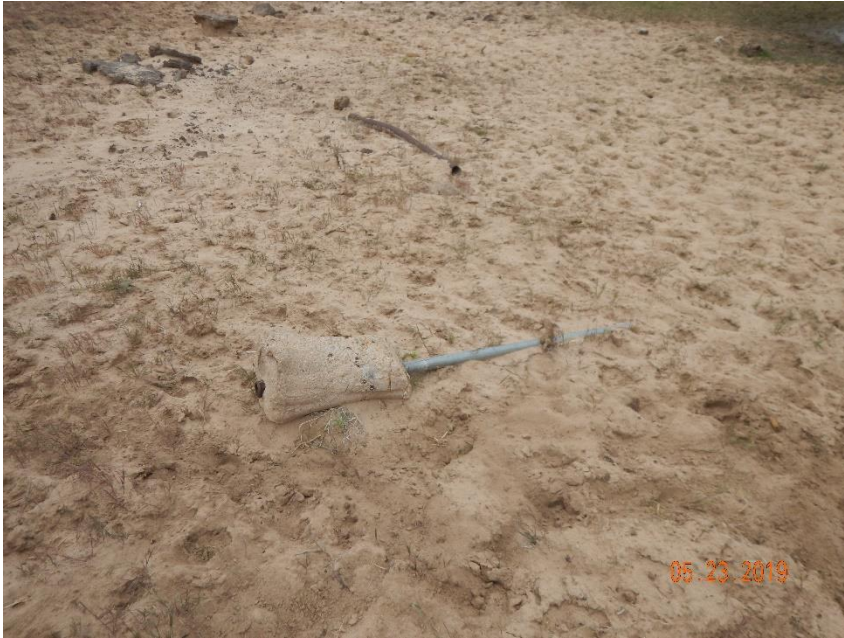
**Photo 5:** Photo shows pipe debris remaining on pit

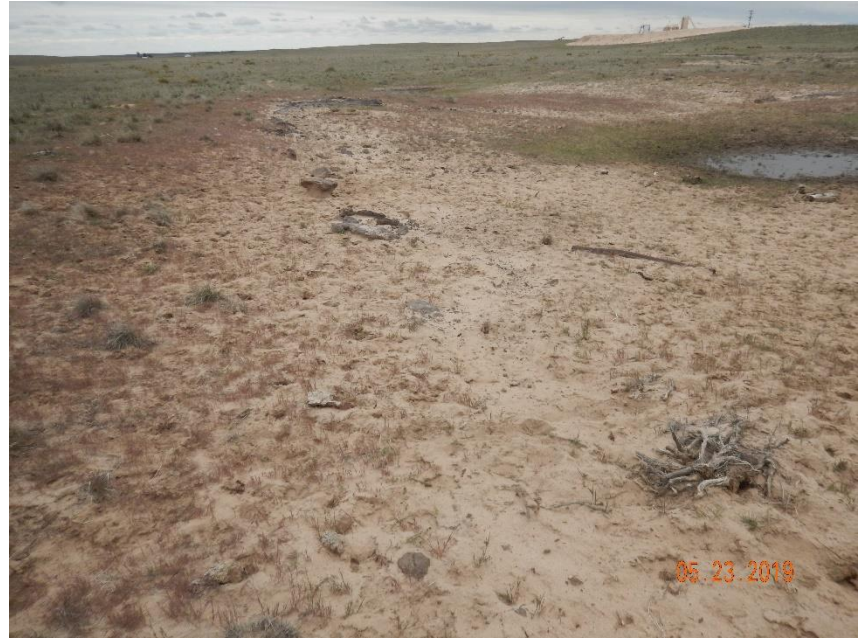
**Photo 6:** Photo taken from the southwest end of the pit, facing north. Photo shows pit has not been closer and stained/contaminated soils remain.

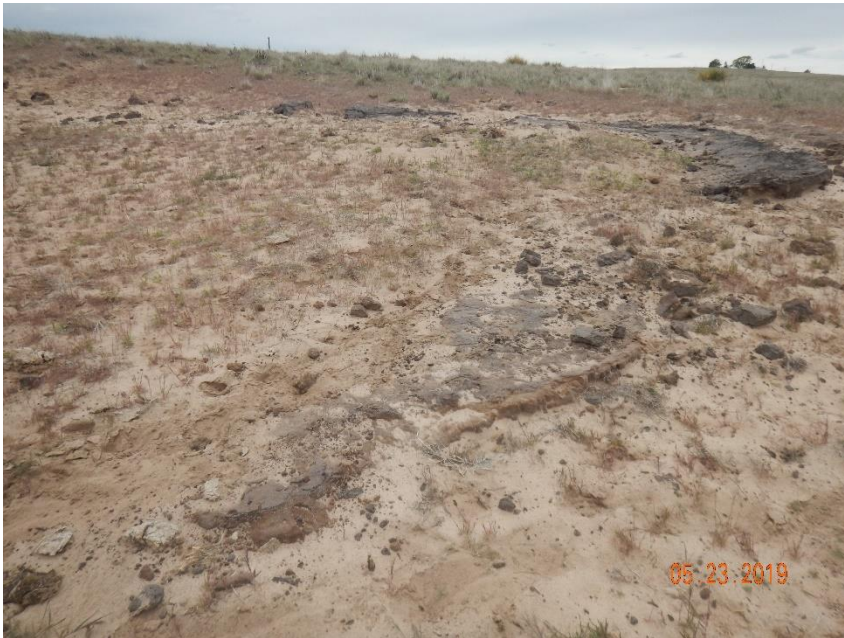
**Photo 7:** Photo shows stained/contaminated soils remaining at pit.

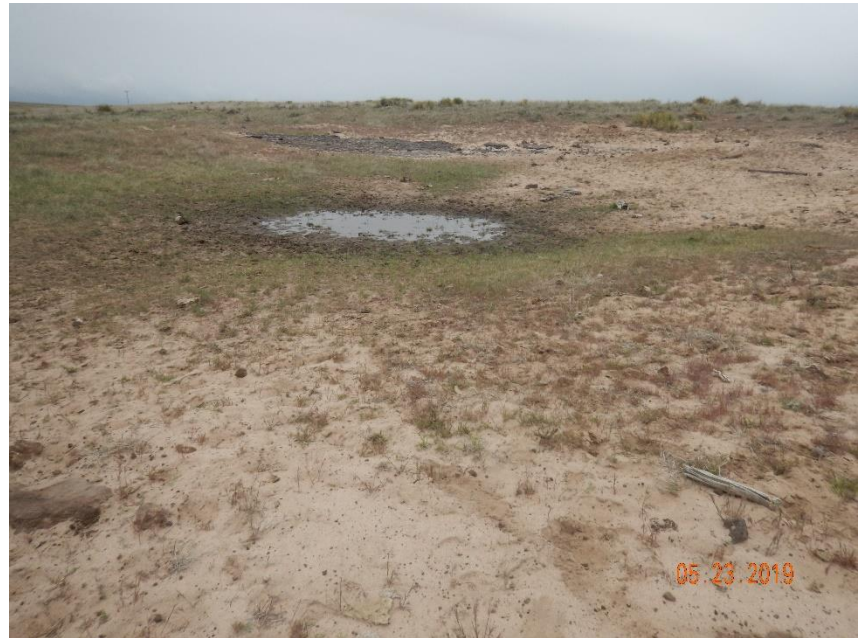
**Photo 8:** Photo shows pits have not been closed and stained/contaminated soils remaining at pit.

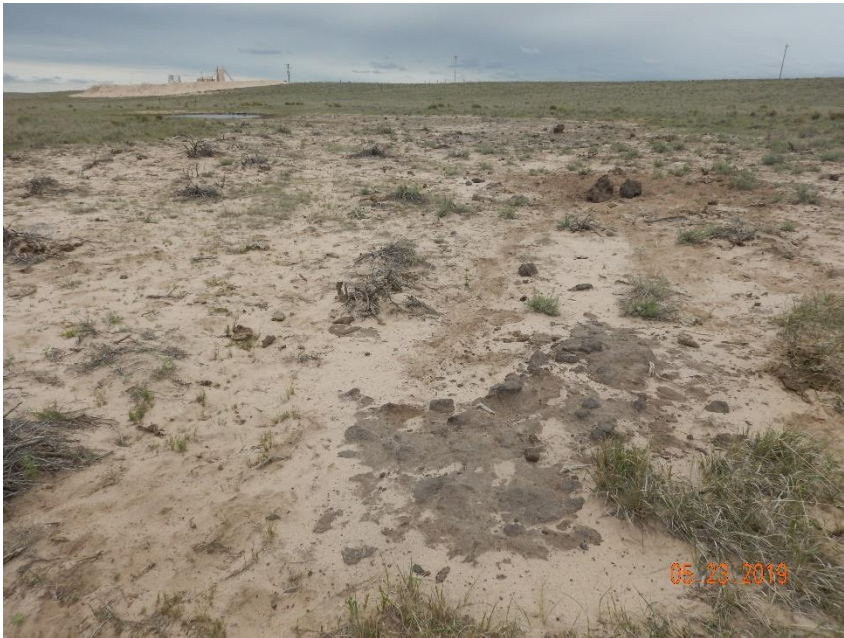
**Photo 9:** Photo taken from the east of the pits, facing northeast. Photo shows unvegetated areas where stained/contaminated soils are also evident. Aerial imagery suggests possible historic spill or discharge from pits.

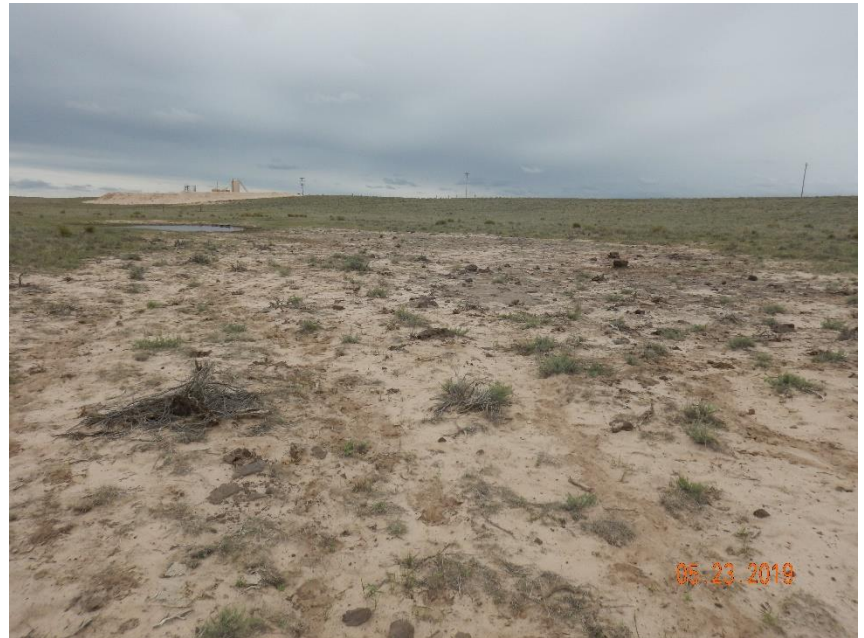
**Photo 10:** Photo taken from the east of the pits, facing north. Photo shows unvegetated areas where stained/contaminated soils are also evident. Aerial imagery suggests possible historic spill or discharge from pits.

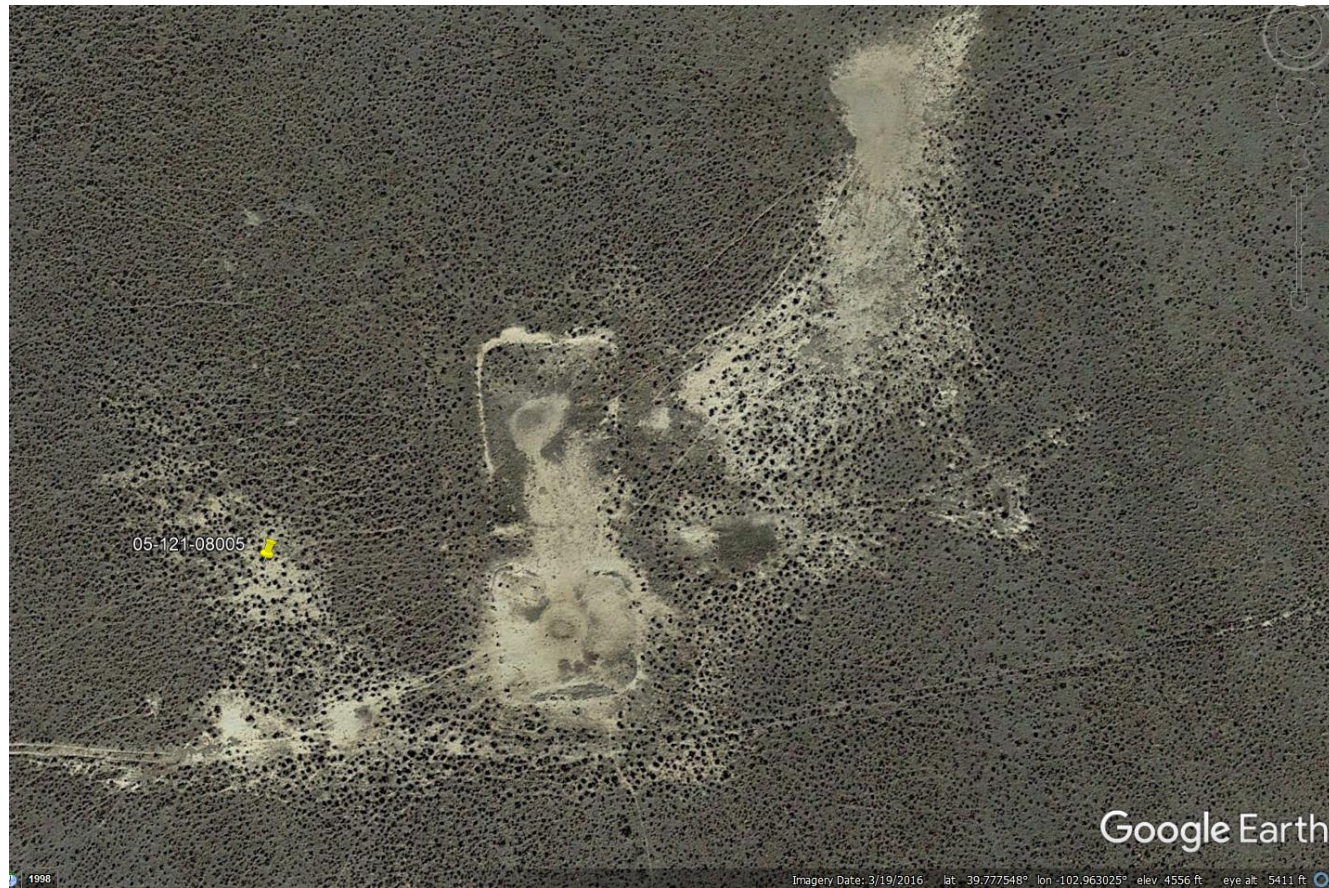
**Photo 11:** 2016 Google earth aerial imagery of the well, location and disturbed areas.
