Inspection Photos  
Location Name: GOPHER 31-9  
API#: 05-071-09599  
INSP. #: 695100797

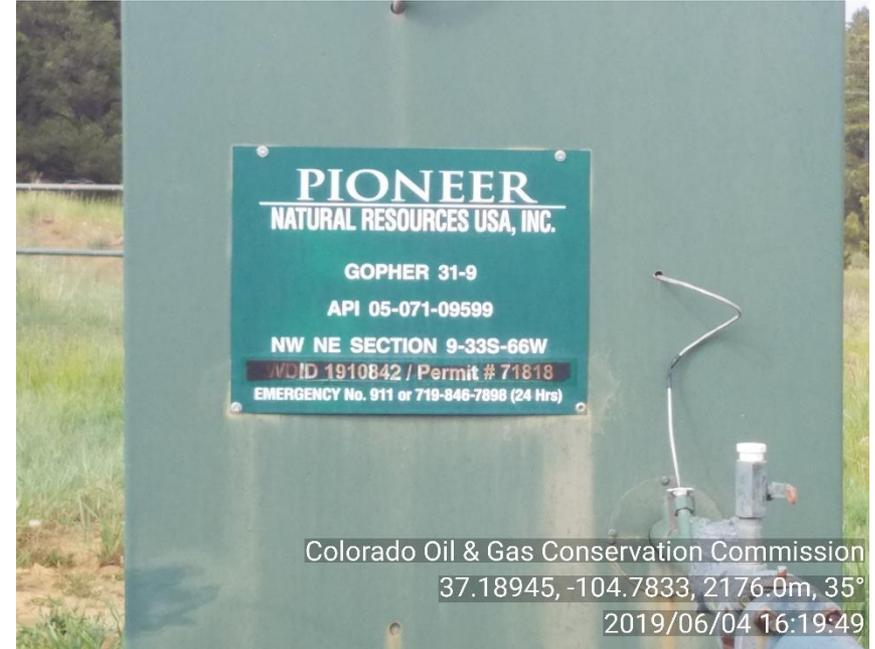
**PHOTO 2: WELL SIGN/ CURRENT OPERATOR IS NOT POSTED ON WELL SIGN. POST CURRENT OPERATOR ON WELL SIGN IN ACCORDANCE WITH 210 SERIES RULES. CA DATE 8/4/19.**

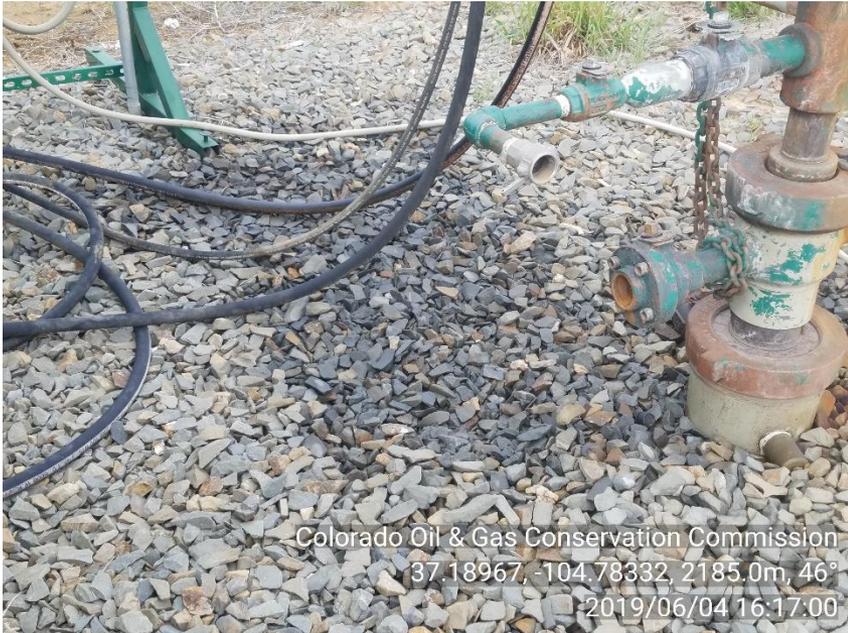
**PHOTO 3: AREA OF IMPACTED GRAVEL AROUND WELLHEAD APP. 2' BY 4' IN SIZE. Remove and dispose impacted material in approved manner, service and maintain equipment and self inspect to prevent recurrence of conditions per 1002.f(2) and 907" CA DATE 7/4/19**

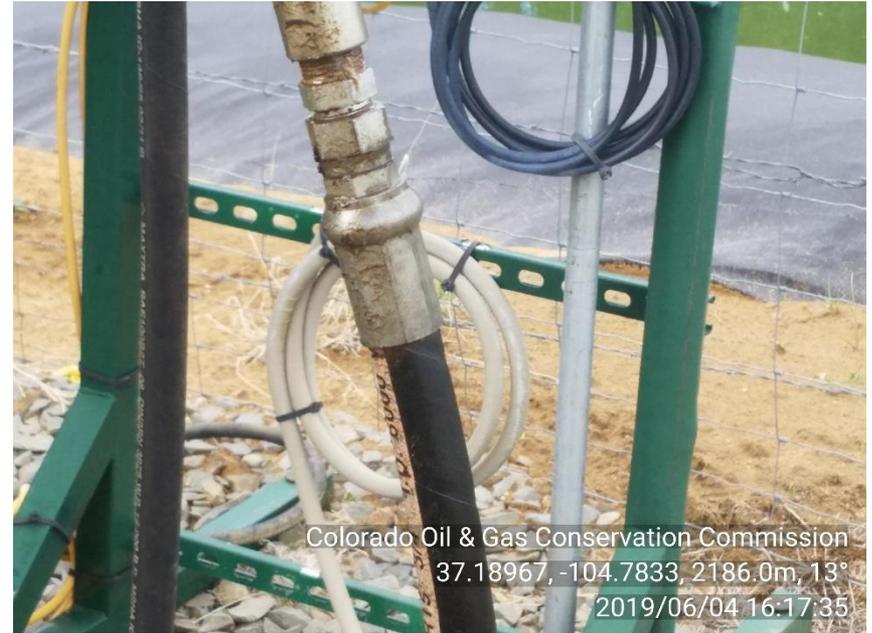
**PHOTO 4: HYDRAULIC FITTING APPEARS TO BE SEEPING FLUID. Increase frequency of maintenance and self inspection schedule of equipment to prevent impacting surface materials and mixing of wastes with precipitation" CA DATE 7/4/19**
