Inspection Photos

Operator: DIVERSIFIED OPERATING
CORPORATION # 24461

Location ID: 408218

Inspection Doc. Number: 696200172
Weld County, CO

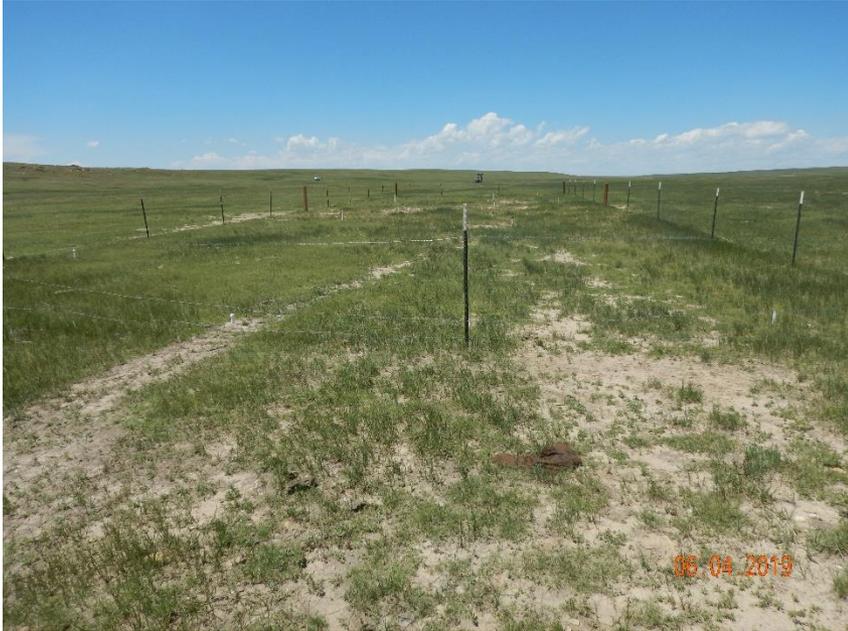
Photo 1: Photo taken from east end of the location, facing west. Photos shows fence remaining at the location and what appears to be ~15 monitoring wells remaining.

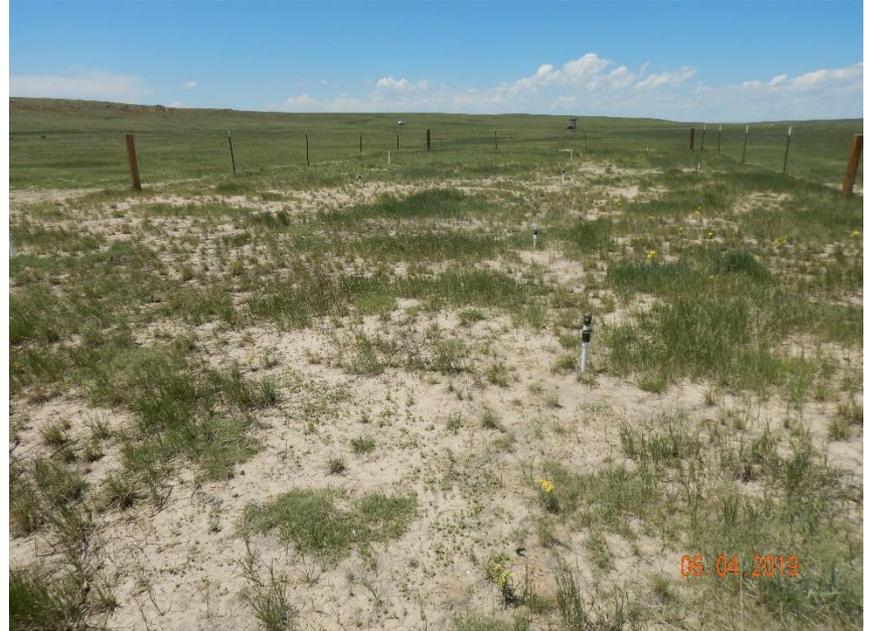
Photo 2: Photo taken from the location, facing west. Photo shows what appears to be ~15 monitoring wells remaining. Photo also shows location has not achieved a uniform vegetative establishment on the location in accordance with 1004.a.

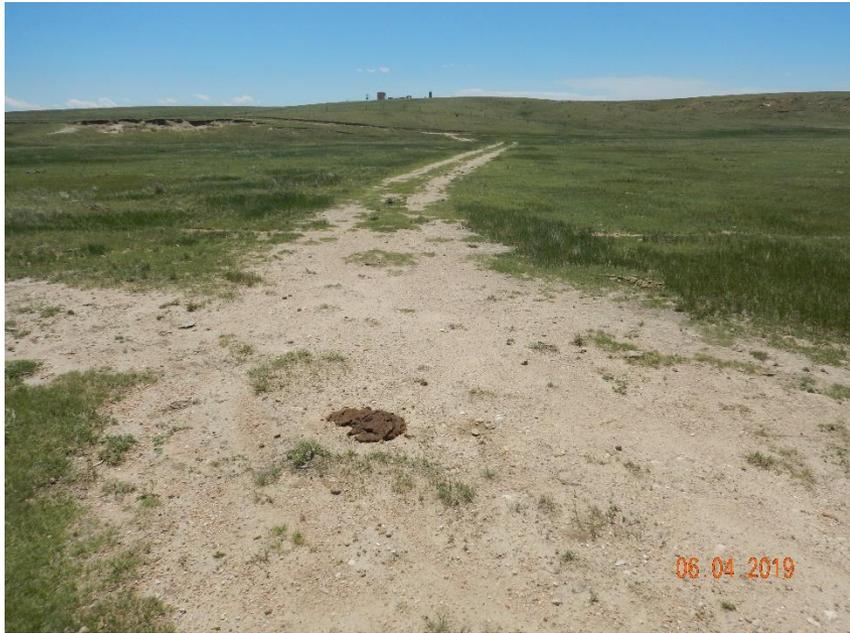
Photo 3: Photo taken from the location, facing south. Photo shows access road remains and has not been reclaimed.

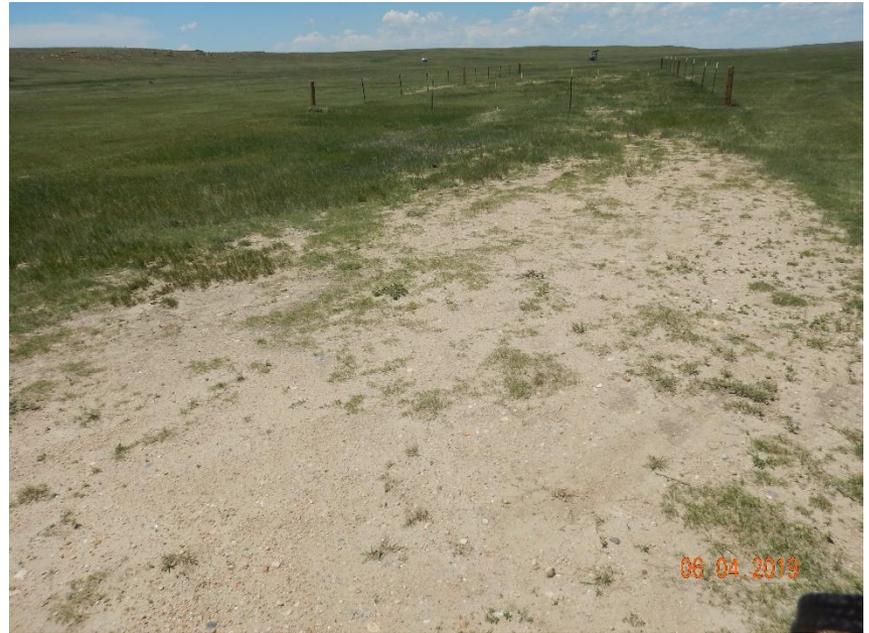
Photo 4: Photo taken from the location, facing west. Photo shows access road remains and has not been reclaimed.

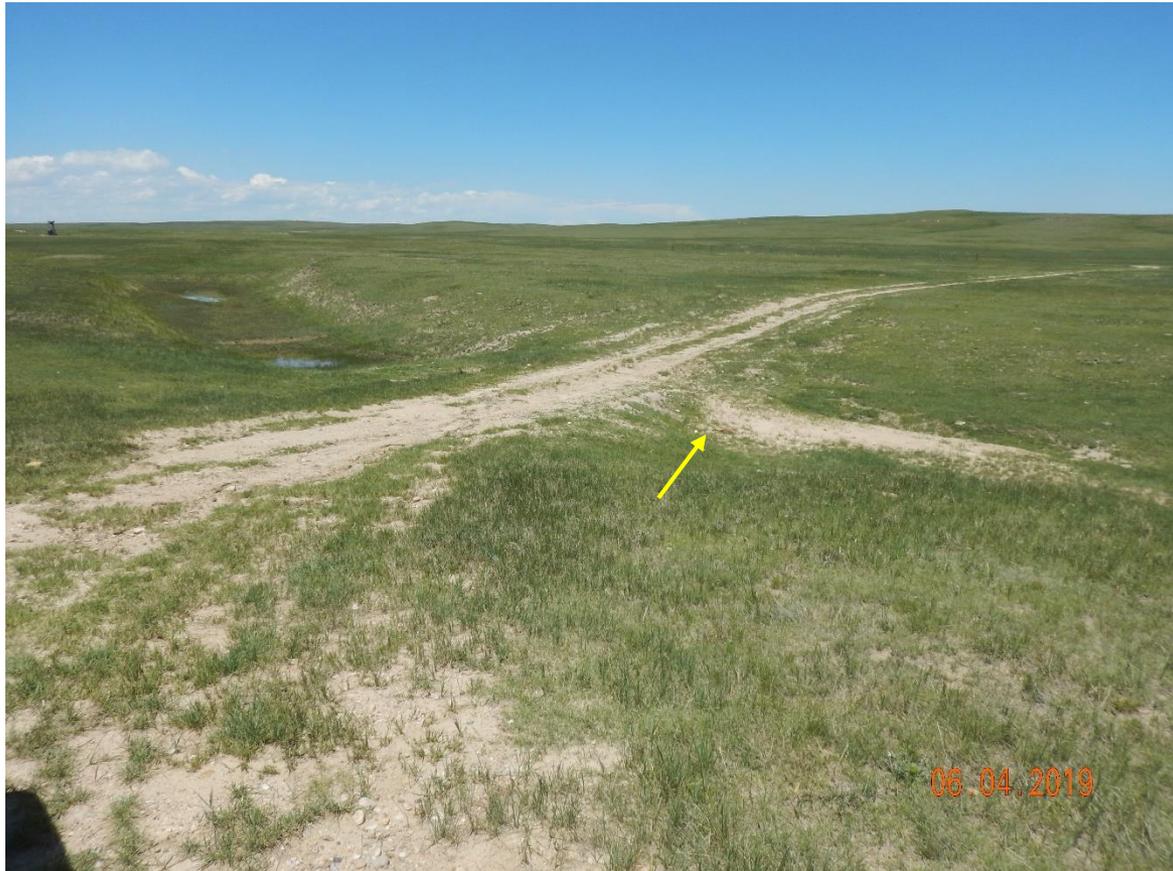
Photo 5: Photo taken from the access road, facing northwest. Photo shows section of access road that crosses a drainage. Photo shows erosion degradation and sediment transport off road. Access road remains and has not been reclaimed
