Final Reclamation Inspection

Operator: NOBLE ENERGY INC - #100322

Location ID: 309839

Inspection Photos
Location Name: RYANN STATE C #16-27
Location ID: 309839

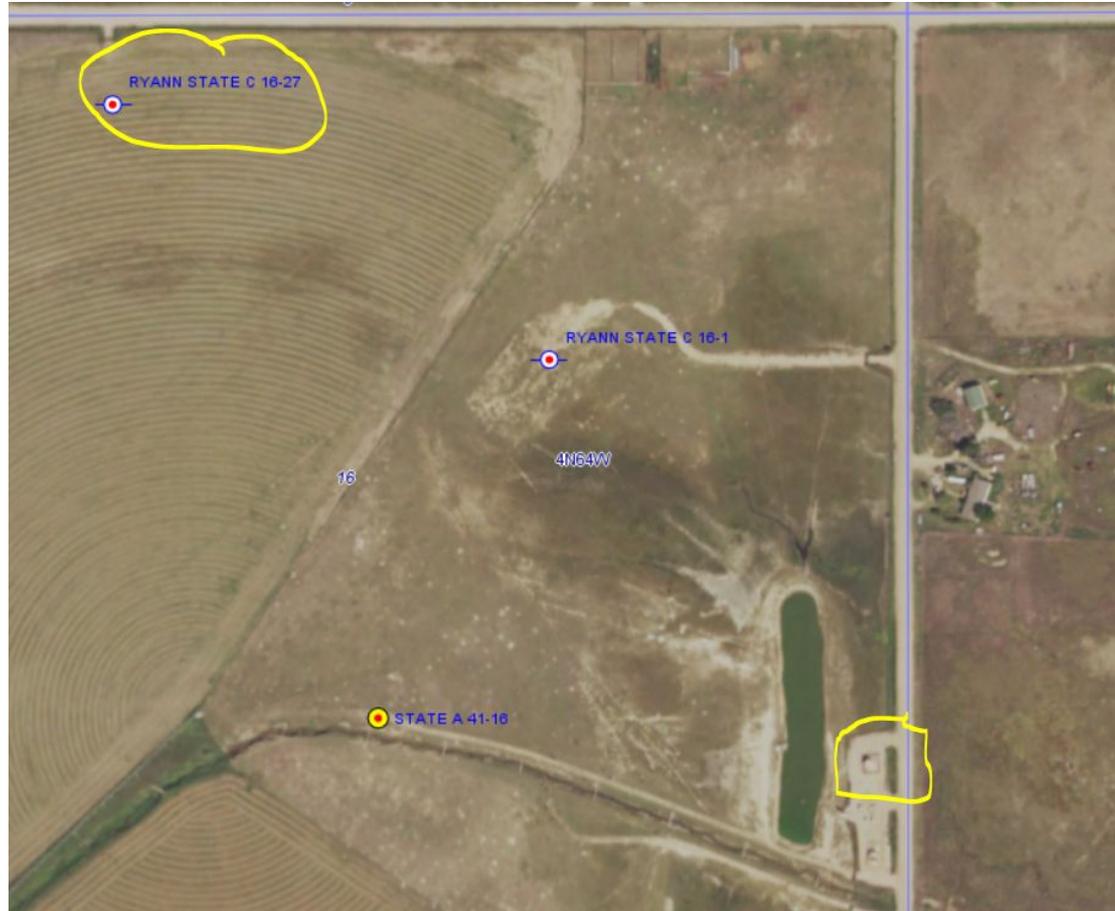
Aerial imagery taken in 2017. Aerial imagery shows two areas circled in yellow. The Ryann State C 16-27 well was serviced by the northern tank battery circled in yellow.

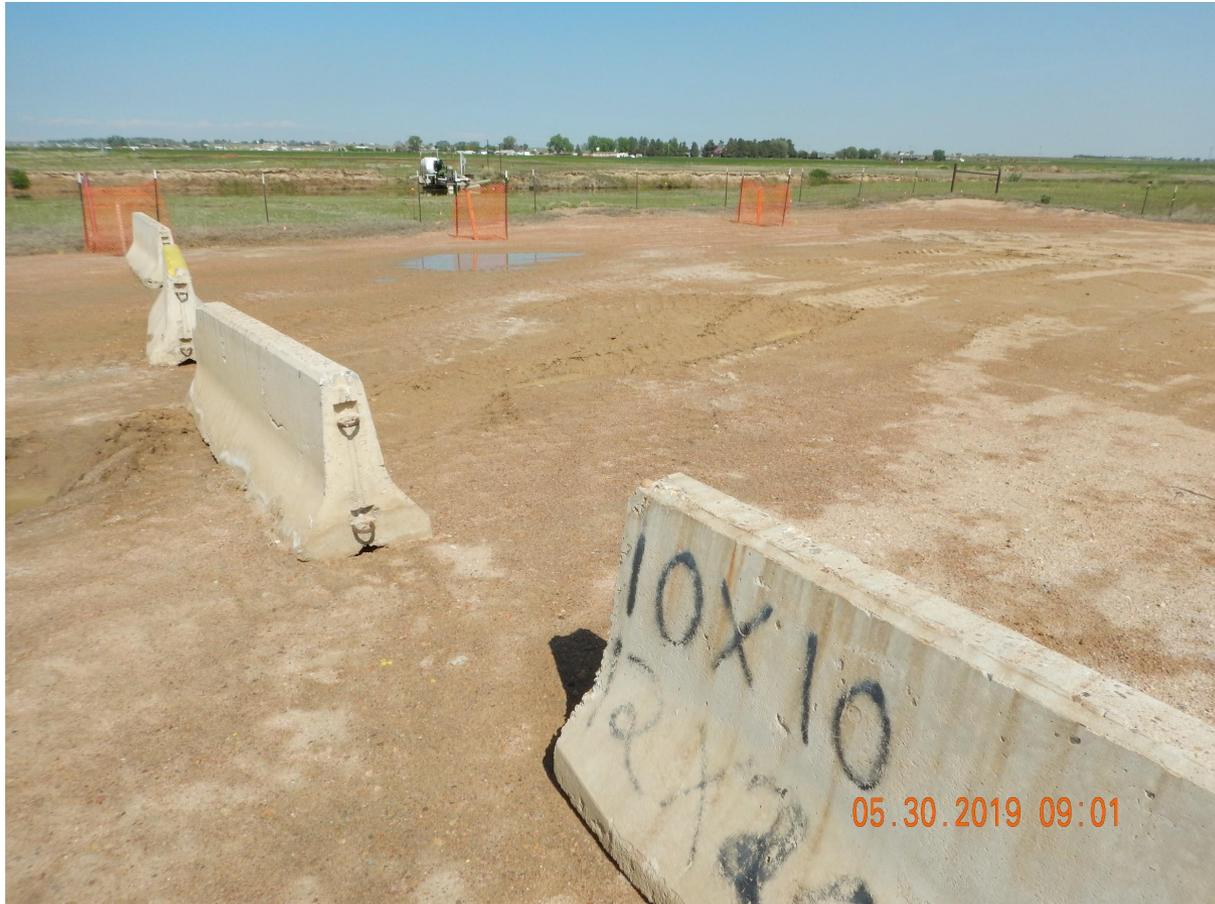
Photo 1. Photo taken from the southern portion of the northern tank battery, facing West. Photo illustrates no equipment was observed at the location. The Ryann State C 16-27 well was plugged 11/8/2018. Per Rule 1004, Operator shall make every reasonable effort to perform final reclamation before the next local growing season. It appears the Operator could have performed Final Reclamation during the 2019 Spring seeding window but failed to do so.

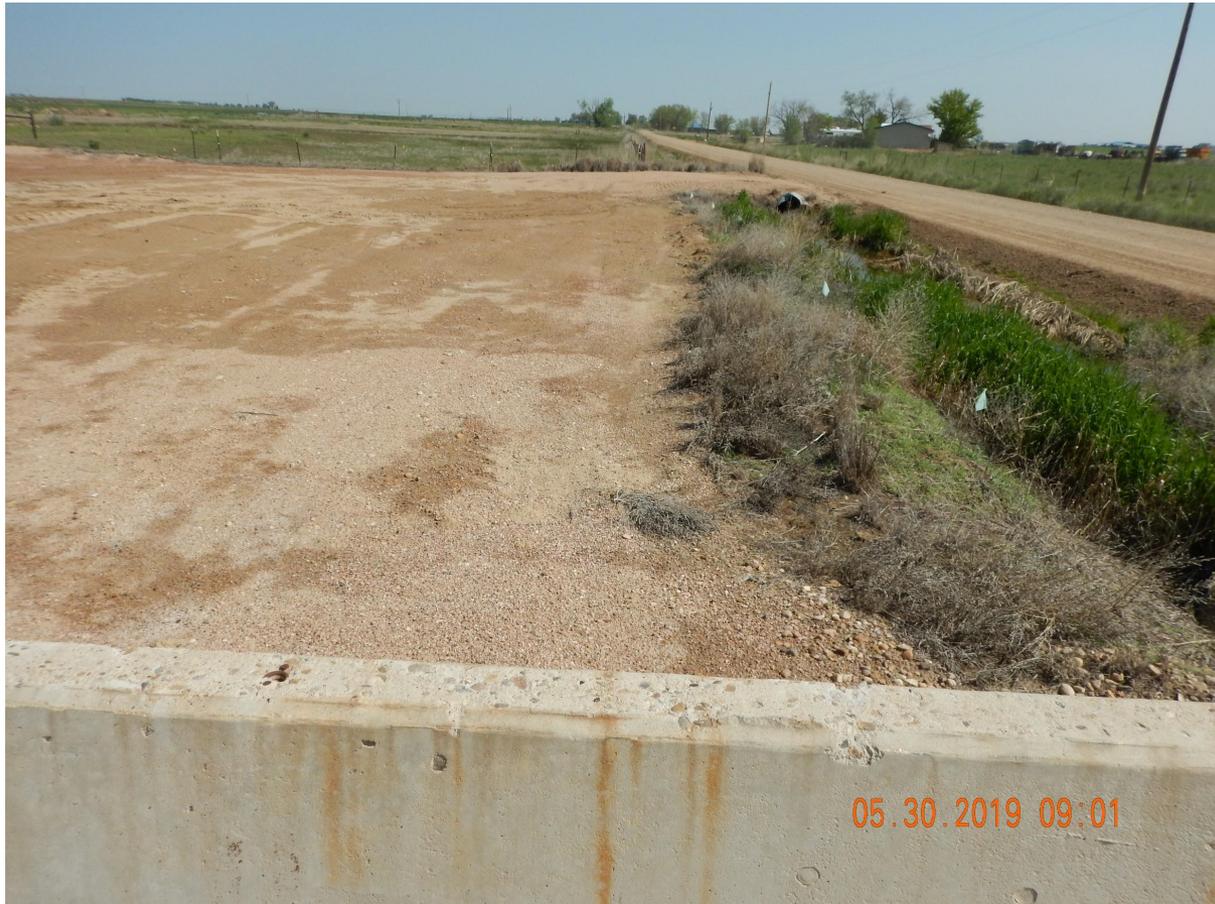
Photo 2. Photo taken from the southern portion of the northern tank battery, facing North. See comments under Photo 1.
