Inspection Photos
Location Name: RIVERSIDE 43-1 & TR
API#: 05-071-06966 & 07548
INSP. #: 695100839

COLORADO
Oil & Gas Conservation
Commission
Department of Natural Resources

Inspection Photos

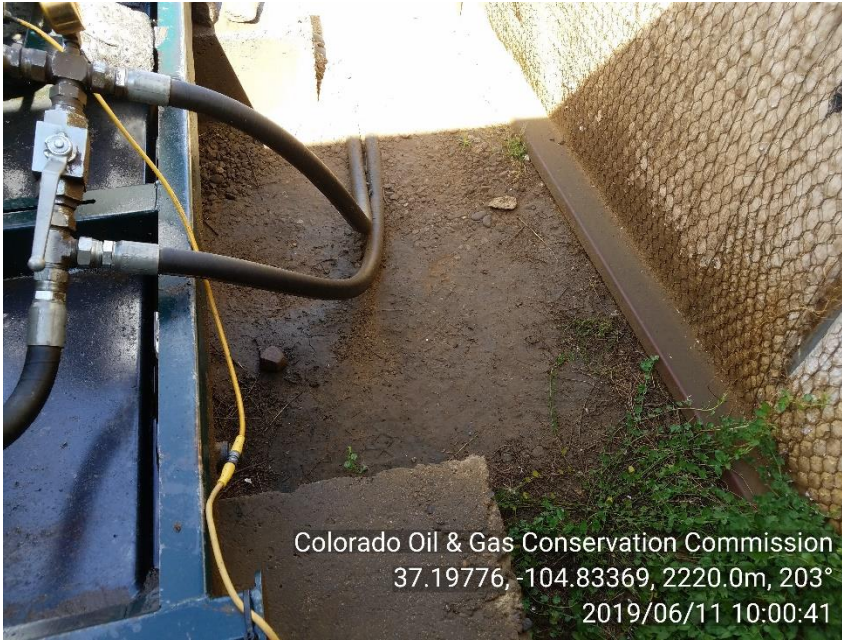
PHOTO 5: AREA OF IMPACTED SOIL APP. 6' BY 6' EXTENDING FROM SOUND WALL UNDER ENGINE SKID FOR ORIGINAL WELL. Remove and dispose impacted material in approved manner, service and maintain equipment and self inspect to prevent recurrence of conditions per 1002.f(2) and 907" CA DATE 7/11/19.

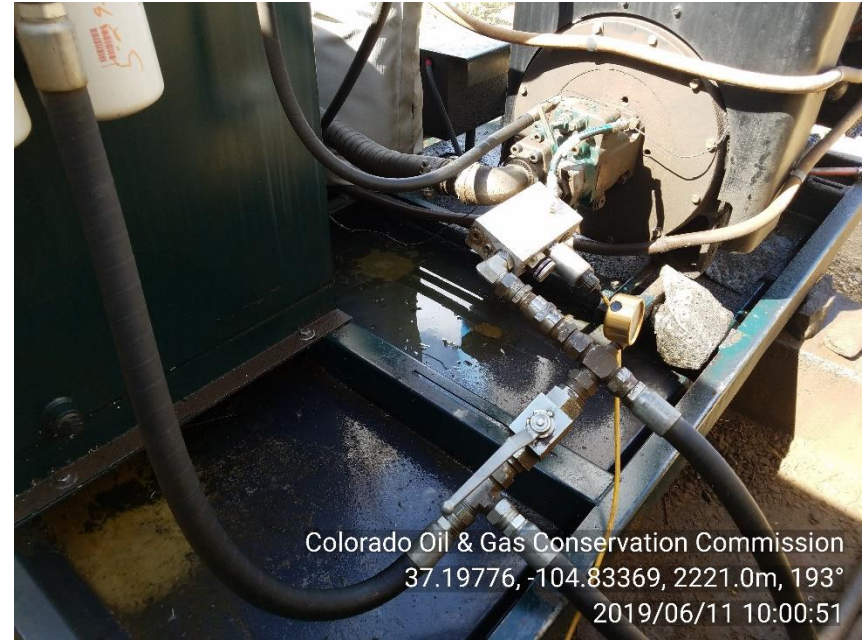
PHOTO 6: STANDING OILY WATER IN ENGINE SKID FOR ORIGINAL WELL. Comply with general provisions of the oil and gas act for wildlife protection. CA DATE 7/11/19.

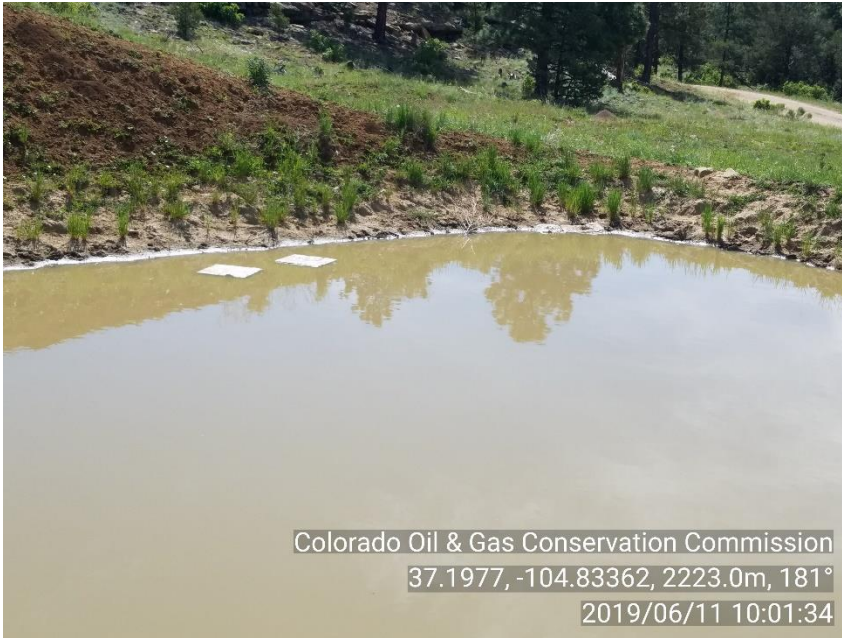
PHOTO 7: TRASH FLOATING IN ORIGINAL WELL PIT. REMOVE TRASH IN COMPLIANCE WITH 603.f. CA DATE 7/11/19.
