Inspection Photos
Location Name: FACE OFF 23-24
API#: 05-071-07513
INSP. #: 695100877

Location Name: FACE OFF 23-24

API#: 05-071-07513

INSP. #: 695100877

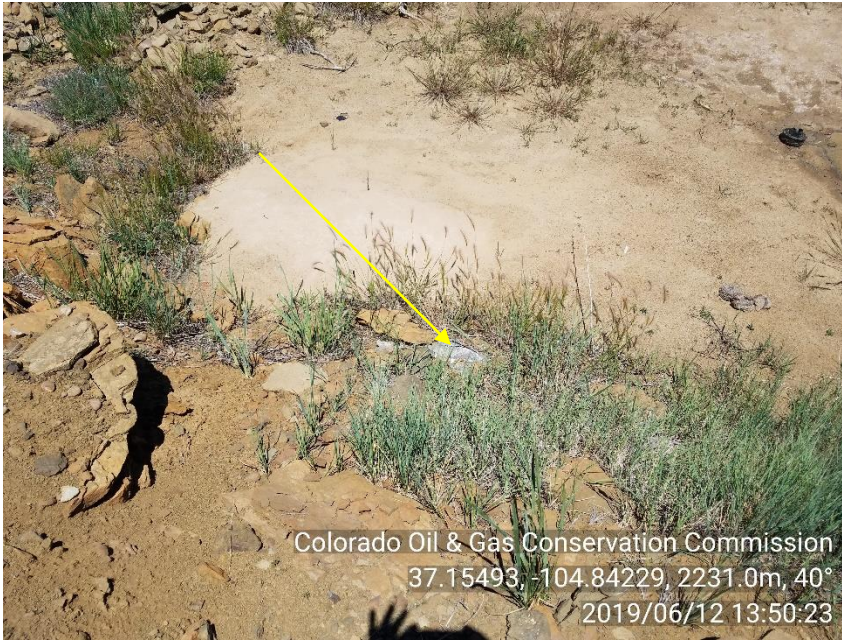
PHOTO 3: TRASH IN PIT. COMPLY WITH RULE 603.f. CA DATE 7/12/19

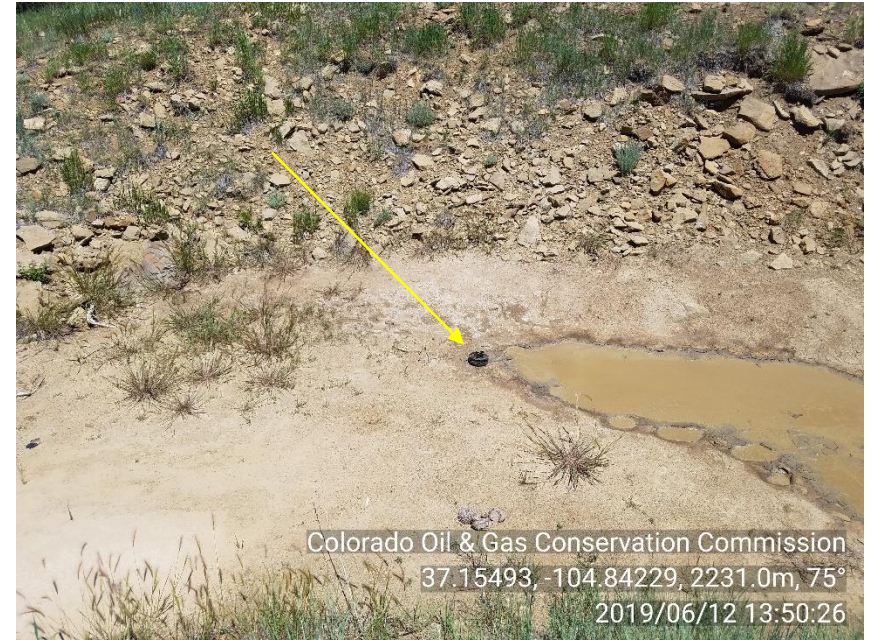
PHOTO 2: TRASH IN PIT. COMPLY WITH RULE 603.f. CA DATE 7/12/19

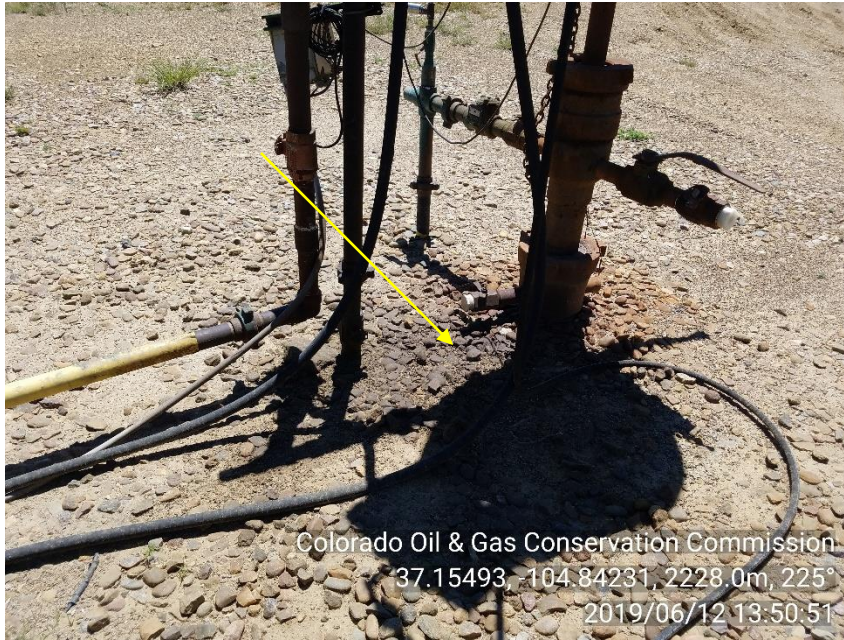
PHOTO 5: APP. 3' BY 2' AREA OF IMPACTED SOIL NEAR WELLHEAD. Remove and dispose impacted material in approved manner, service and maintain equipment and self inspect to prevent recurrence of conditions per 1002.f(2) and 907. CA DATE 7/12/19.

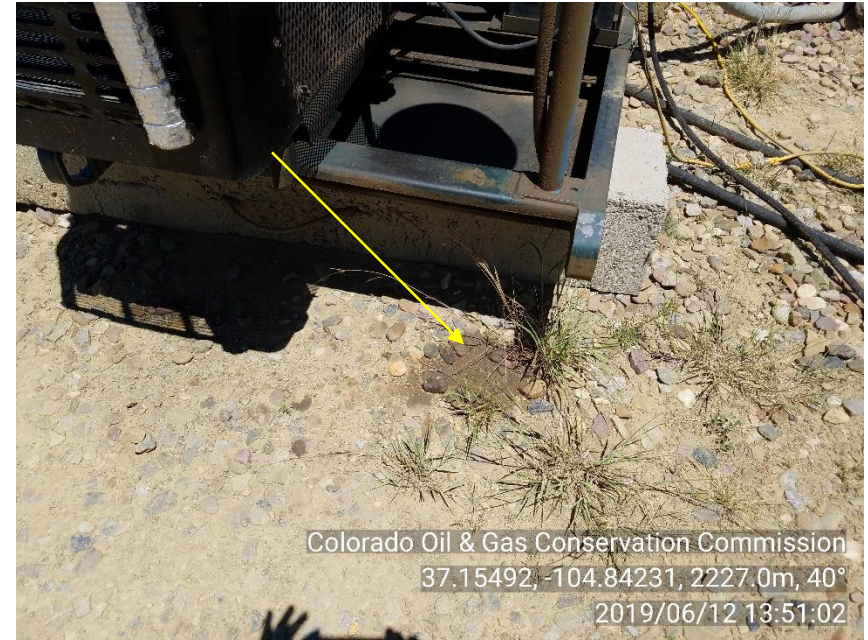
PHOTO 6: APP. 1' ROUND AREA OF IMPACTED SOIL NEAR ENGINE SKID. Remove and dispose impacted material in approved manner, service and maintain equipment and self inspect to prevent recurrence of conditions per 1002.f(2) and 907. CA DATE 7/12/19.
