Inspection Photos

06/26/2019

Operator: MONAHAN* REX FAMILY TRUST -
59100

Location ID: 117501 (Pit)
Washington County, CO

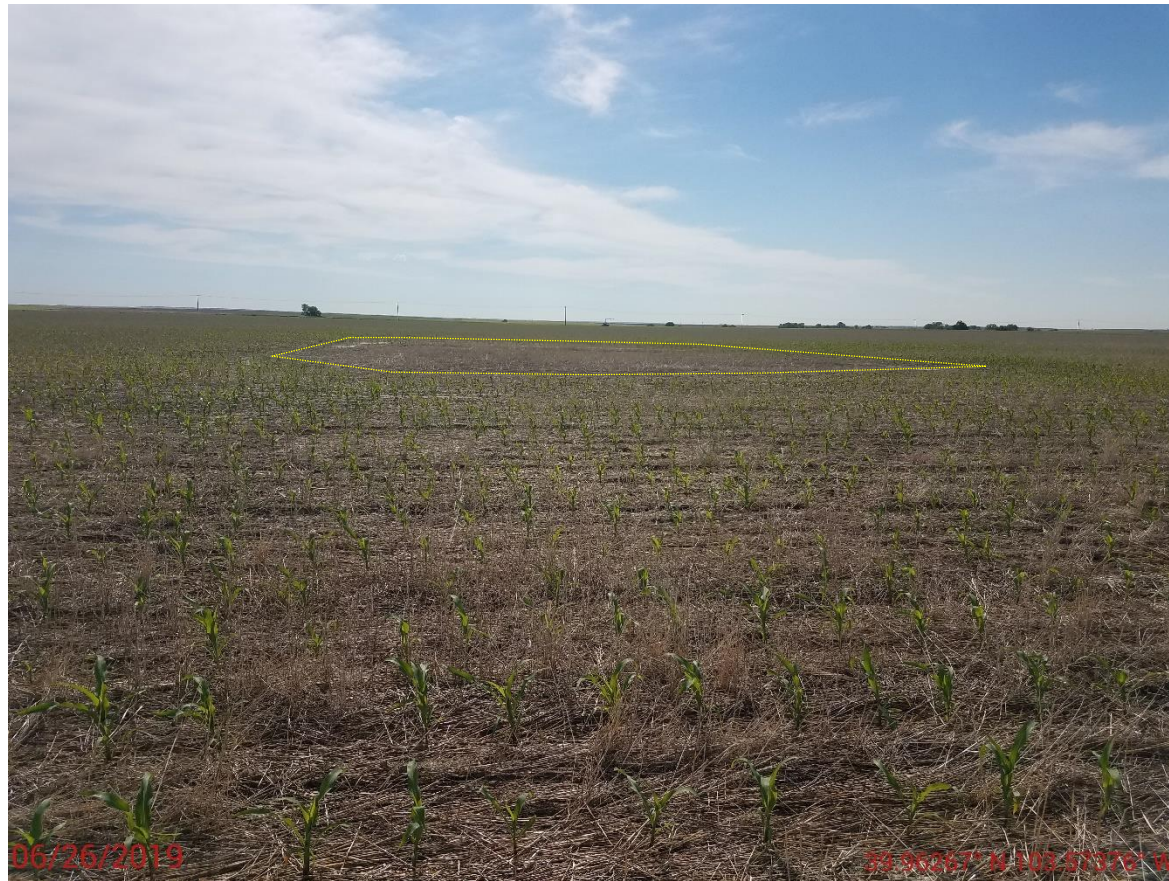
Photo 1: Photo taken from the west of the pit location, facing east. Photo shows no agricultural production (crop establishment) from the 2019 crop seeding is occurring within the pit.

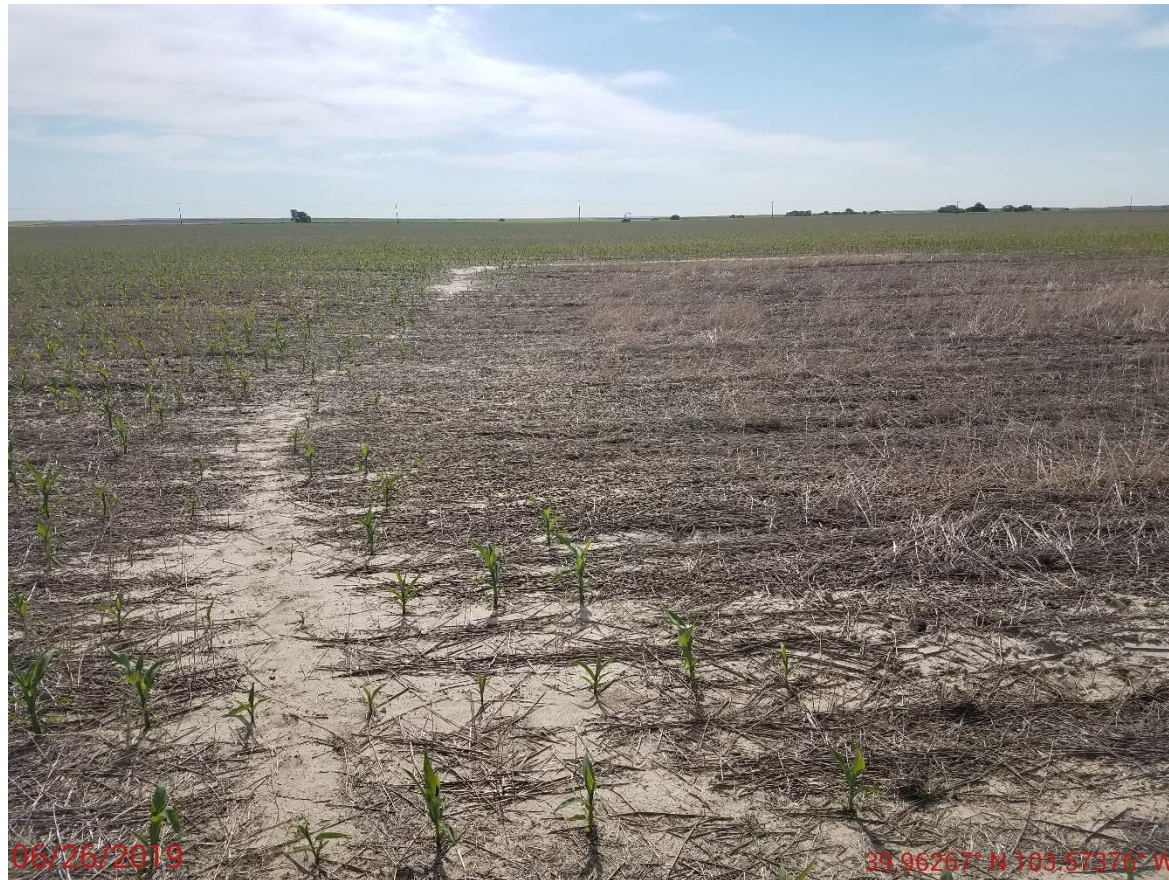
Photo 2: Photo taken from the northwest corner of the pit, facing east. Photo shows no agricultural production from the 2019 crop seeding is occurring within the pit. Additionally, the pit walls remain evident with no growth.

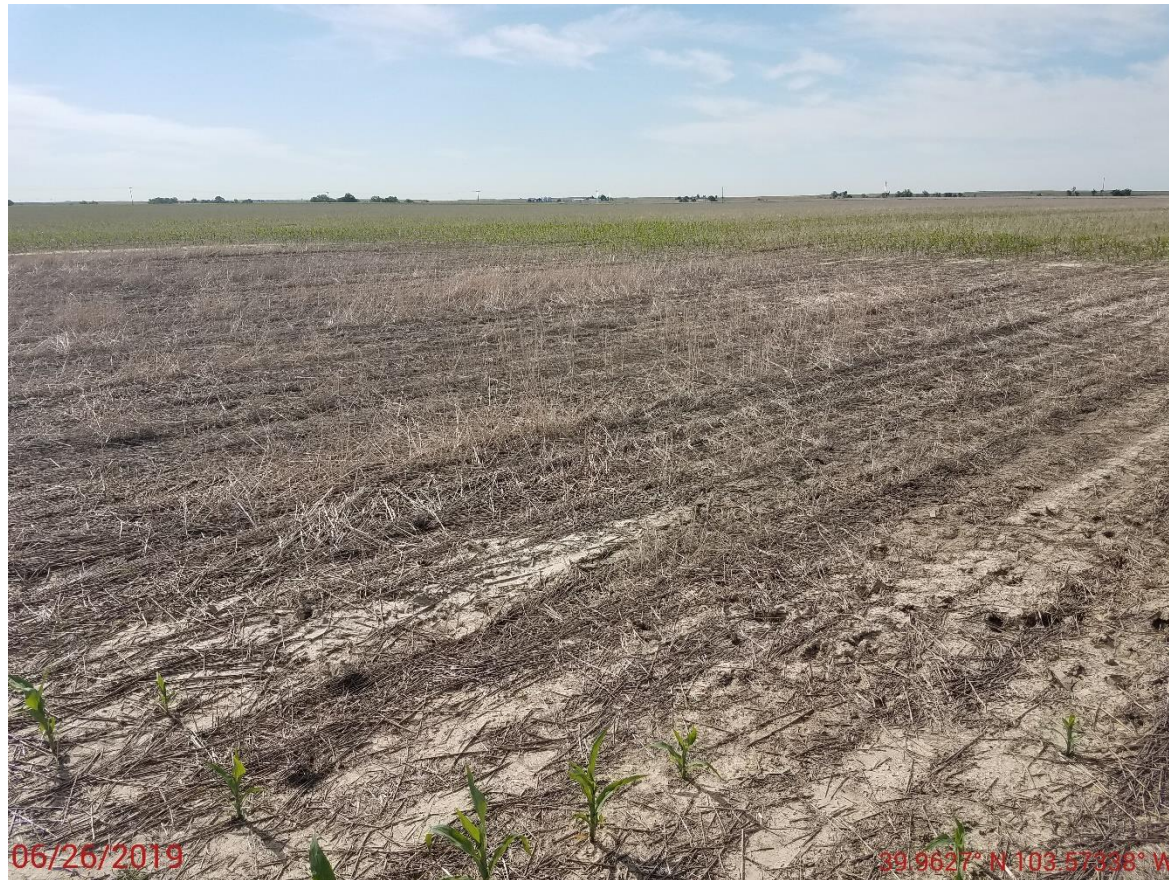
Photo 3: Photo taken from the northwest corner of the pit, facing southeast. Photo shows no agricultural production from the 2019 crop seeding is occurring within the pit.

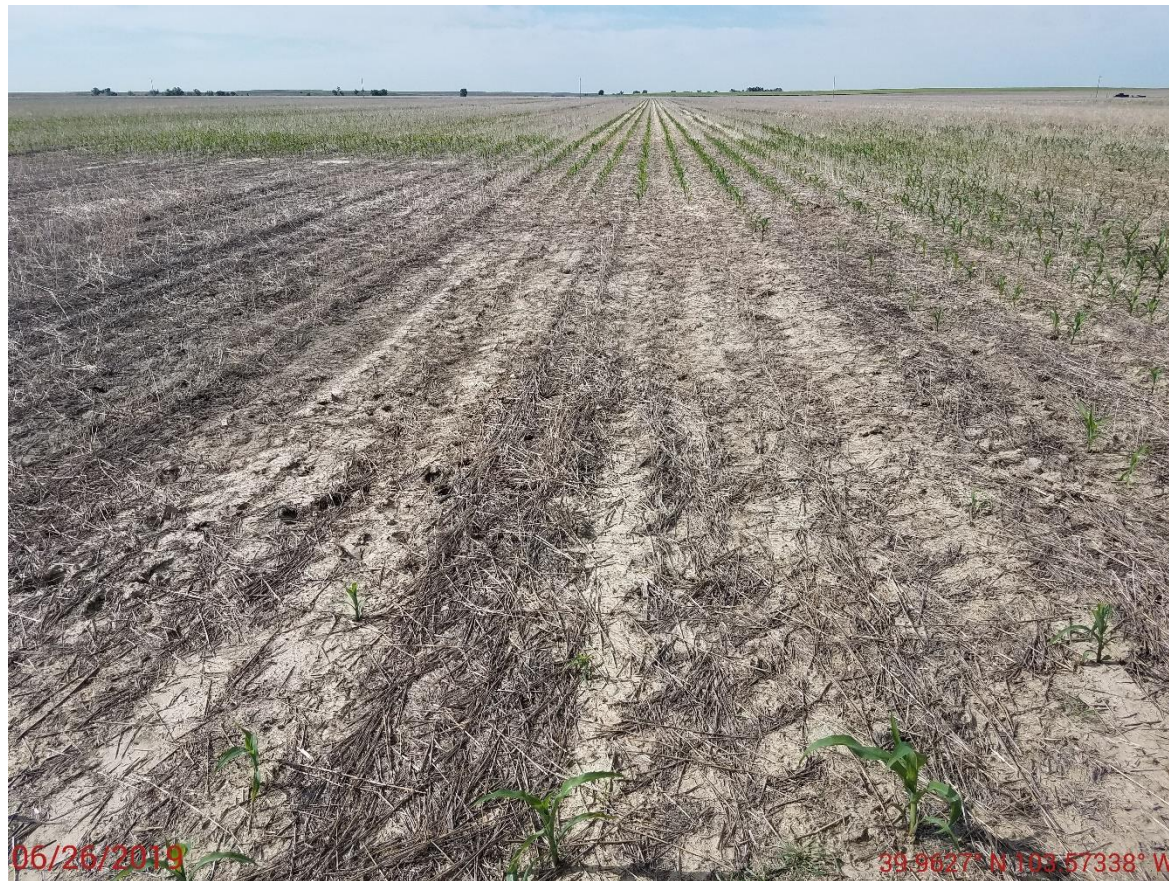
Photo 4: Photo taken from the northwest corner of the pit, facing south. Photo shows no agricultural production from the 2019 crop seeding is occurring within the pit.

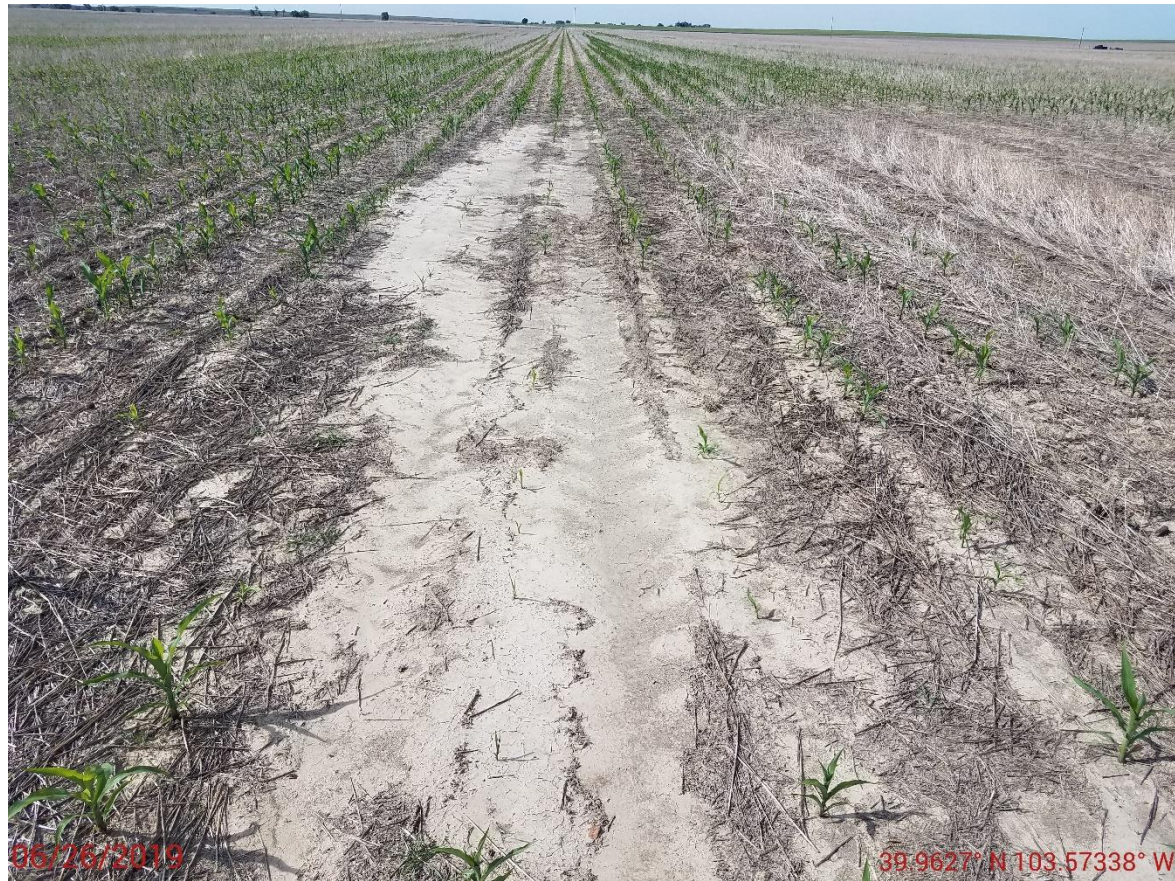
Photo 5: Photo taken from the northeast corner of the pit, facing south. Photo shows no agricultural production from the 2019 crop seeding is occurring within the pit. Additionally, the pit walls remain evident with no growth.

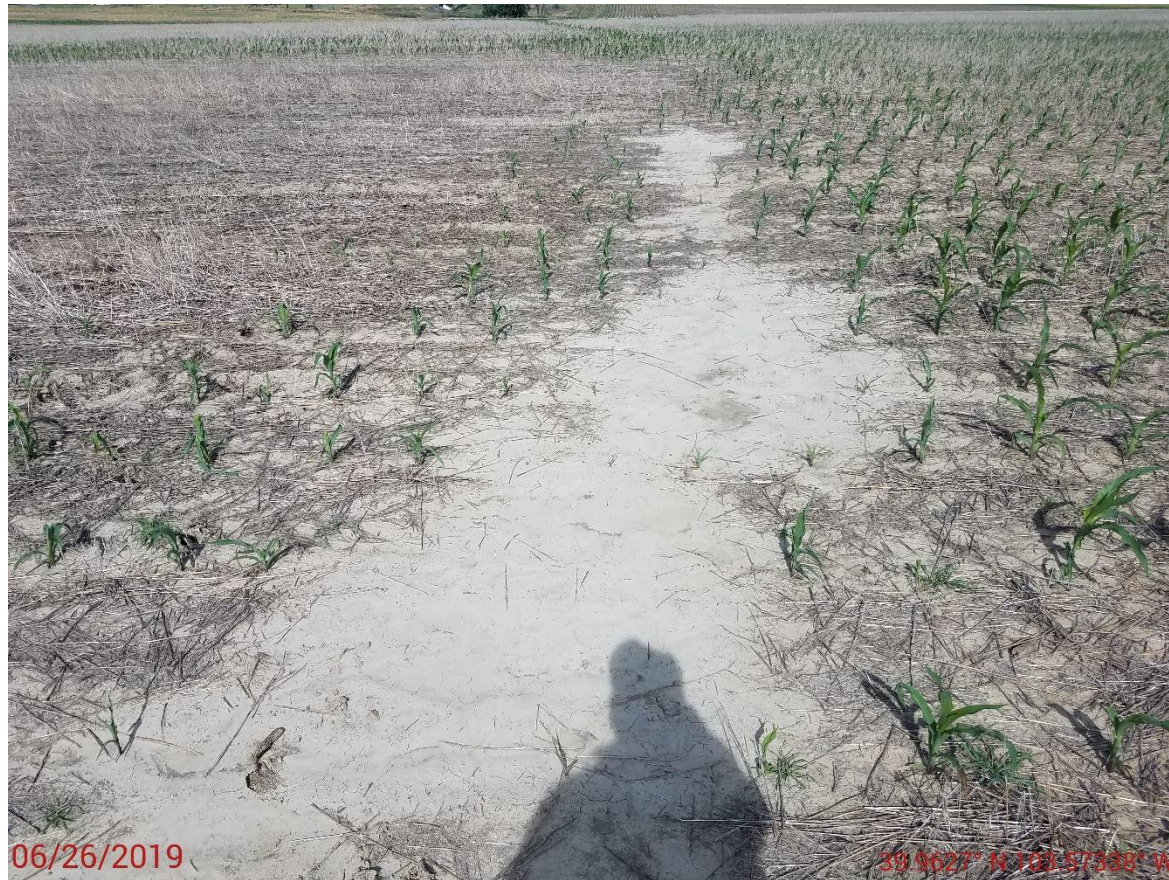
Photo 6: Photo taken from the northeast corner of the pit, facing west. Photo shows no agricultural production from the 2019 crop seeding is occurring within the pit. Additionally, the pit walls remain evident with no growth.

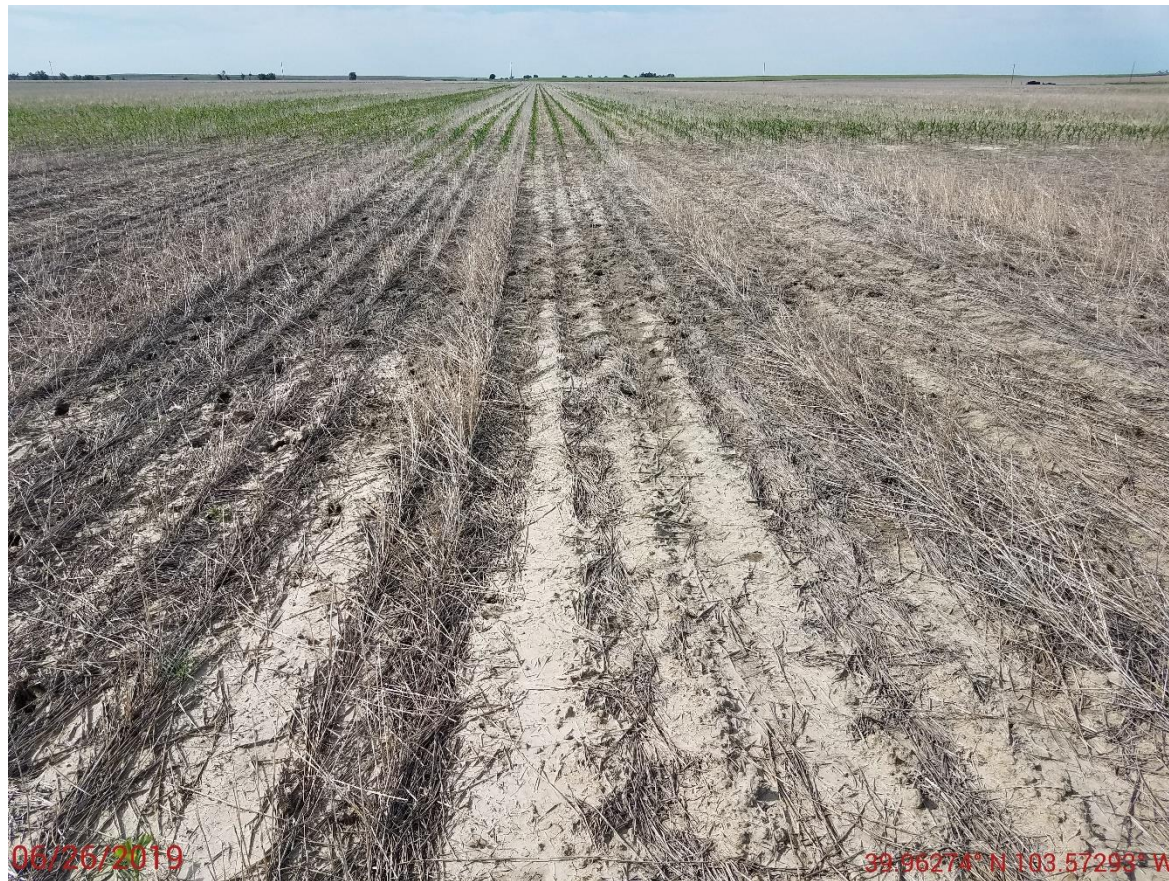
Photo 7: Photo taken from the north end of the of the pit, facing south. Photo shows no agricultural production from the 2019 crop seeding is occurring within the pit.

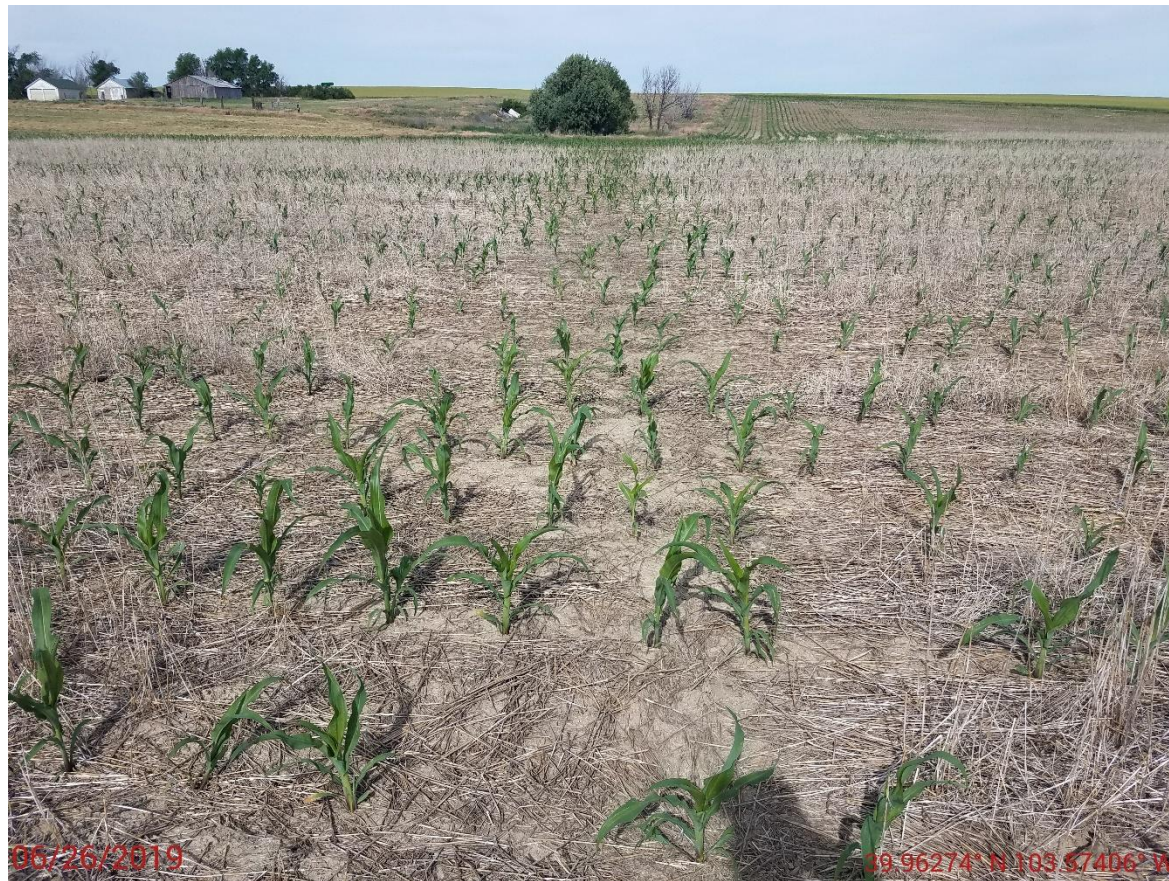
Photo 8: Photo taken from the former access road, facing west. Photo shows crop appears to be sufficiently establishing on access road.

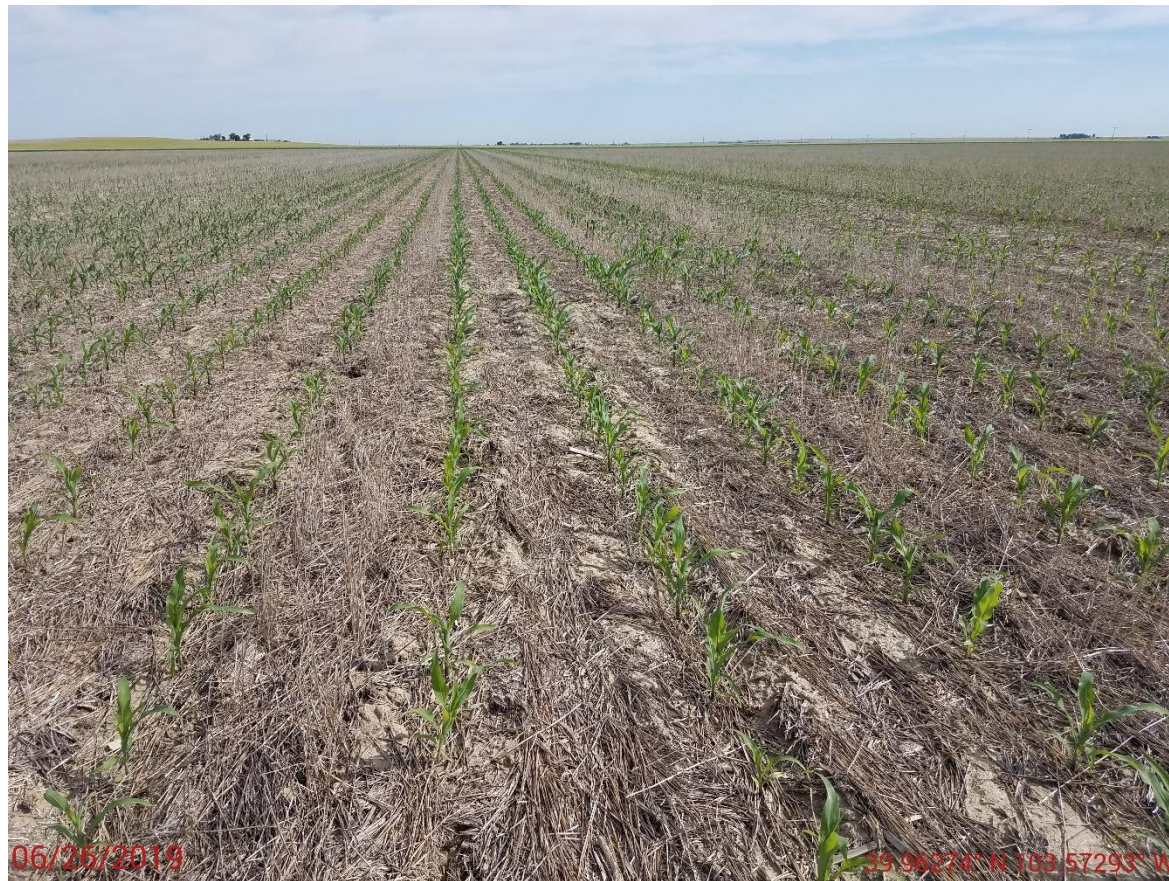
Photo 9: Photo taken from the adjacent reference area. Photo shows crop establishment on reference to compare to the disturbance area.

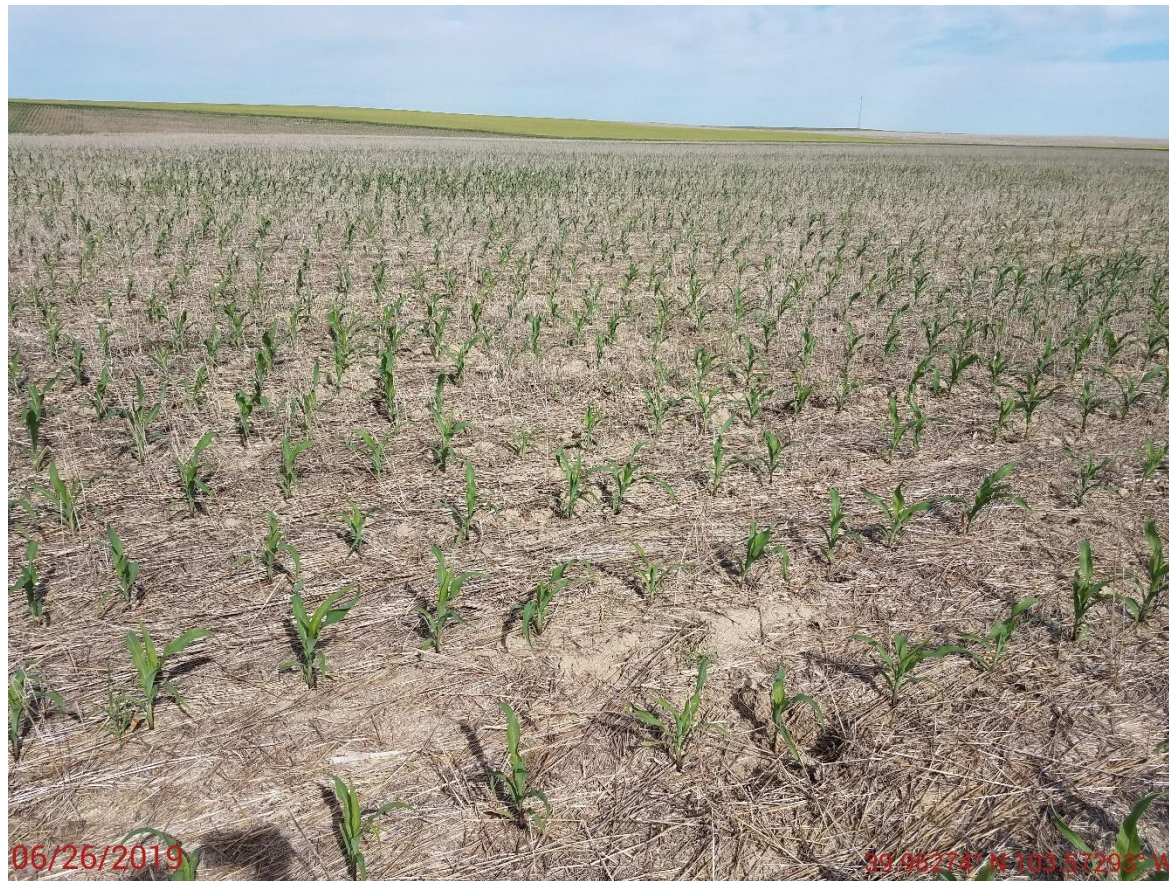
Photo 10: Photo taken from the adjacent reference area. Photo shows crop establishment on reference to compare to the disturbance area.
