Reclamation Inspection

Operator: K P KAUFFMAN COMPANY INC - 46290

Location ID: 455229

Inspection Photos
Location Name: SPILL/RELEASE POINT
Location ID: 455229

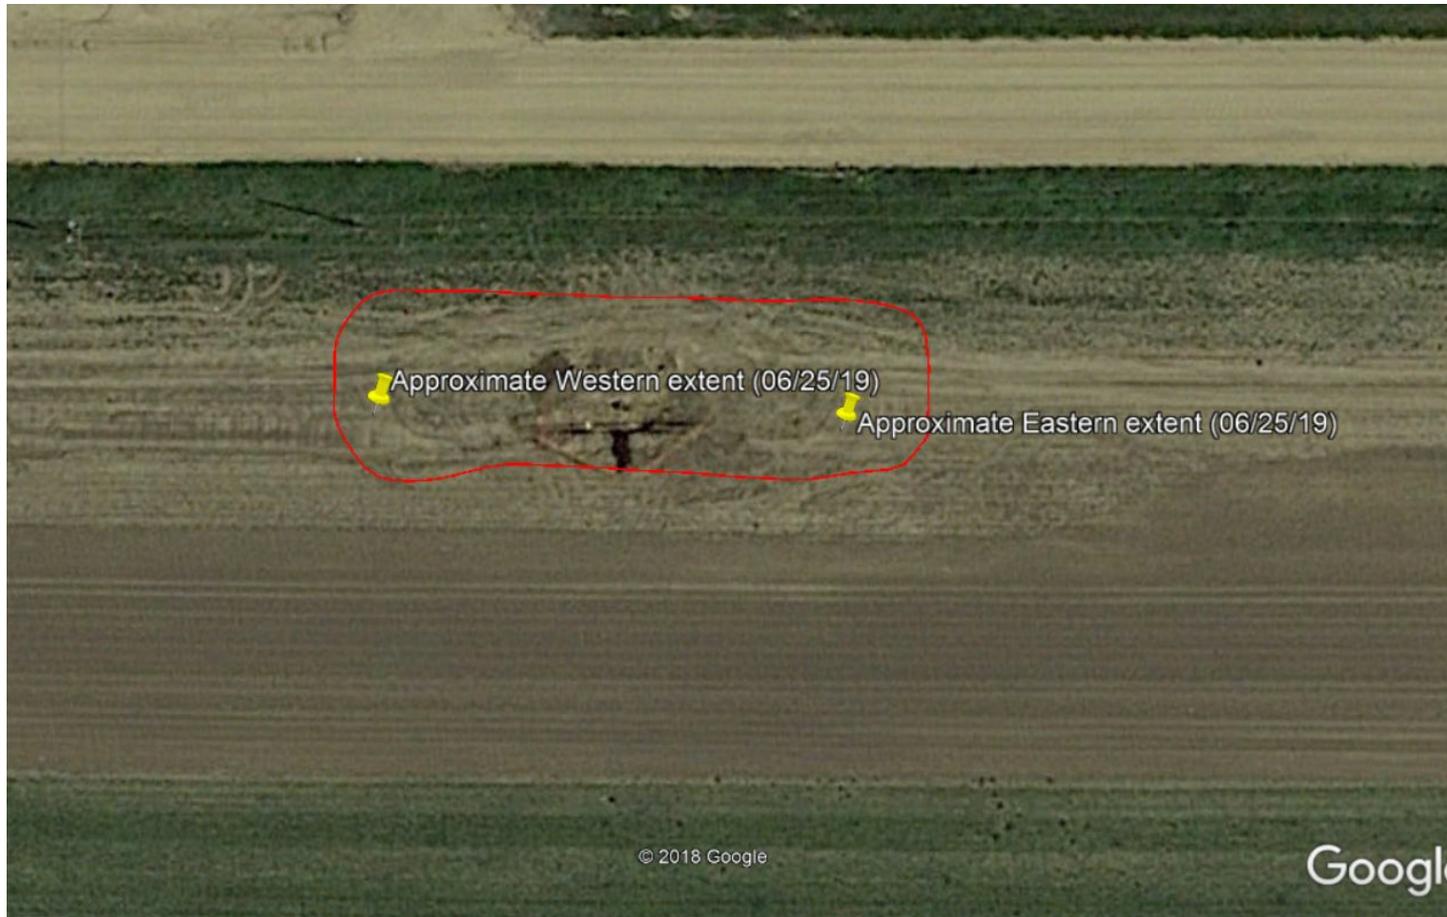
Google Earth aerial imagery from May 31, 2018. Image illustrates disturbance related to a spill/release point. Red line = ~5300 square feet of an excavated area that was mapped back in August 2018. Two photos were taken on June 25, 2019 at the approximate western and eastern extents of the observed stunted crop growth.

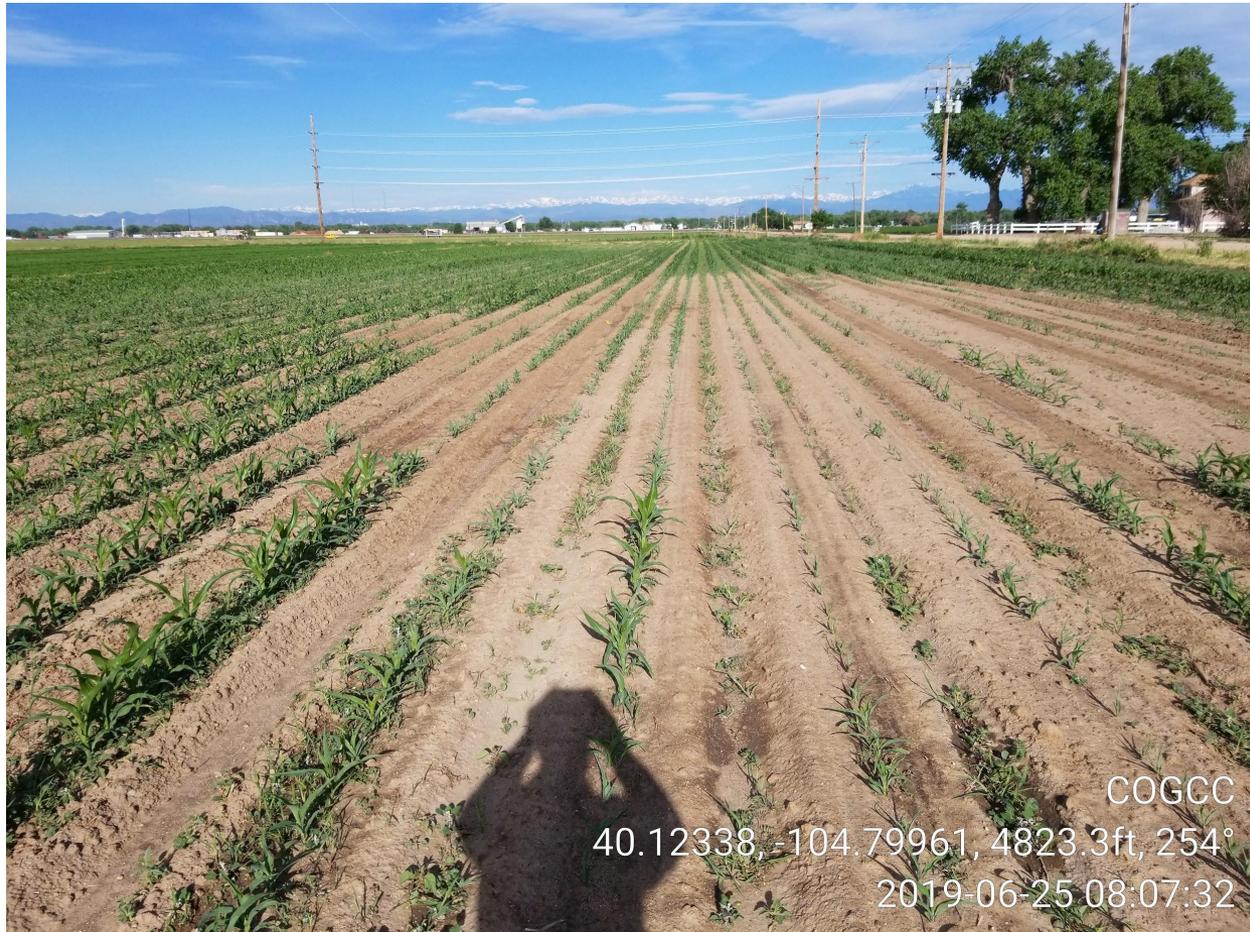
Photo 1. Photo taken from the approximate eastern extent of the stunted crop growth, facing West. This area is within the excavated spill/release area.

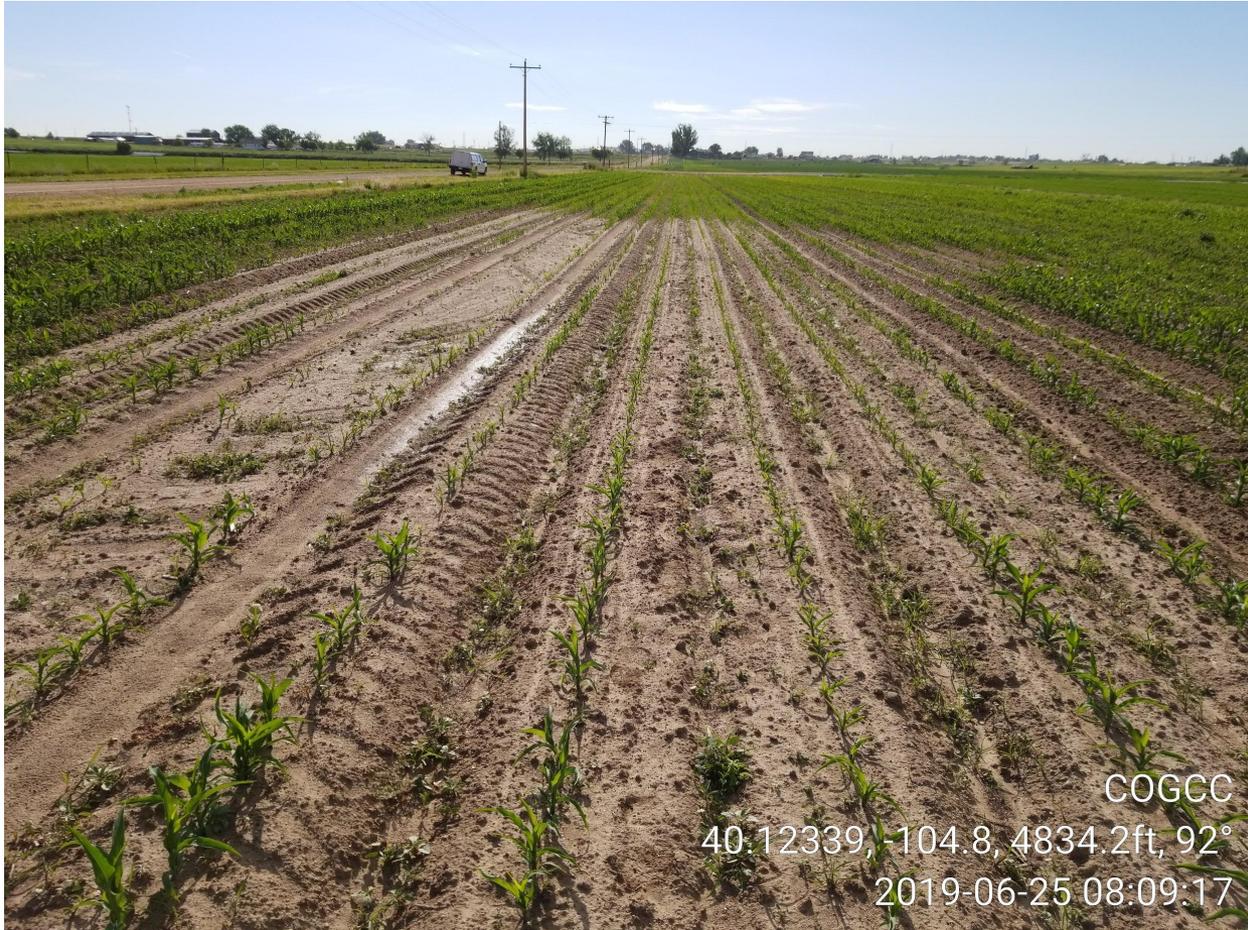
Photo 2. Photo taken from the approximate western extent of the stunted crop growth, facing East. This area is within the excavated spill/release area.
