## Inspection Photos

Location Name: LORENCITO 11-30-34-66 TR

API#: 05-071-08770

INSP. #: 695100986

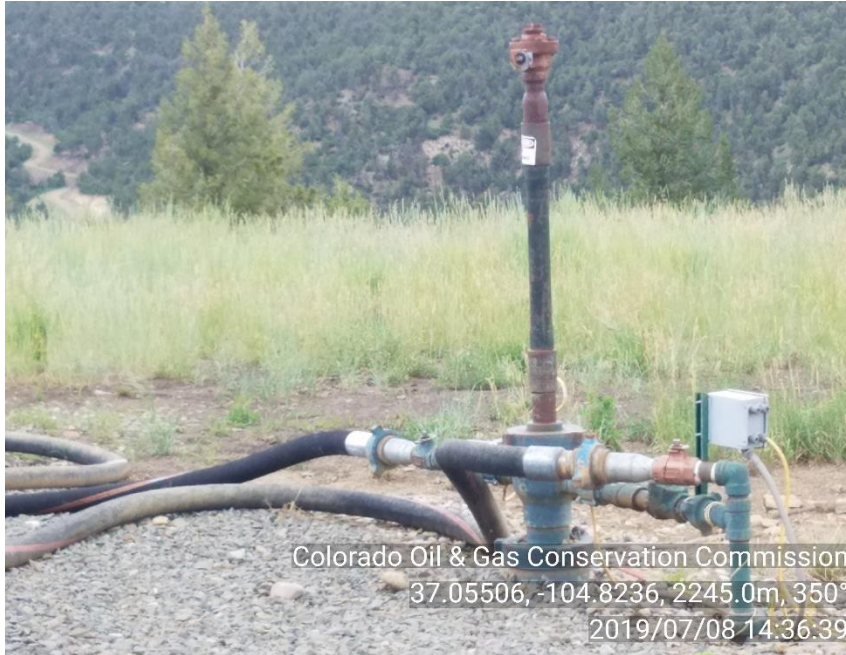
PHOTO 1: WELLHEAD

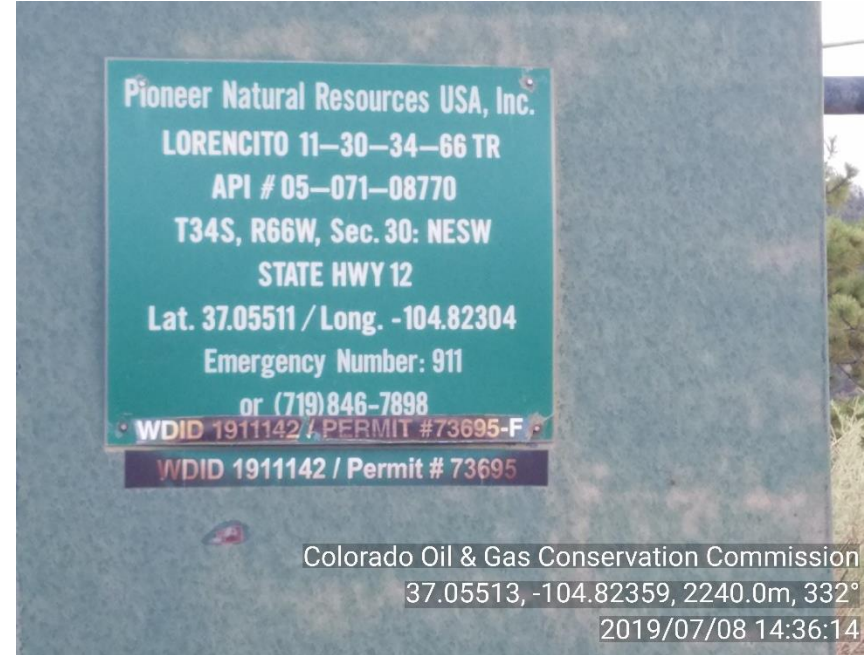
PHOTO 2: WELL SIGN

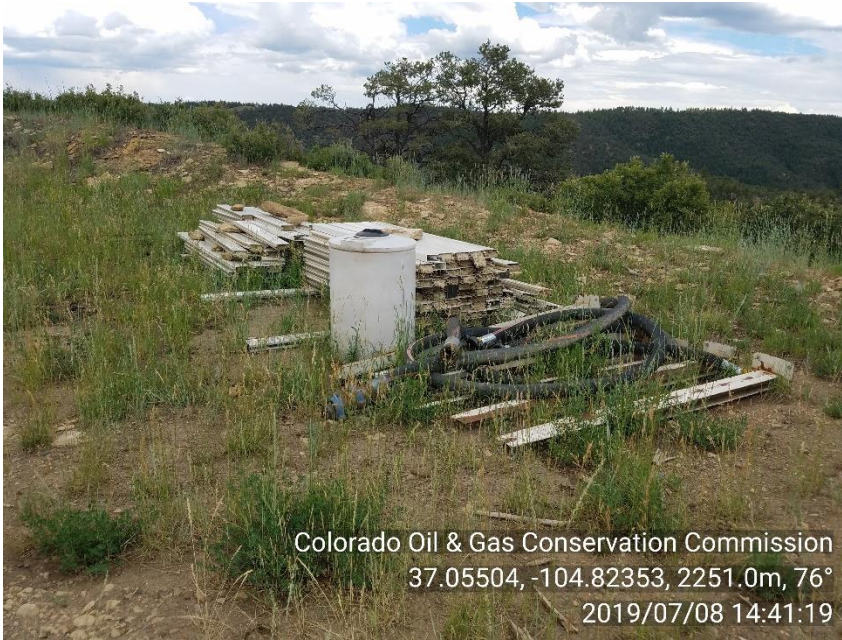
Colorado Oil & Gas Conservation Commission  
37.05504, -104.82353, 2251.0m, 76°  
2019/07/08 14:41:19

**PHOTO 3: UNUSED EQUIPMENT STORED ON SOUTHEAST  
CORNER OF LOCATION. REMOVE UNUSED EQUIPMENT  
COMPLY WITH RULE 603.f. CA DATE 8/8/19**

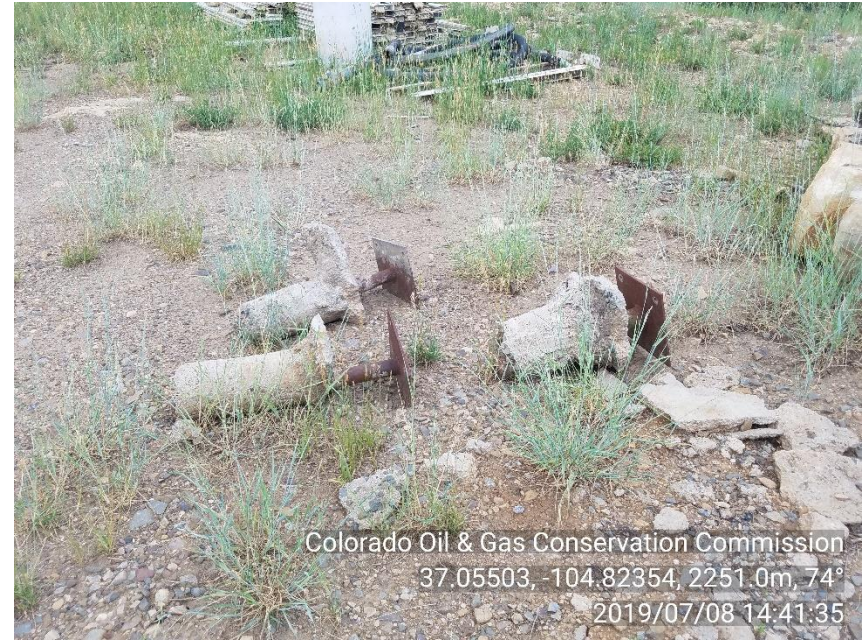
Colorado Oil & Gas Conservation Commission  
37.05503, -104.82354, 2251.0m, 74°  
2019/07/08 14:41:35

**PHOTO 4: UNUSED EQUIPMENT STORED ON SOUTHEAST  
CORNER OF LOCATION. REMOVE UNUSED EQUIPMENT  
COMPLY WITH RULE 603.f. CA DATE 8/8/19**
