Inspection Photos

07/10/2019

Operator: PCR OPERATING LLC - 10657

Location ID: 313705

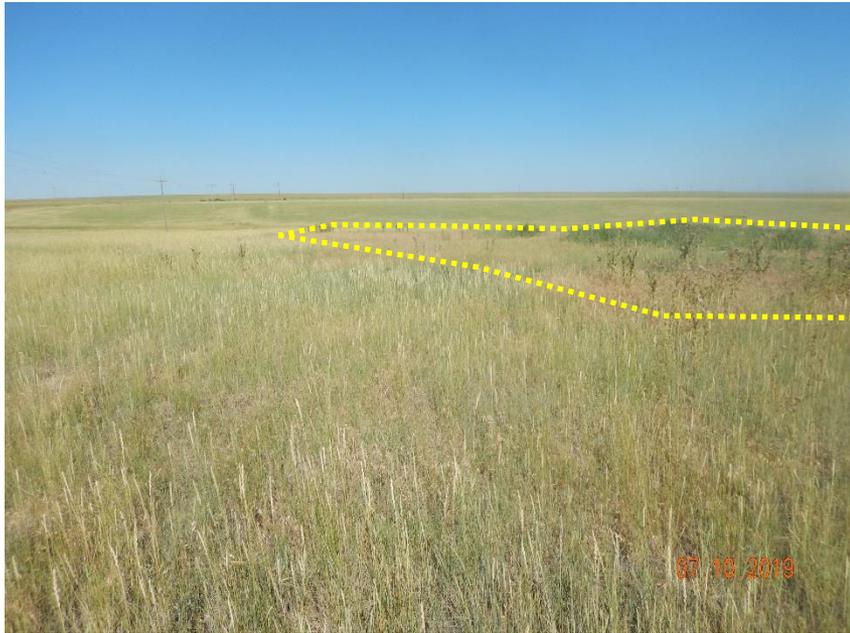
Photo 1: Photo taken from the south end of the location/disturbance area, facing northwest. Photo provides an overview of the location

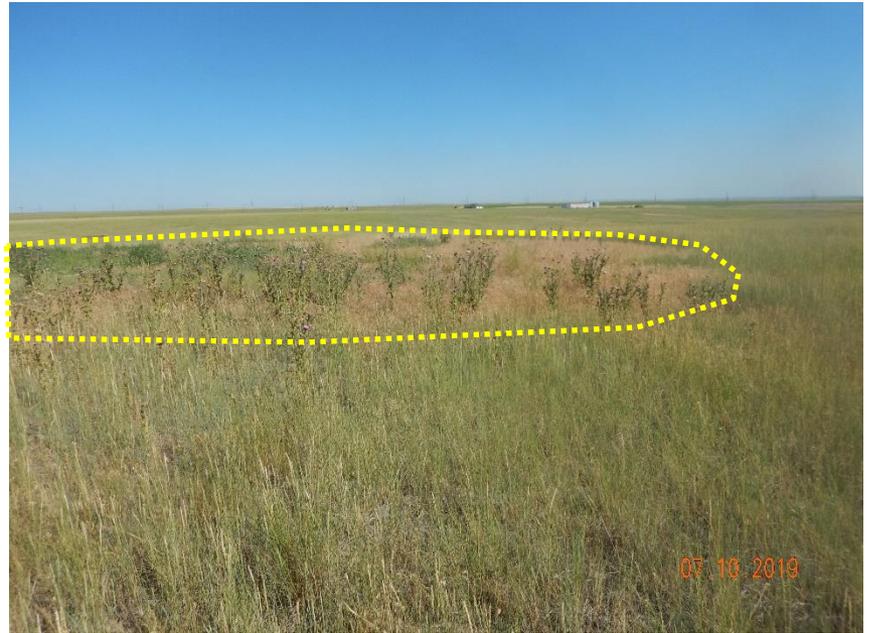
Photo 2: Photo taken from the south end of the location/disturbance area, facing north. Photo provides an overview of the location

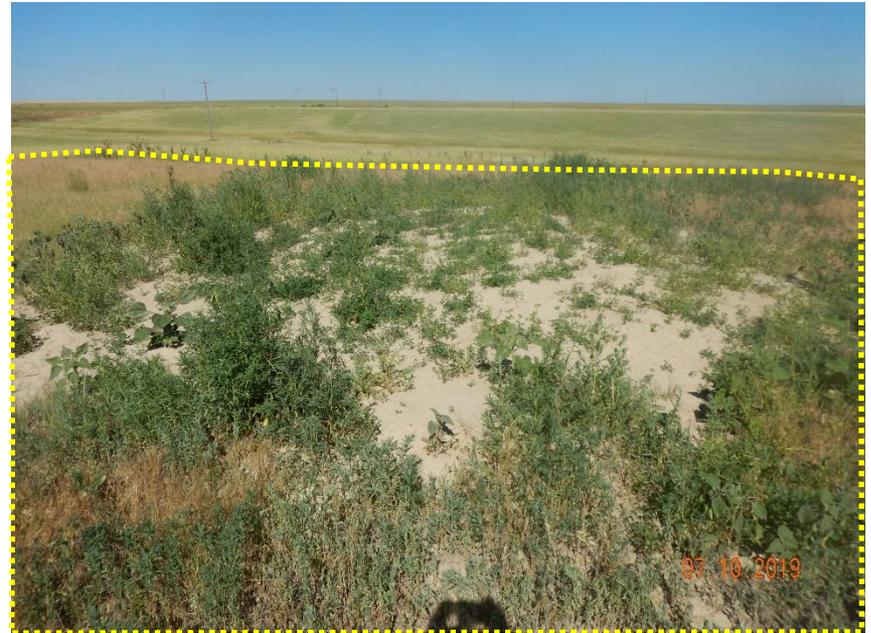
Photo 4: Photo shows well area where concrete pump base was location. Photo shows area remains bare soil or predominantly undesirable weedy plant species. Unable to find evidence that seeding/revegetation activities have been conducted and stabilization controls implemented to stabilize the seeded soil per 1000 series rules and corrective action over the location/disturbance area.

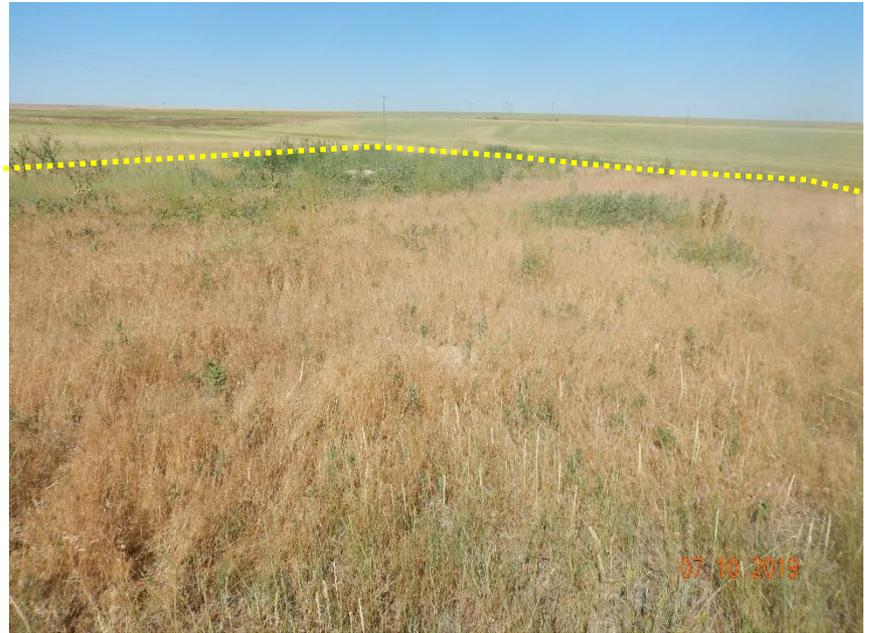
Photo 5: Photo taken from the east end of the location/disturbance area, facing southwest. Photos 5-7 provide an overview of the location/disturbance area from southwest, west, northwest to west. Photos show location/disturbance area remains predominantly undesirable weedy plants species such as Cheatgrass, Musk Thistle, Canada thistle, and Kochia. Unable to find evidence that seeding/revegetation activities have been conducted and stabilization controls implemented to stabilize the seeded soil per 1000 series rules and corrective action over the location/disturbance area.

Photo 6: See comments under photo 5.

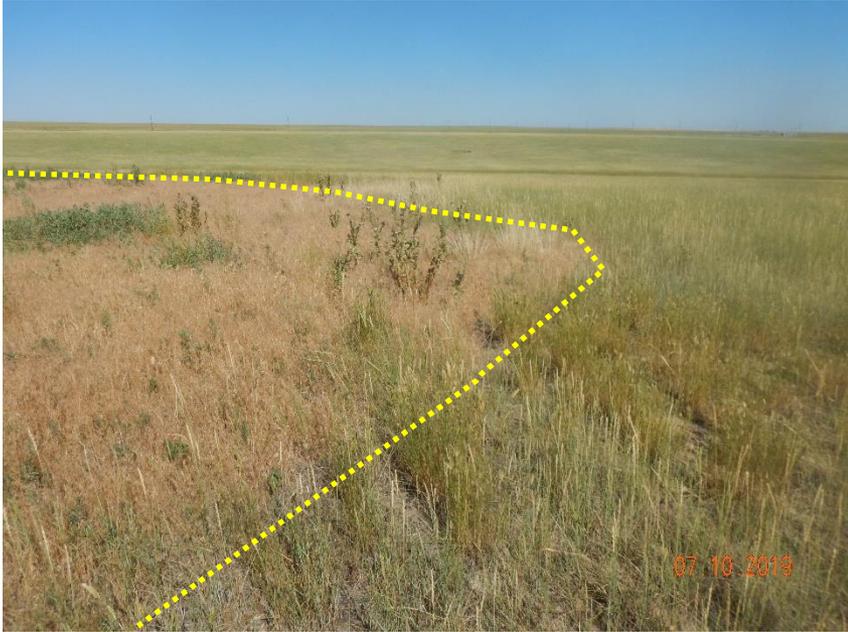
Photo 7: See comments under photo 5.

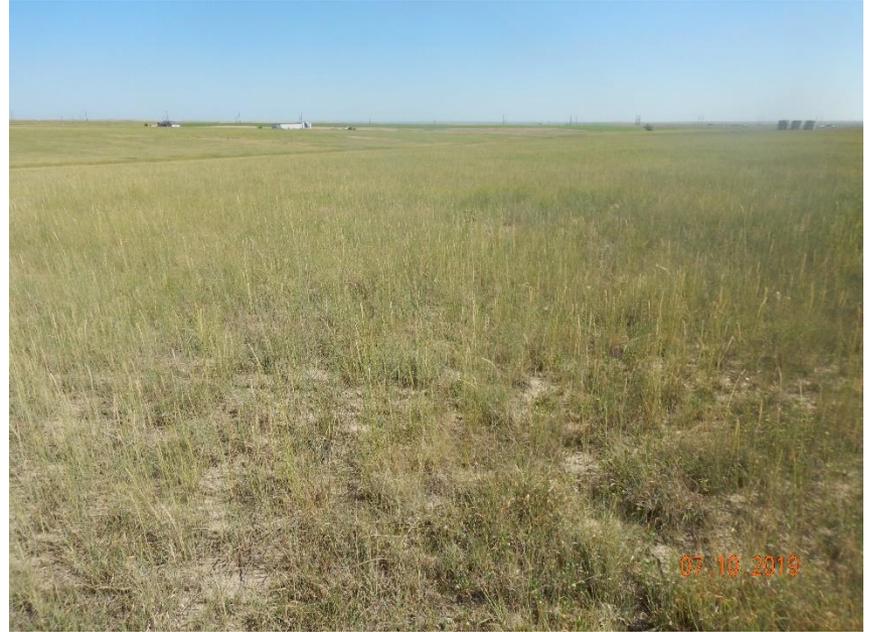
Photo 8: Photo taken from the adjacent reference area. Photo shows vegetation over the reference. Species observed predominantly Crested Wheatgrass.

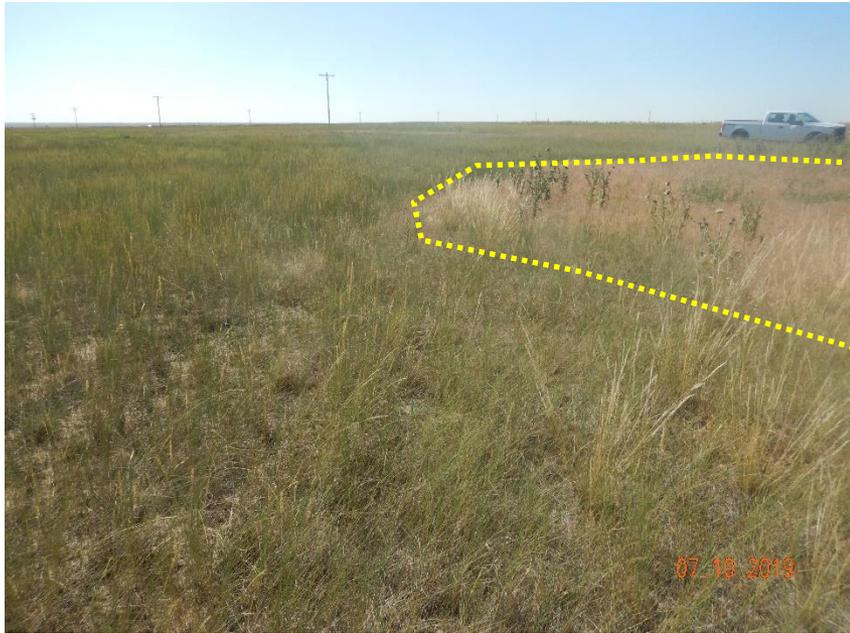
Photo 9: Photo taken from the northeast end of the location/disturbance area, facing southeast. Photos 9-12 provide an overview of the location/disturbance area from southeast, south, southwest, to west. Photos show location/disturbance area remains predominantly undesirable weedy plants species such as Cheatgrass, Musk Thistle, Canada thistle, and Kochia. Unable to find evidence that seeding/revegetation activities have been conducted and stabilization controls implemented to stabilize the seeded soil per 1000 series rules and corrective action over the location/disturbance area.

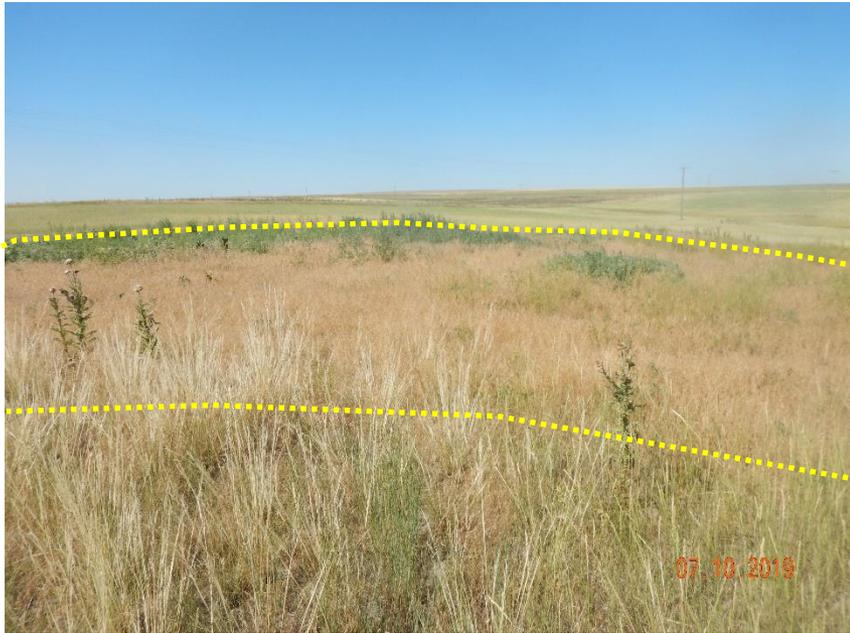
Photo 11: See comments under photo 9.

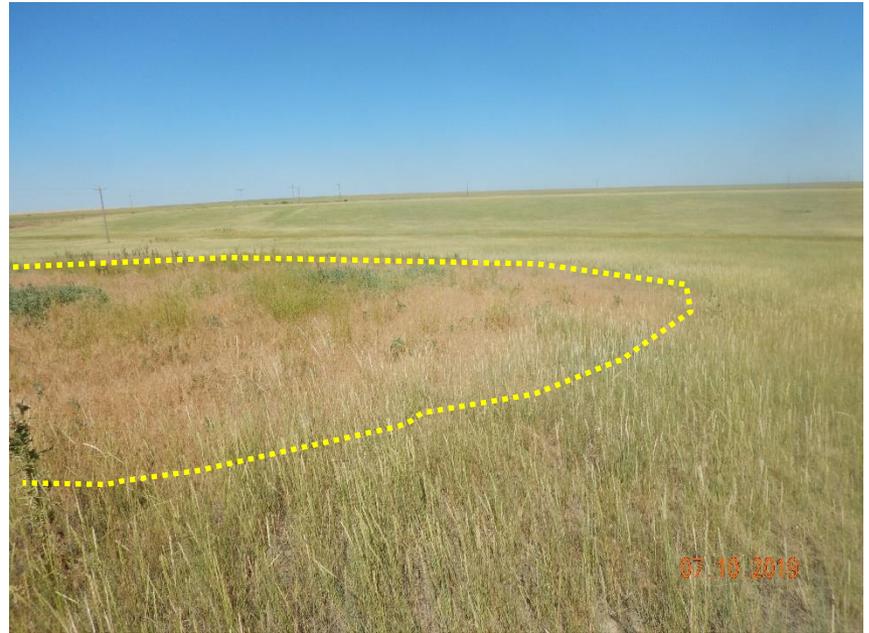
Photo 12: See comments under photo 9.

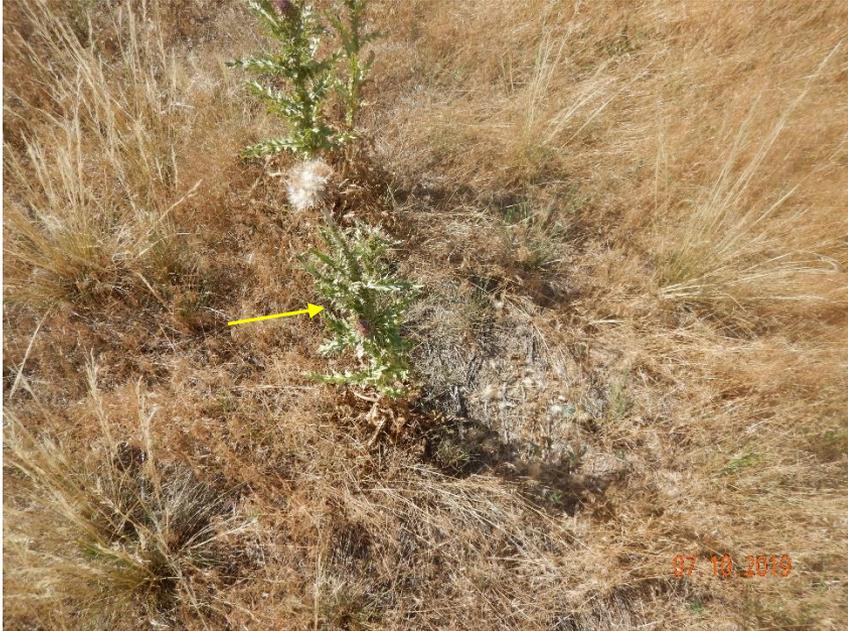
Photo 13: Photo taken from the location. Photo shows Scotch thistle that has matured and dispersed seeds.

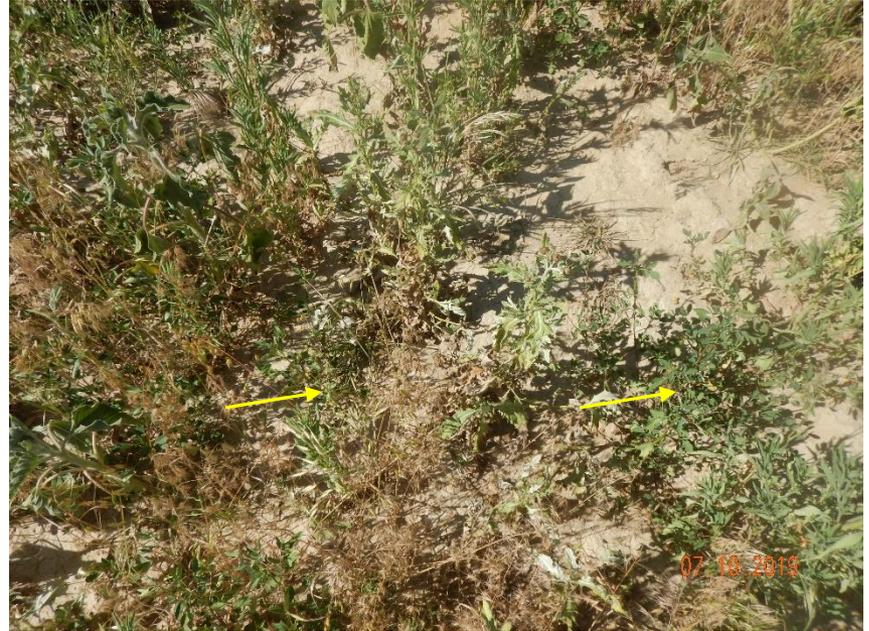
Photo 14: Photo of Canada thistle on location.
