Inspection Photos

07/10/2019

Operator: PCR OPERATING LLC - 10657

Location ID: 313755

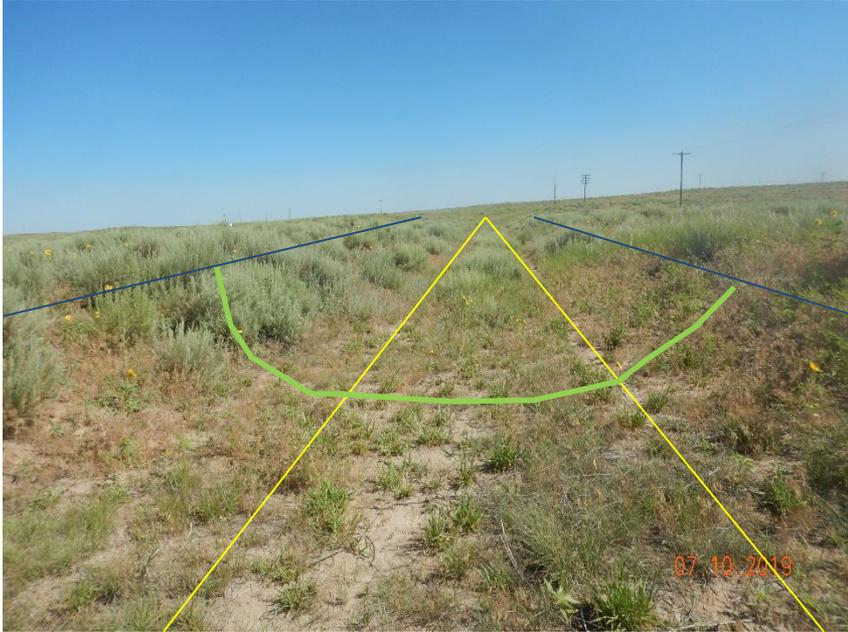
Photo 1: Photo taken from the south of the location, facing north. Photo shows access road (yellow) has not been recontoured/regraded to that of the adjacent lands (blue), or reclaimed.

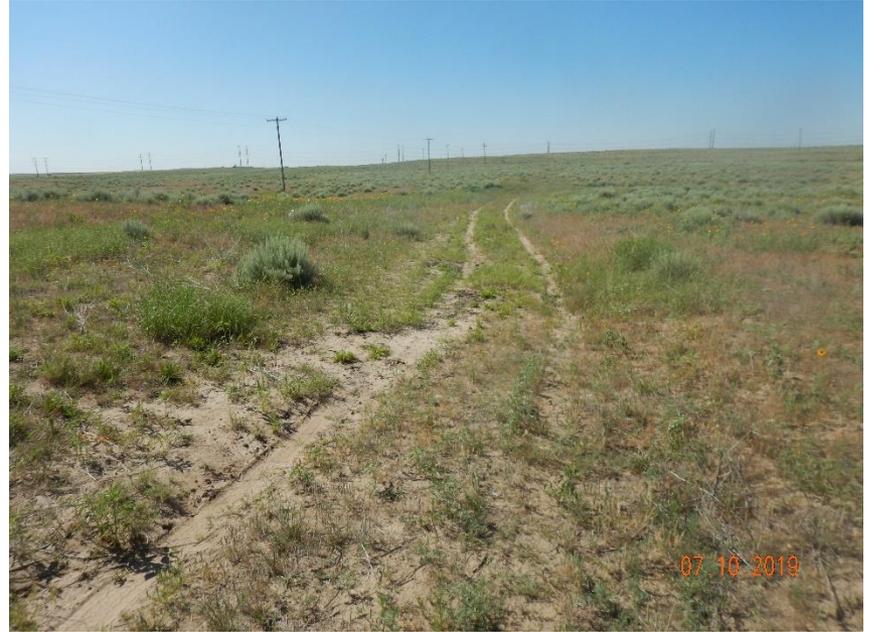
Photo 2: Photo taken from the location, facing south. Photo shows access road remains has not been reclaimed.

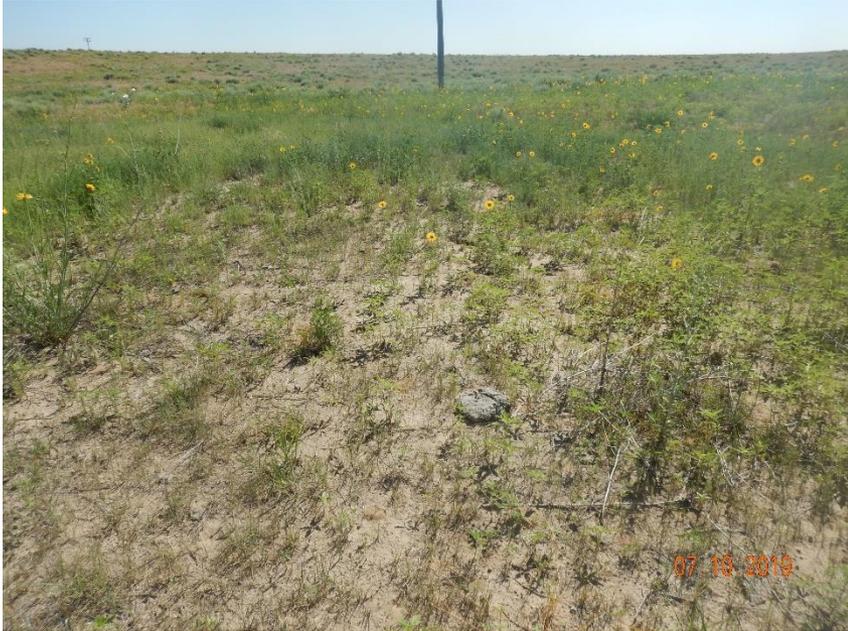
Photo 3: Photo taken from the well location, facing east. Photo shows well location remains predominantly bare and exposed soil, or composed of undesirable weedy plant species. Unable to find evidence that reclamation work has been conducted per corrective actions.

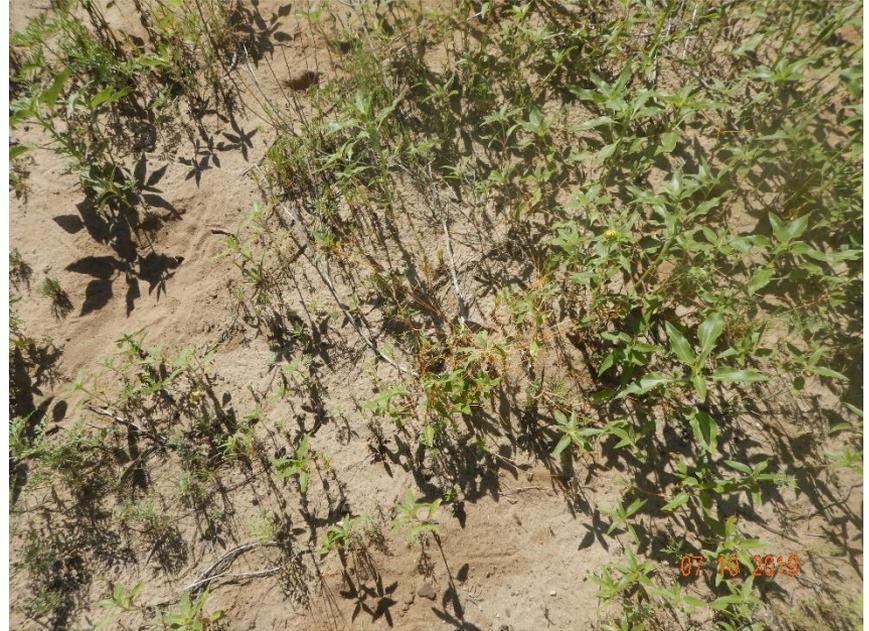
Photo 4: Photo taken from the well location. Photo shows location remains predominantly bare and exposed soil, or undesirable weedy plant species.

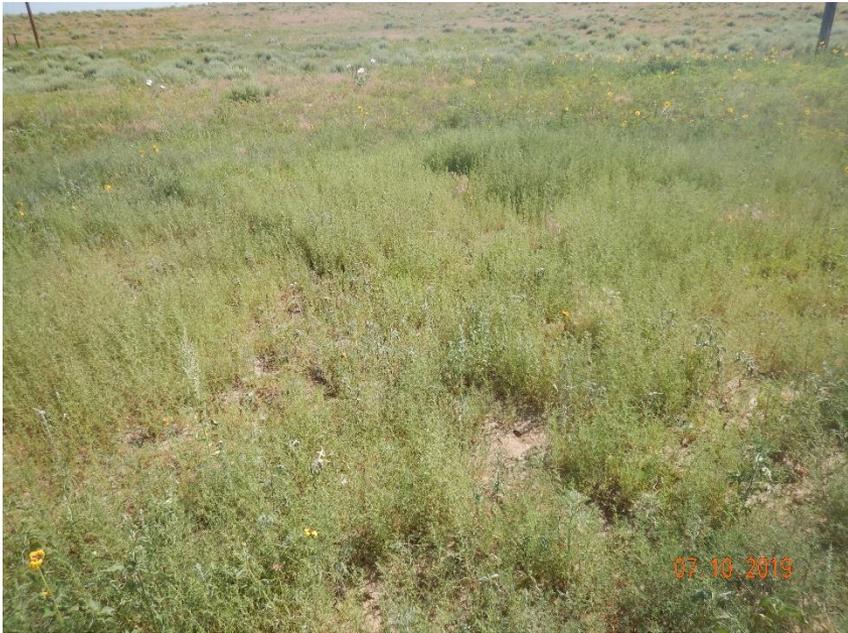
Photo 5: Photo taken from the well location. Photo shows location remains predominantly bare and exposed soil, or undesirable weedy plant species. Plants observed in photo predominantly Kochia/Russian thistle.

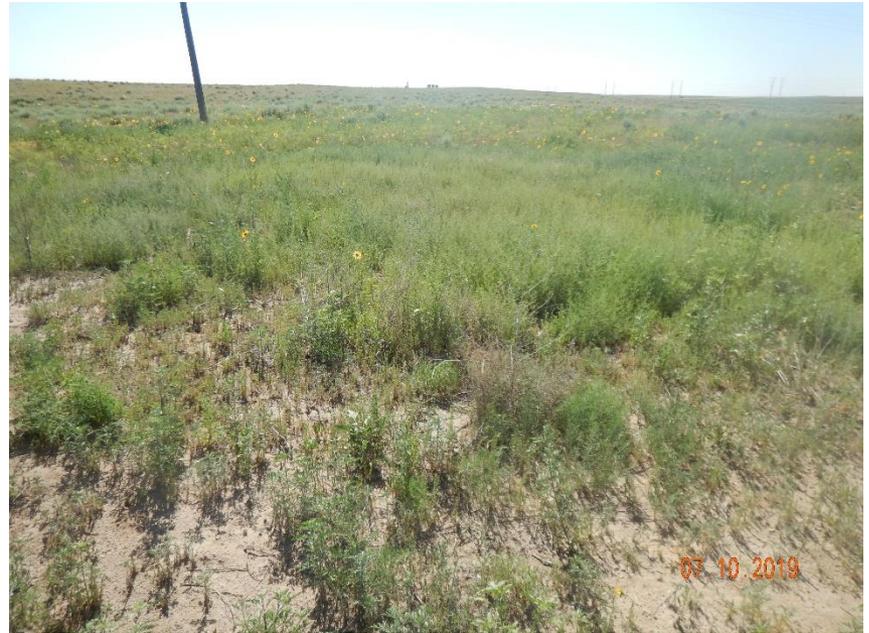
Photo 6: Photo taken from the well location. Photo shows location remains predominantly bare and exposed soil, or undesirable weedy plant species. Plants observed in photo predominantly Kochia/Russian thistle.

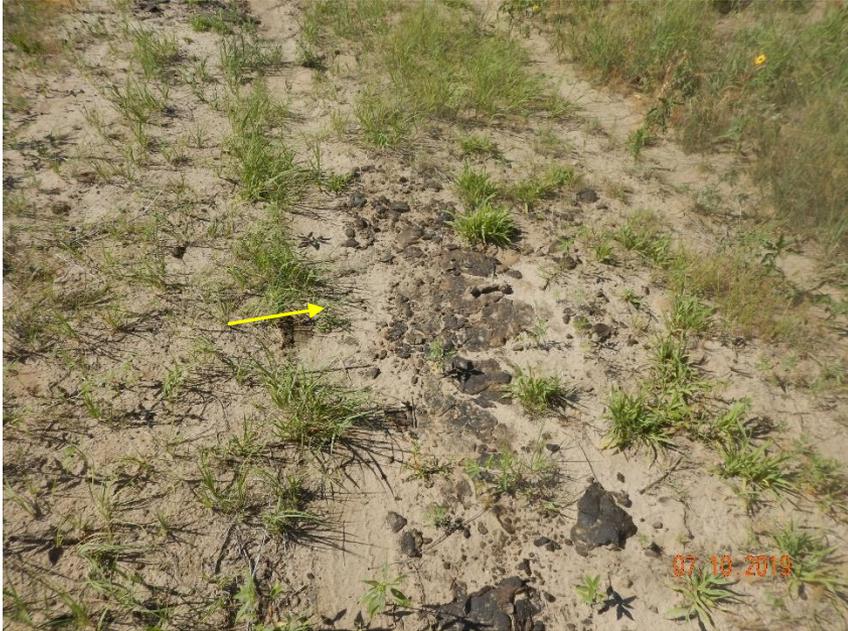
Photo 7: Photo taken from the access road. Photo shows stained soils.

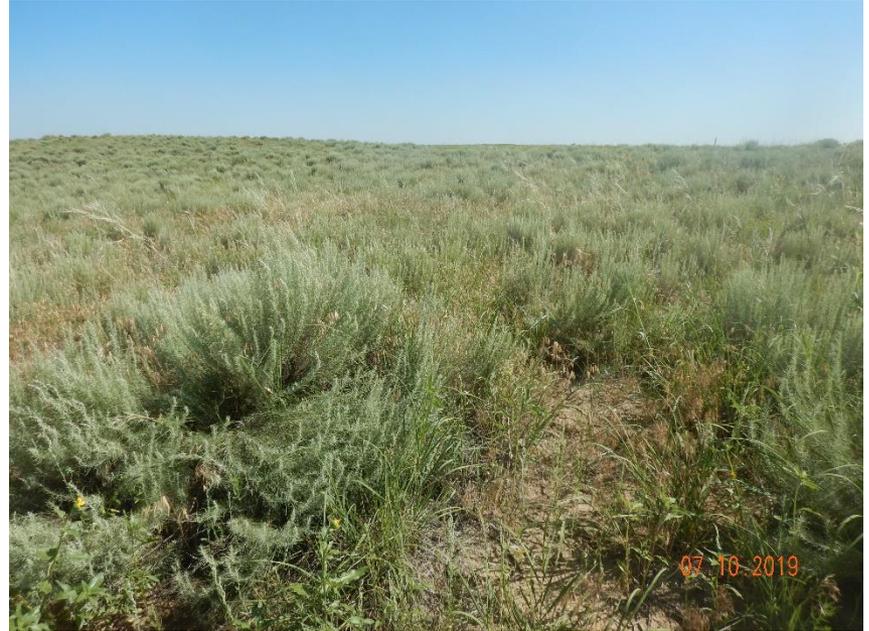
Photo 8: Photo taken from the adjacent reference area. Photo shows vegetation on reference to compare to vegetation on disturbance area.
