Interim Reclamation and Stormwater Inspection

July 10, 2019

Operator: GREAT WESTERN OPERATING COMPANY LLC- #10110

Inspection Photos
Location Name: Rio LC Pad
Location ID: 465146

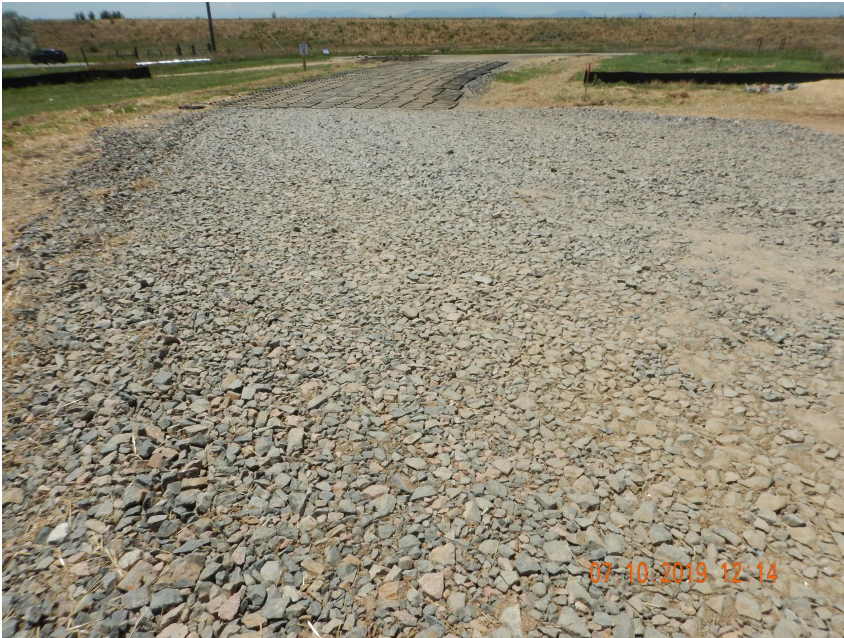
Photo 1. Photo taken from the entrance of location, facing West. Photo illustrates one of two vehicle tracking device BMPs.

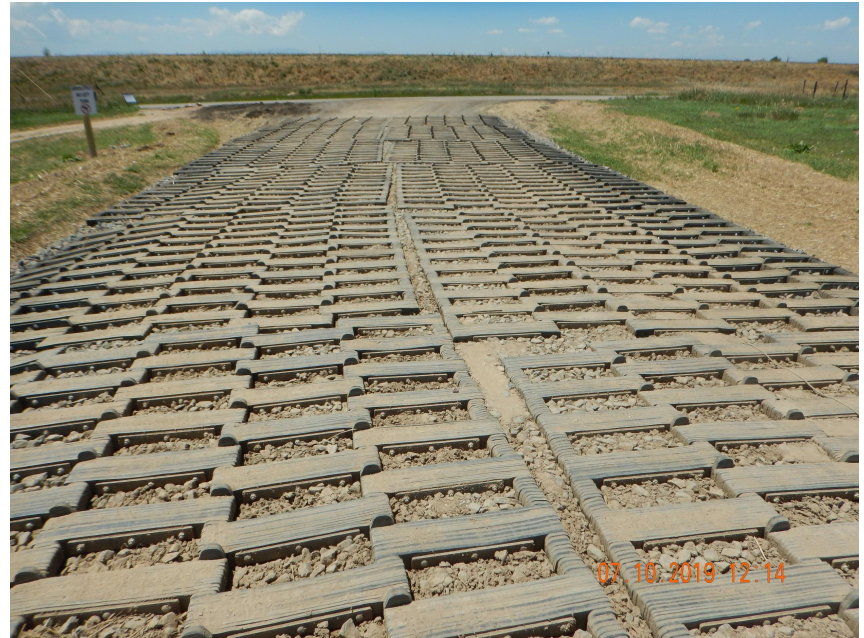
Photo 2. Photo taken from the entrance of location, facing West. Photo illustrates the second vehicle tracking device BMP.

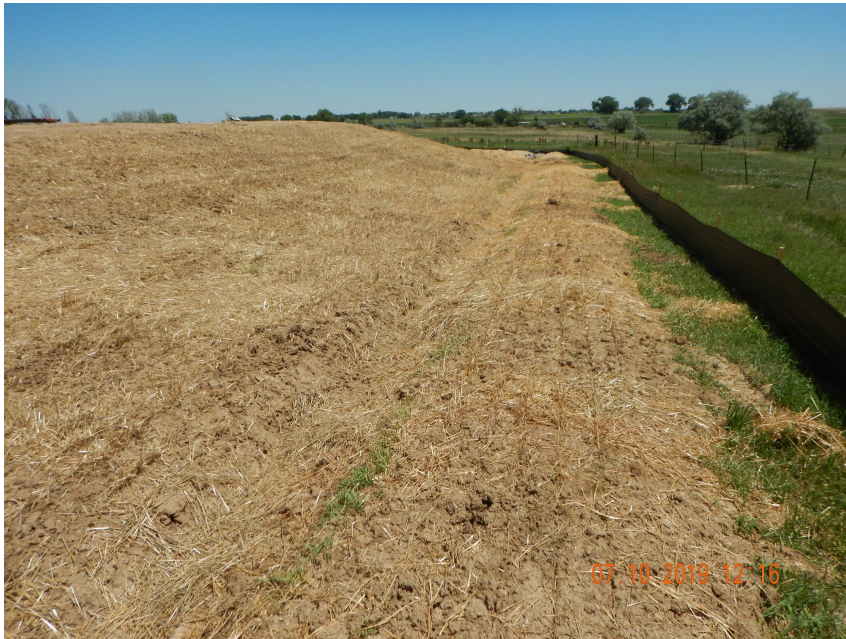
Photo 3. Photo taken from the southern location, facing East. Photo illustrates a ditch and berm BMP has been installed in conjunction with silt fence. Disturbance areas have been seeded and straw crimped with mulch.

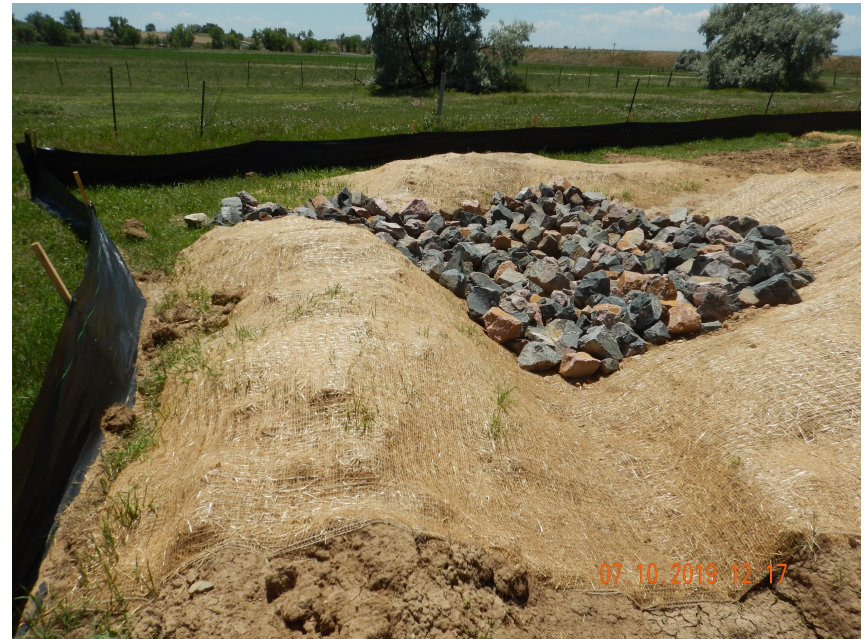
Photo 4. Photo taken from the southeastern location, facing South. Photo illustrates a sediment trap with a stabilized outlet. Embankment berms of sediment trap and adjacent areas have been temporarily stabilized with erosion control blankets.

Note: Operator should consider future maintenance logistics on the sediment trap if the catch basin is filled with riprap.

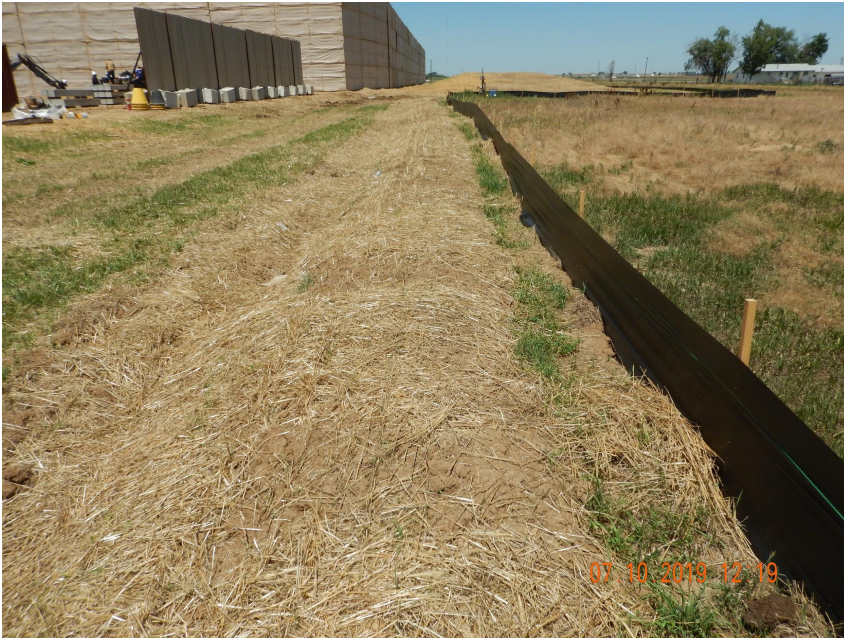
Photo 5. Photo taken from the eastern location, facing North. See comments under Photo 3.

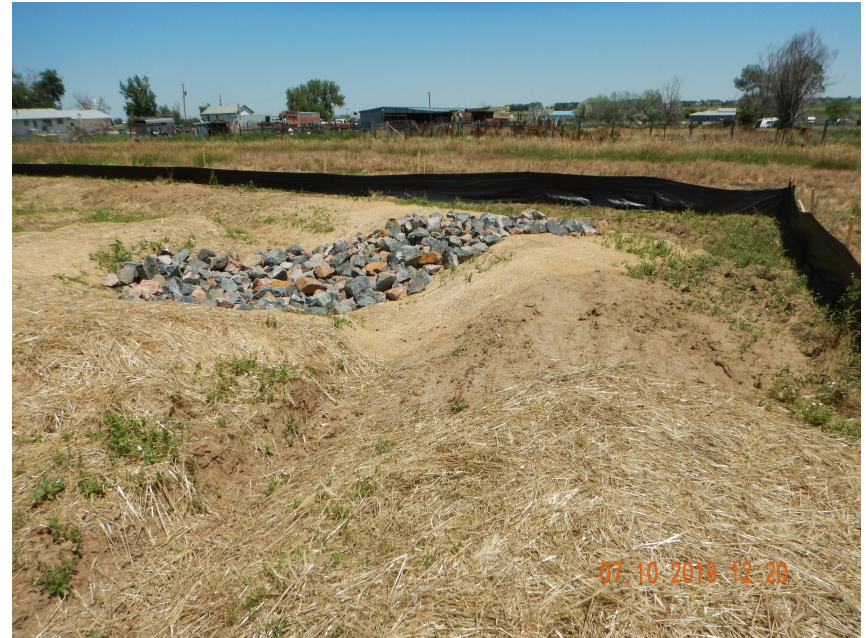
Photo 6. Photo taken from the eastern location, facing East. See comments under Photo 4.

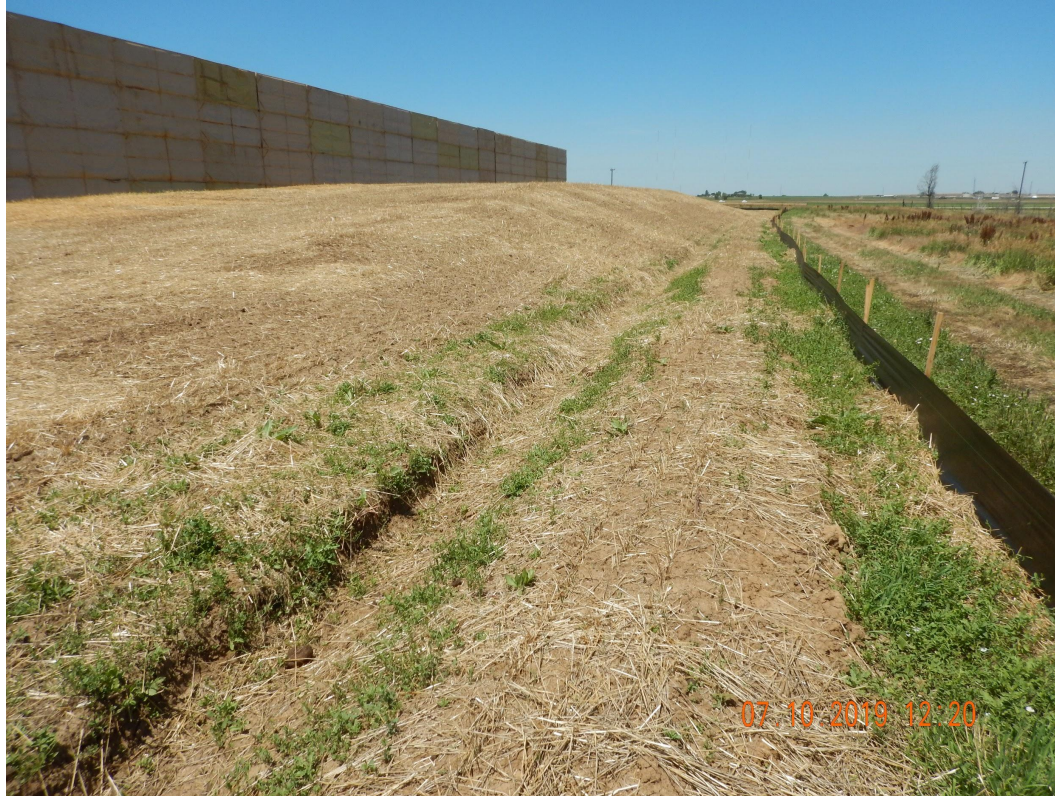
Photo 7. Photo taken from the eastern location, facing North. See comments under Photo 3. Photo also illustrates the topsoil stockpile which has been stabilized with equipment tracking, seeded, and straw crimped with mulch.

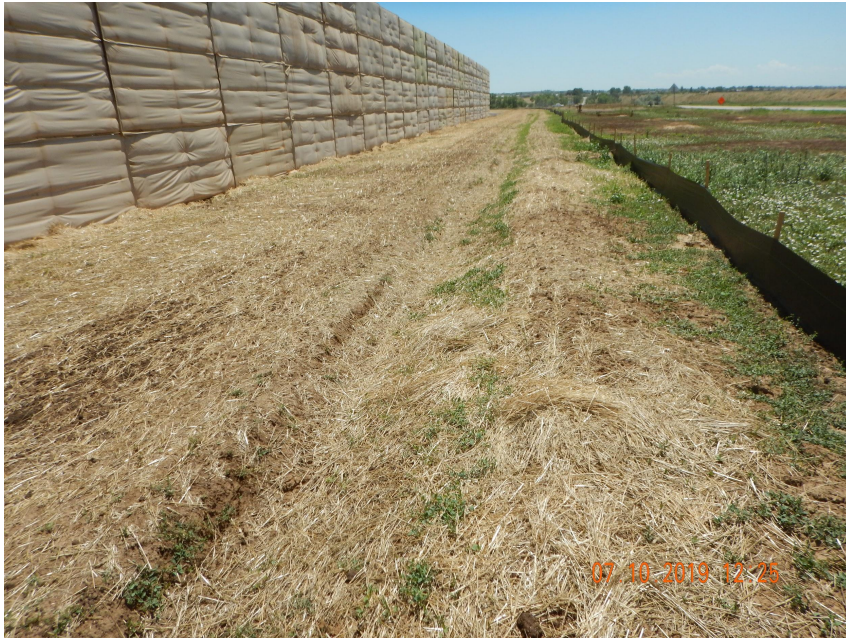
Photo 8. Photo taken from the northwestern location, facing South. See comments under Photo 3.

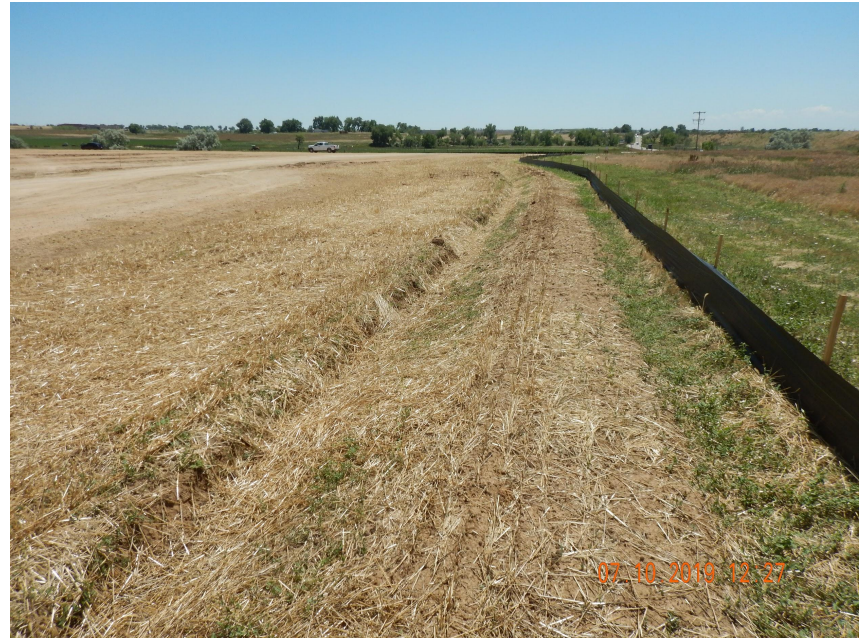
Photo 9. Photo taken from the western location, facing South. See comments under Photo 3.

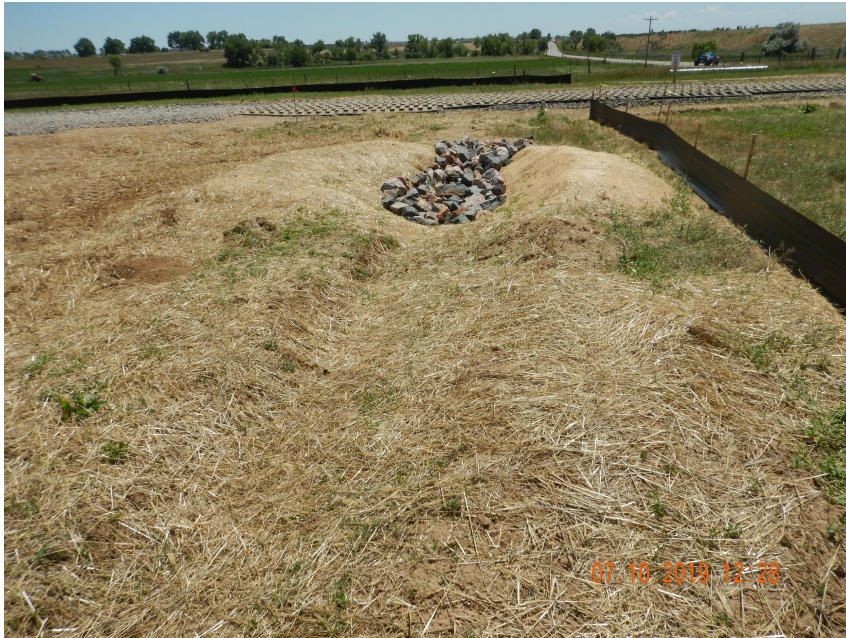
Photo 10. Photo taken from the southwestern location, facing South. See comments under Photo 4.

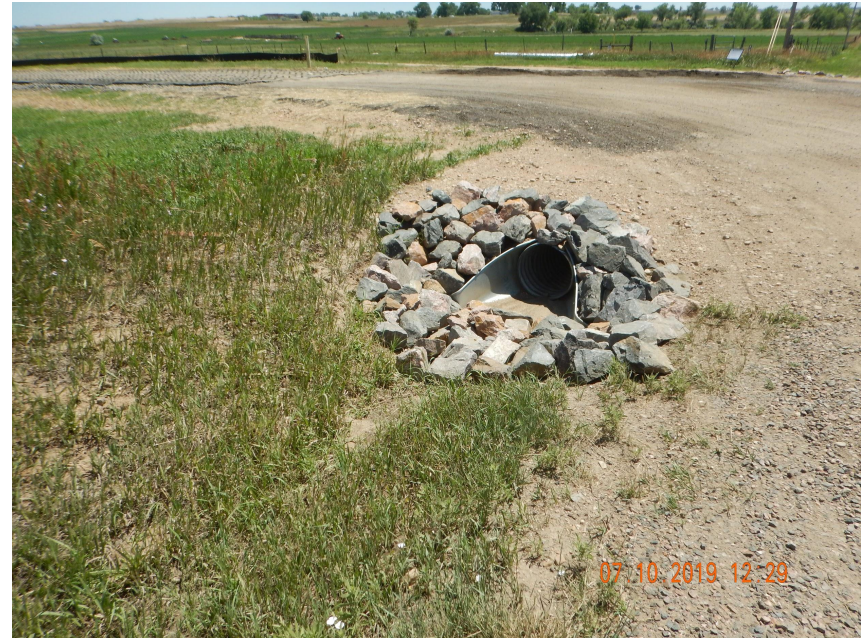
Photo 11. Photo taken from the entrance of location, facing South. Photo illustrates the culvert has been stabilized along inlet.
