Interim Reclamation and Stormwater Inspection

Operator: PDC ENERGY INC - #69175

Location ID: 319511

Inspection Photos
Location Name: Zeiler /SW-7 Pad
Location ID: 319511

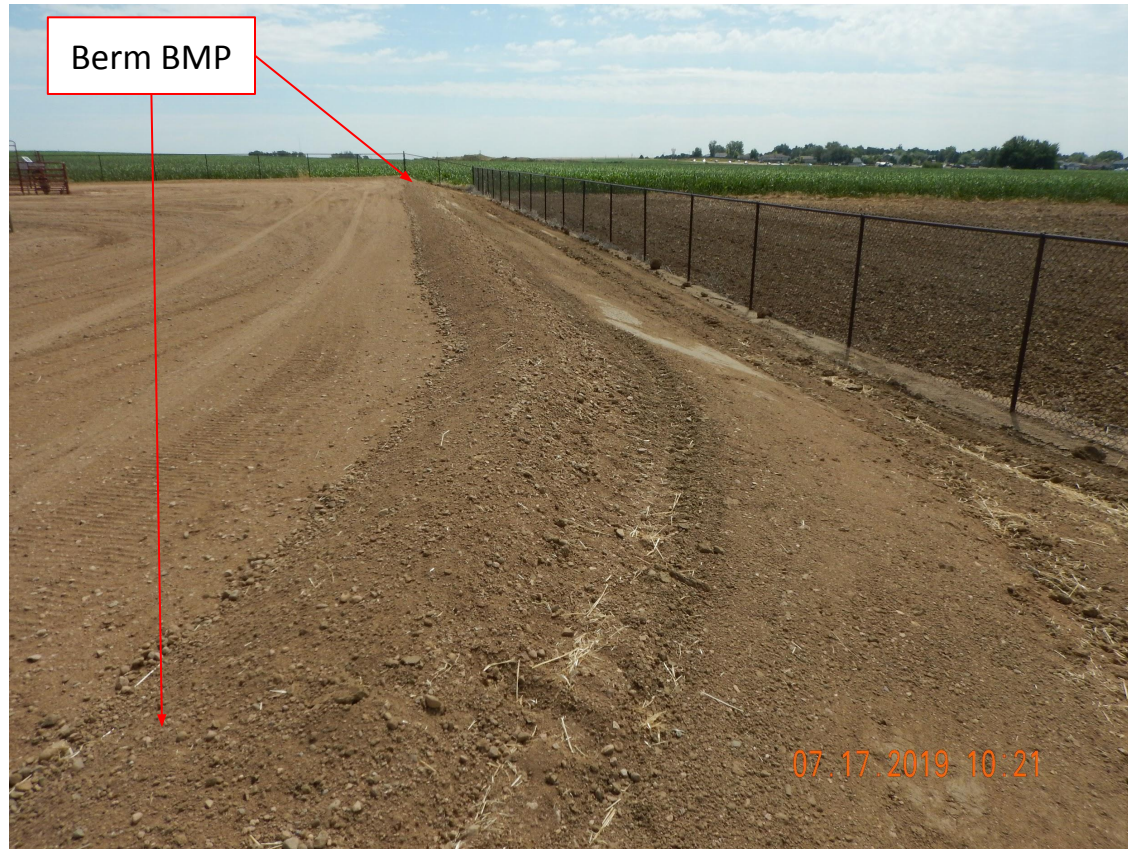
Photo 1. Photo taken from the southwestern location, facing East. Photo illustrates a berm BMP that has been installed along the southern and southwestern perimeter of the well pad. Berm BMP appears to be intended to help direct stormwater to an inlet area along the western well pad perimeter- see Photo 2. Berm BMP has not been compacted or otherwise stabilized.

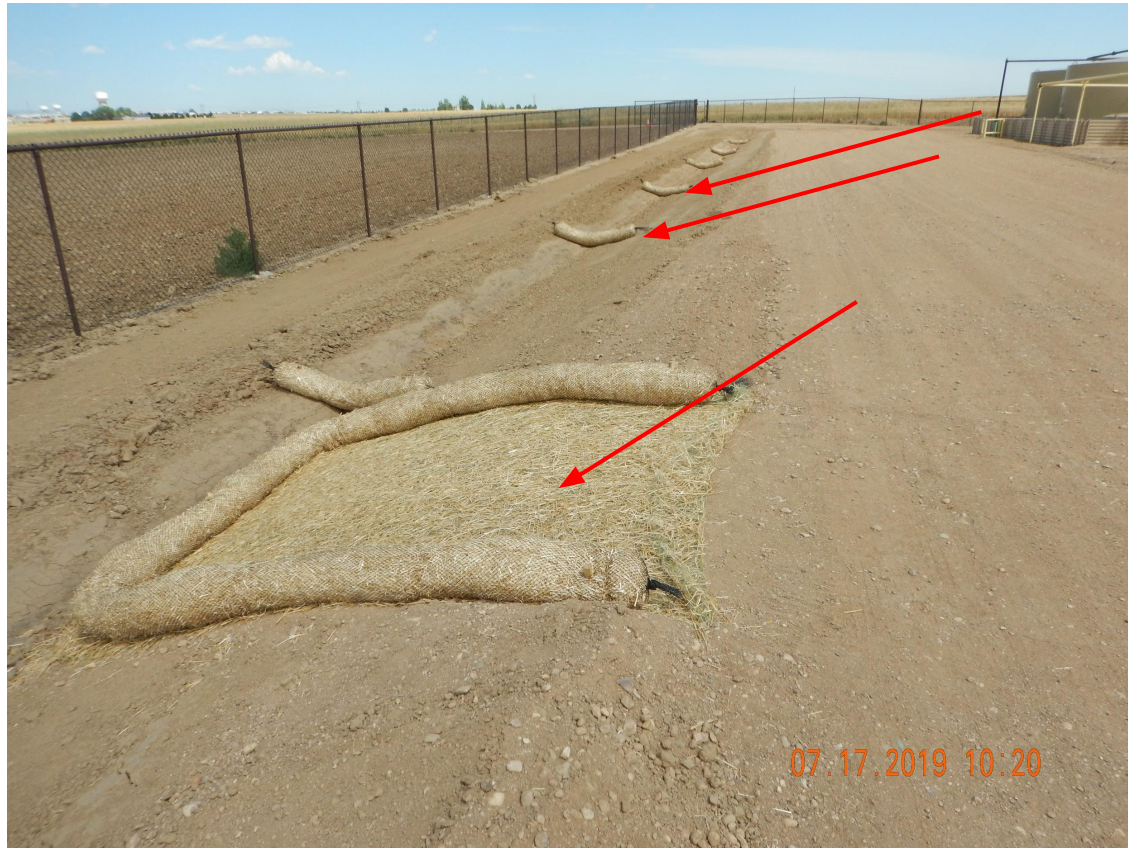
Photo 2. Photo taken from the western location, facing North. See comments under Photo 1. In addition, the type of erosion control blanket and wattles are not intended as a long-term stormwater BMP, only temporary. Operator was required to install long-term stormwater BMPs.

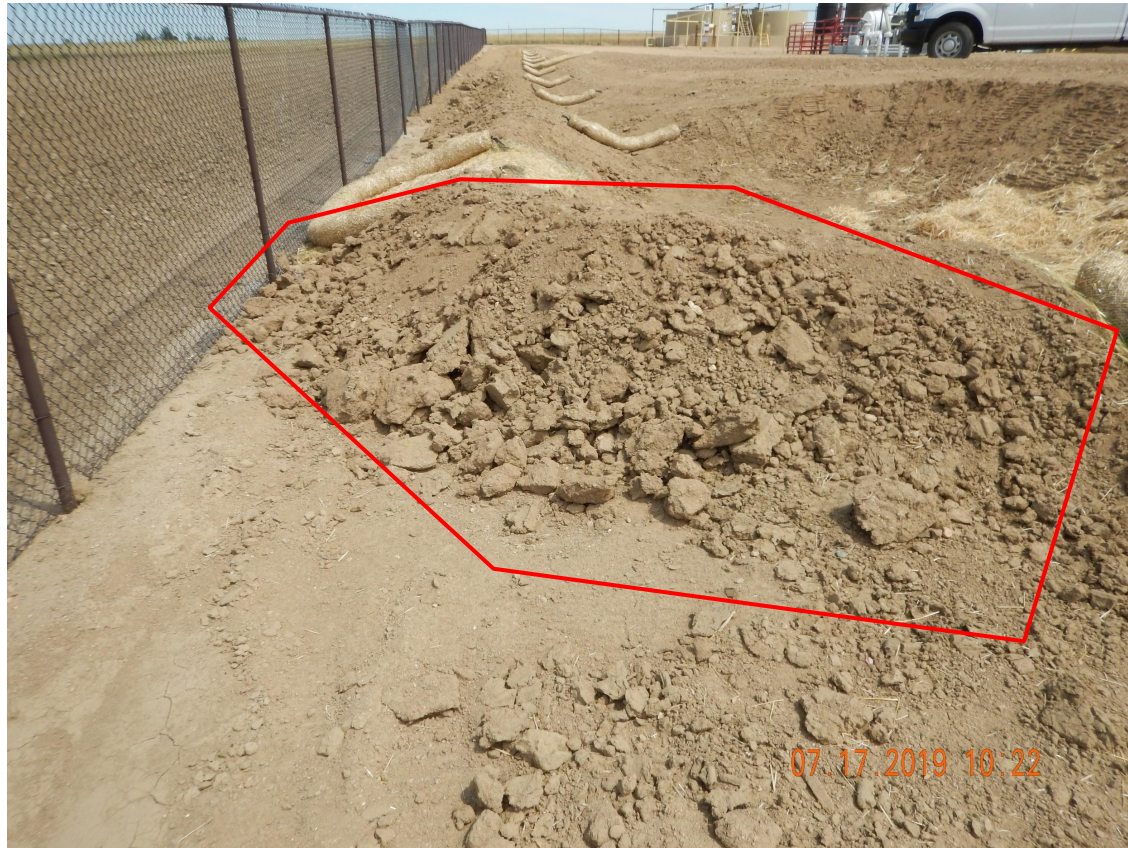
Photo 3. Photo taken of the southern sediment trap, facing North. Photo illustrates the Operator has not installed the sediment trap per good engineering practices. The embankment berm is unconsolidated and not stabilized.

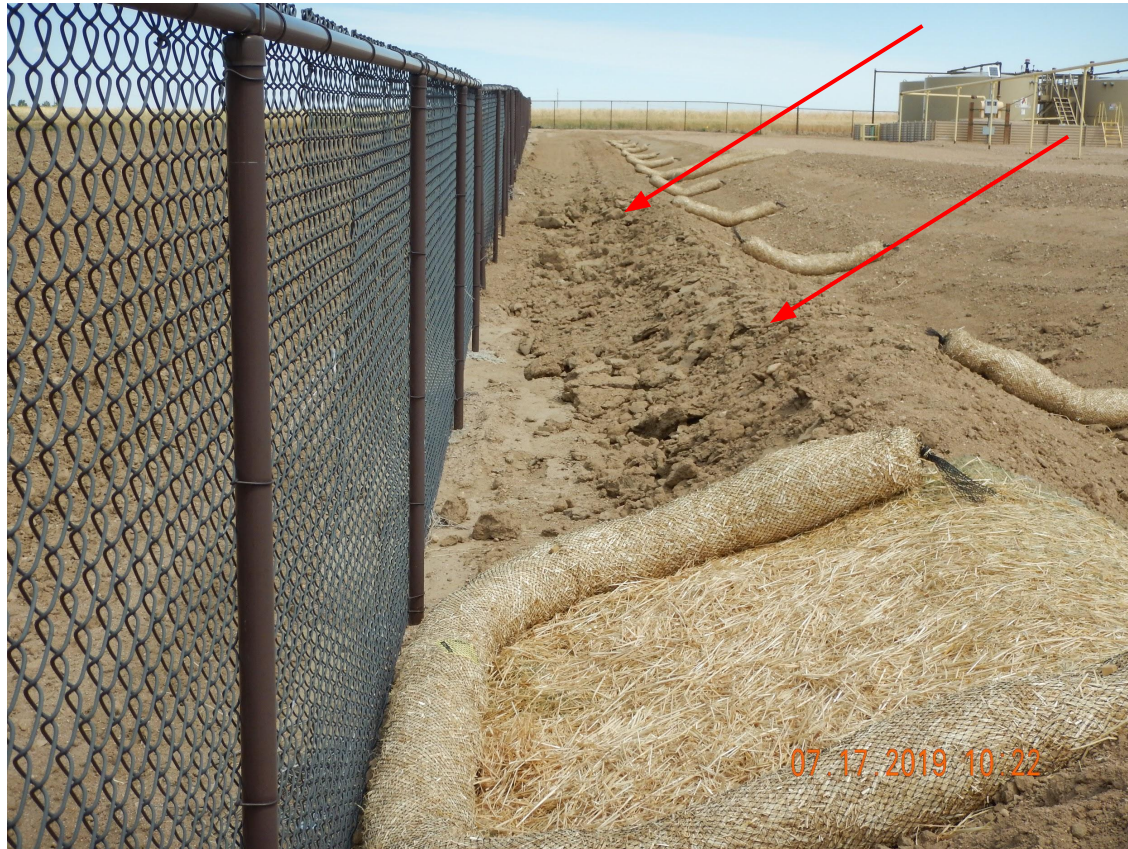
Photo 4. Photo taken from the southwestern location, facing North. Photo illustrates the Operator has not installed the berm BMP per good engineering practices. The berm BMP is unconsolidated and not stabilized. Also, the spillway material installed is not intended as a long-term stormwater BMP, only temporary. Operator was required to install long-term stormwater BMPs.

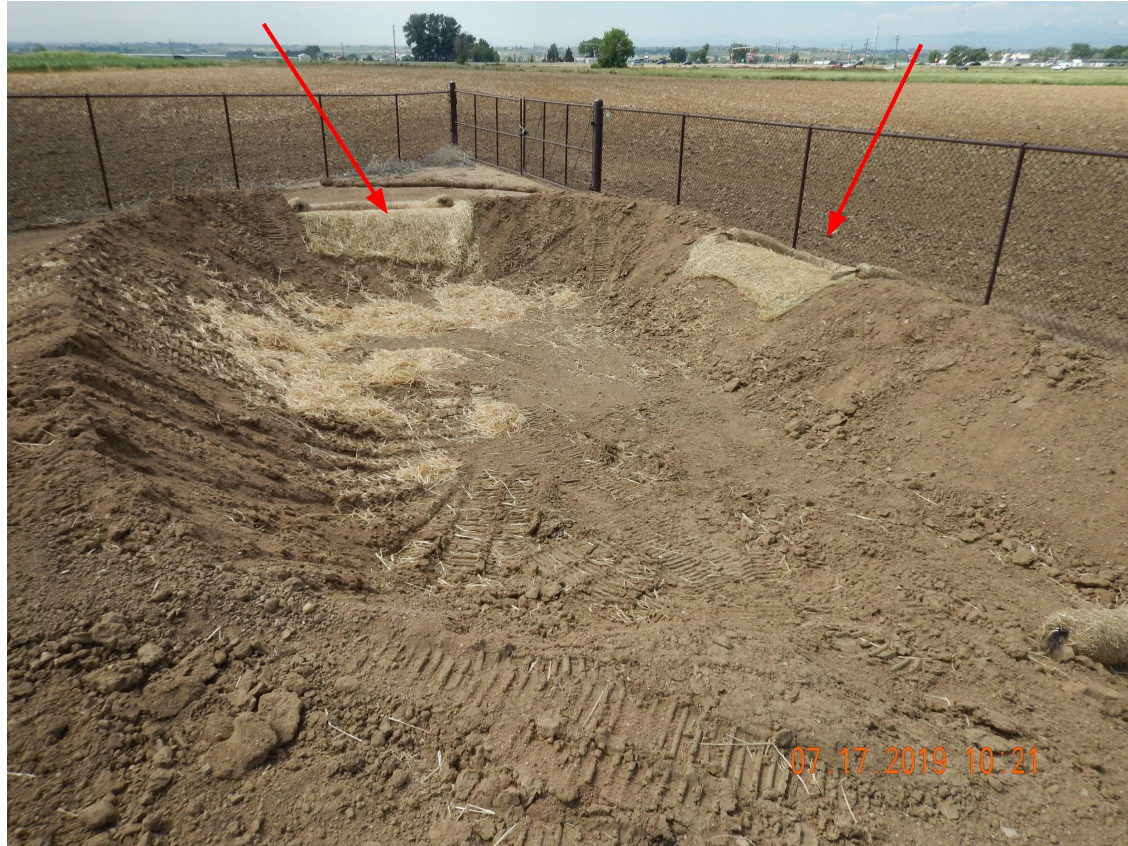
Photo 5. Photo taken from the southwestern location, facing South. Photo illustrates the spillway material used is not intended as a long-term stormwater BMP, only temporary. Operator was required to install long-term stormwater BMPs.
