## Inspection Photos

Location Name: COTTONTAIL PASS UNIT 31-2 FOLLOWUP

API#: 05-071-06386

INSP. #: 695101155

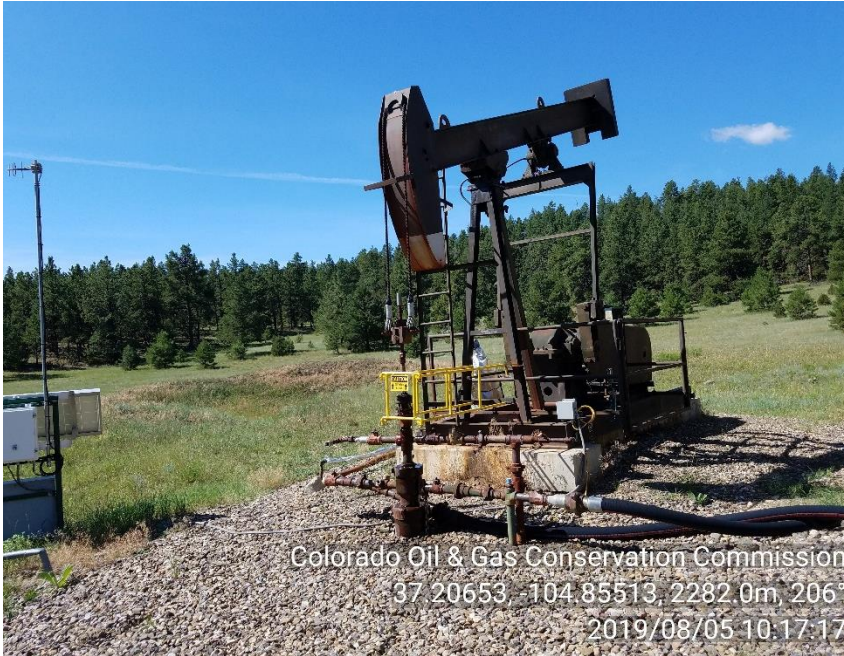
PHOTO 1: WELLHEAD

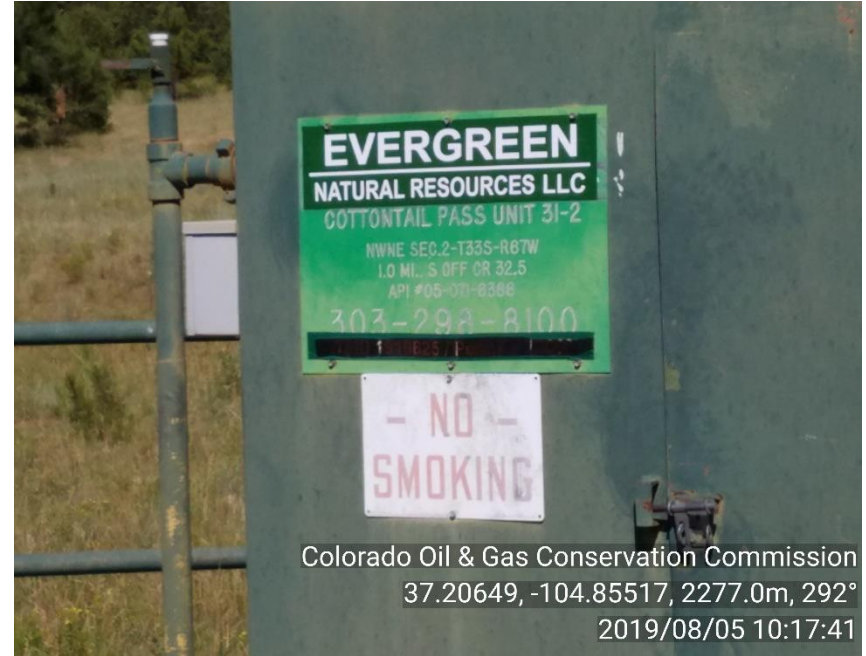
PHOTO 2: WELL SIGN/ CURRENT OPERATOR HAS BEEN POSTED HOWEVER 911 IS NOT INCLUDED IN EMERGENCY CONTACT. **COMPLY WITH 210.b. CA DATE 7/11/19.**

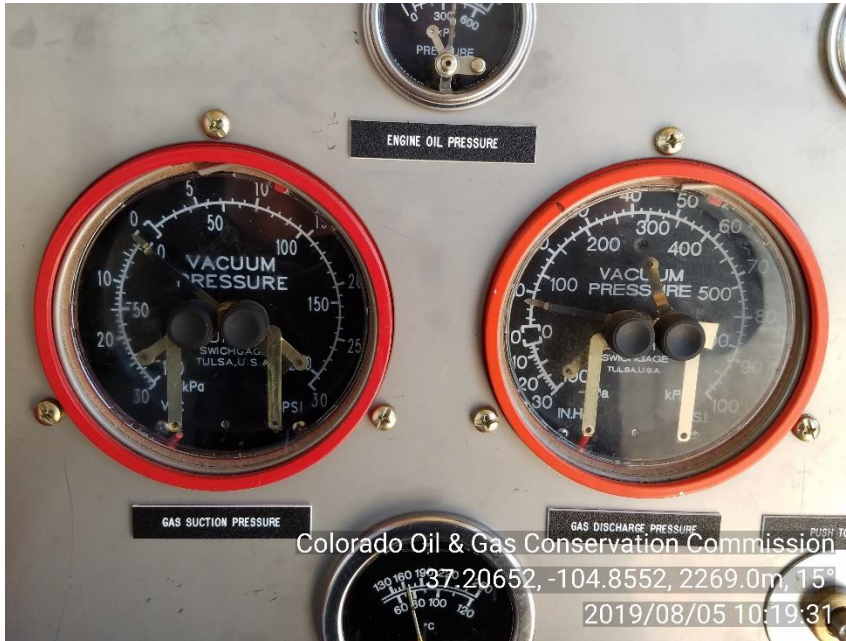
**PHOTO 3: Vacuum pump observed on well without COGCC approval. Provide COGCC with documentation showing approval of use of vacuum pump. CA DATE 6/26/19**
