Inspection Photos

08/02/2019

Operator: WHITING OIL & GAS CORPORATION
- 96155

Location ID: 435945
Weld County, CO

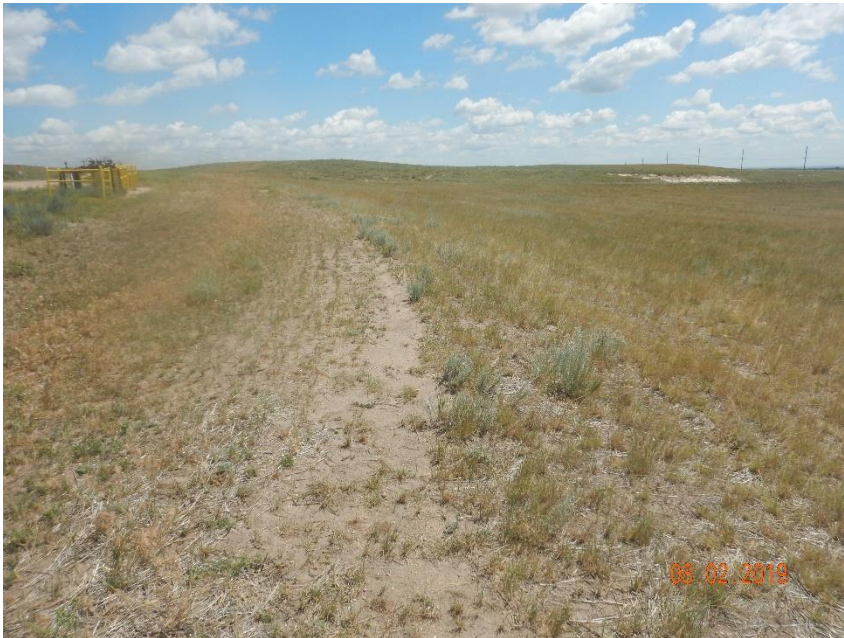
Photo 1: Photo taken from the north end of the location, facing east. Photos 1-4 provide an overview of the location and reclamation from east, southeast, southwest to west.

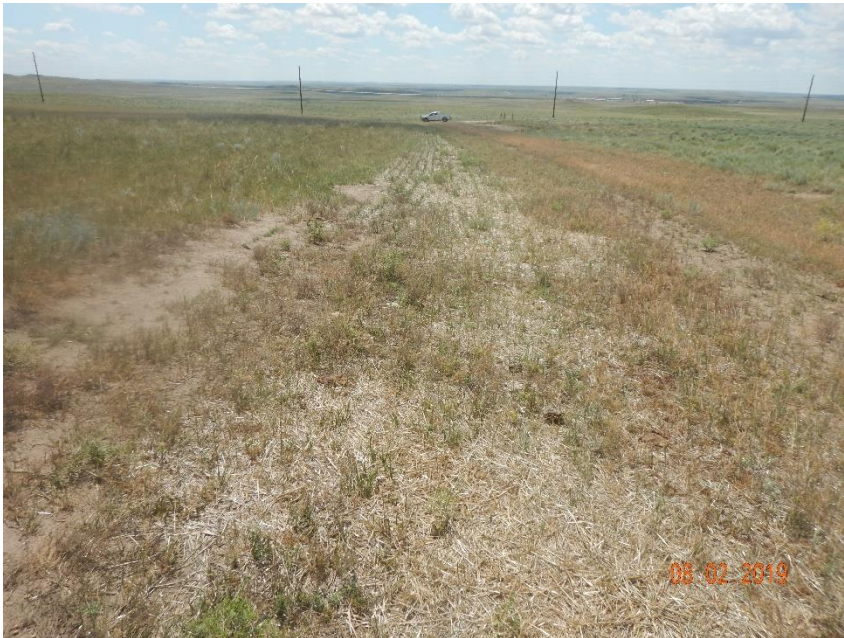
Photo 5: Photo taken from the northwestern end of the location, facing south. Photo shows additional reclamation activities appear to have recently been conducted on areas of the location.

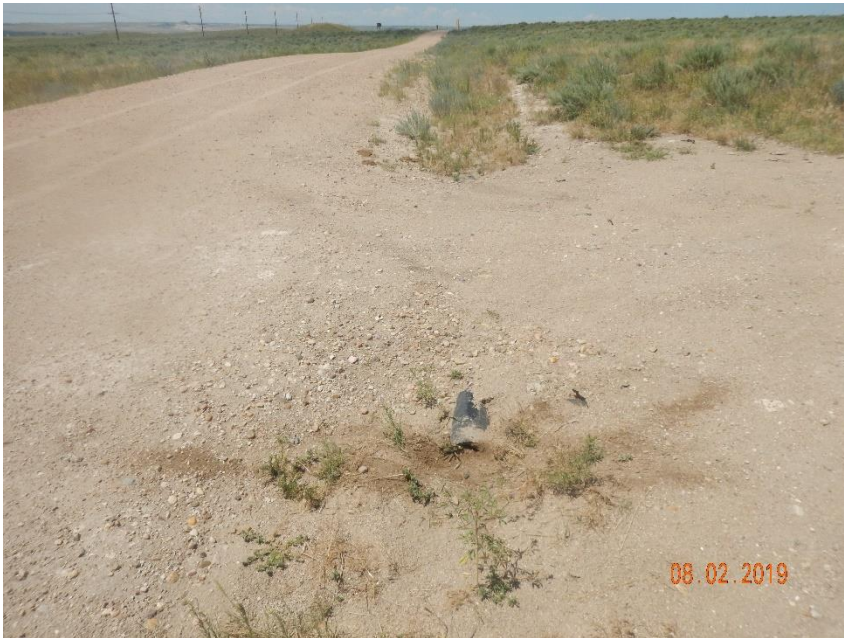
Photo 7: Photo taken from the west end of the location, facing west. Photo also shows culvert remaining at road.

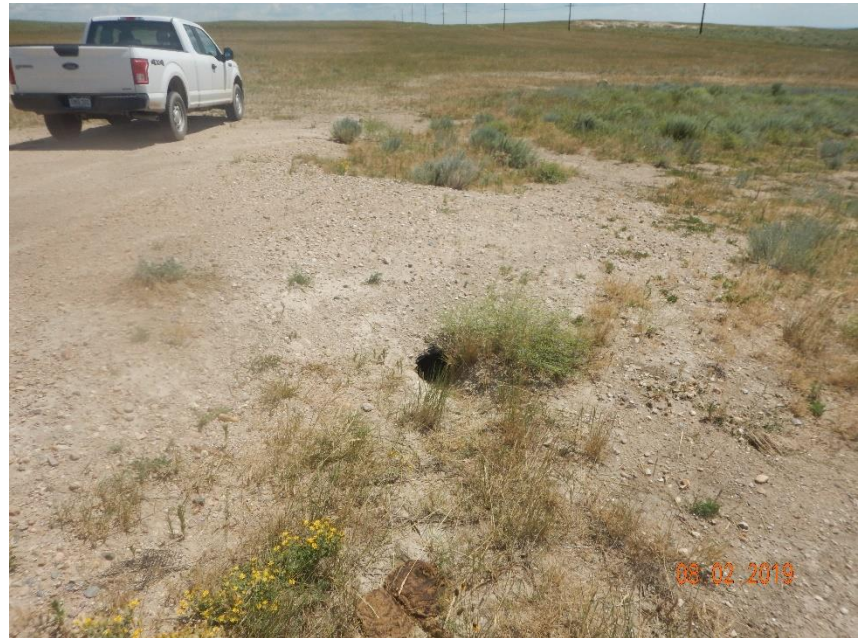
Photo 8: Photo taken from the access road, facing east. Photo shows a second culvert remaining on road.

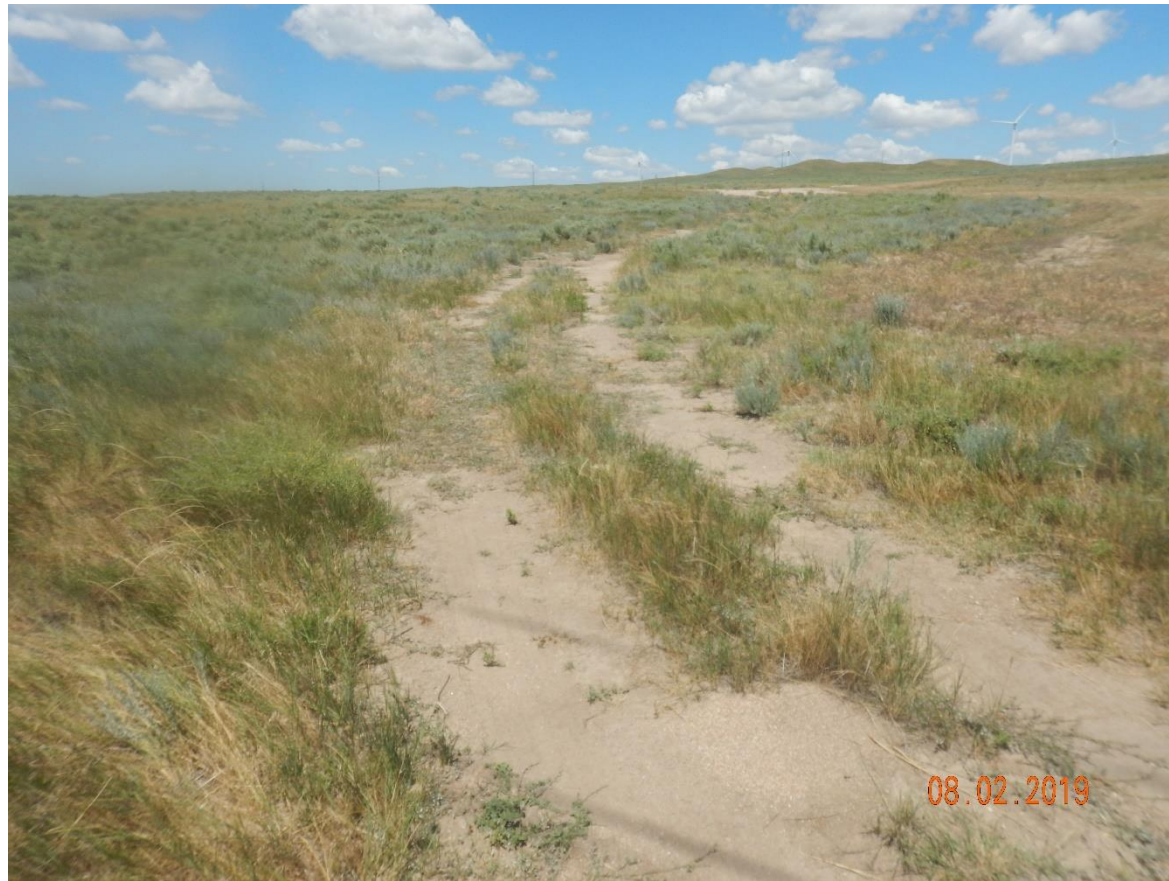
Photo 9: Photo taken from the southwest corner of the location. Photo shows additional road disturbance on the location.
