Inspection Photos

Operator: WHITING OIL & GAS CORPORATION
- 96155

Location ID: 437221
Weld County, CO

Aaron Trujillo
NE Reclamation Specialist
COGCC

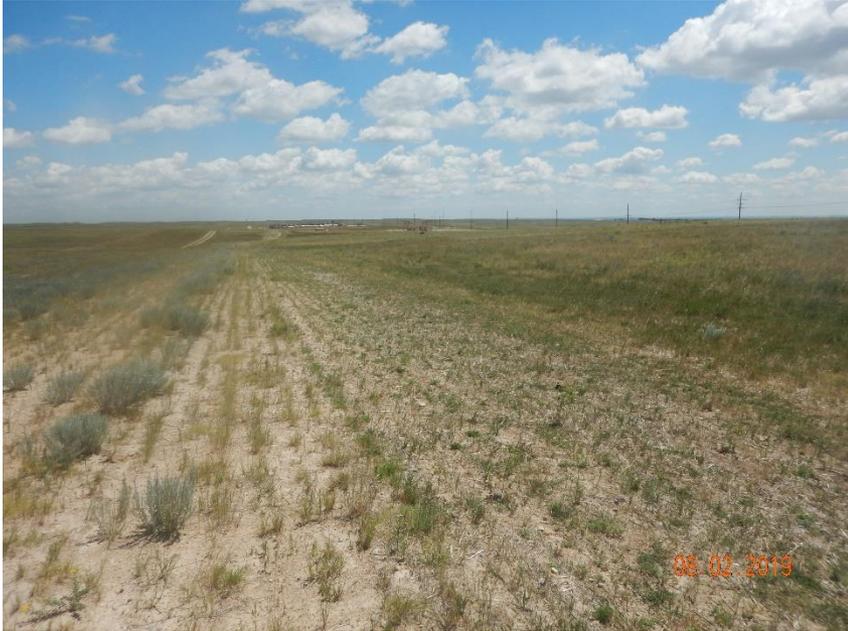
Photo 1: Photo taken from the north end of the location, facing east. Photos 1-4 provide an overview of the location and reclamation from east, southeast, southwest to west.

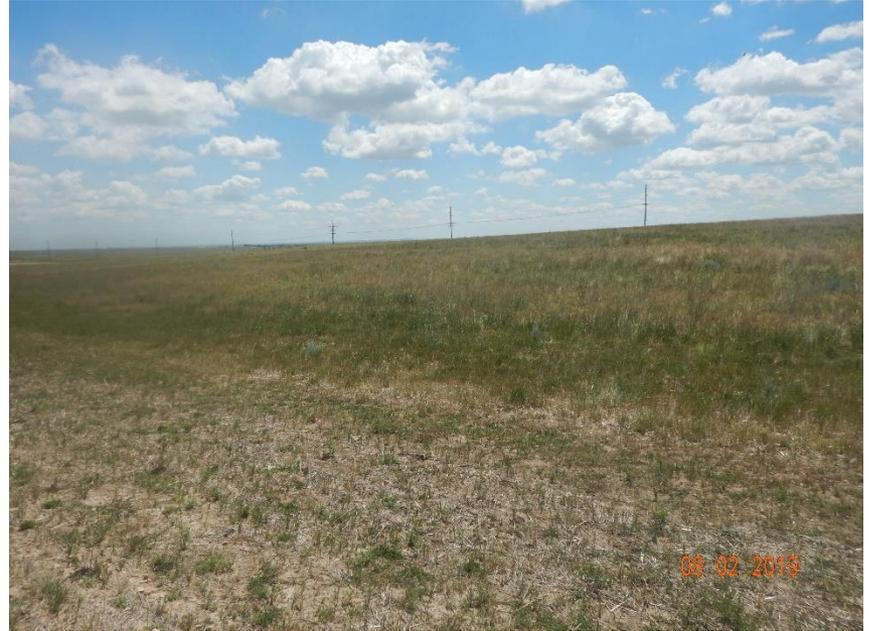
Photo 2: See comments under photo 1.

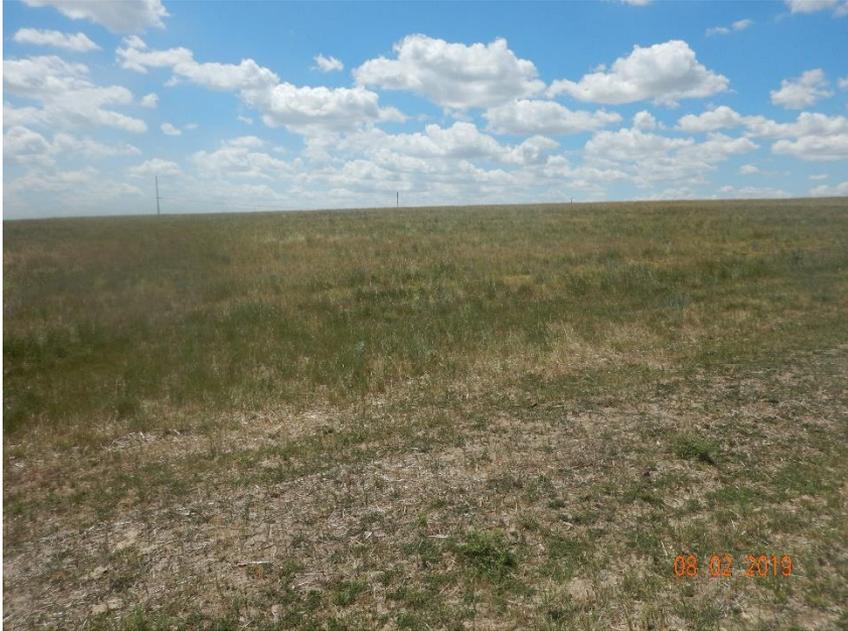
Photo 3: See comments under photo 1.

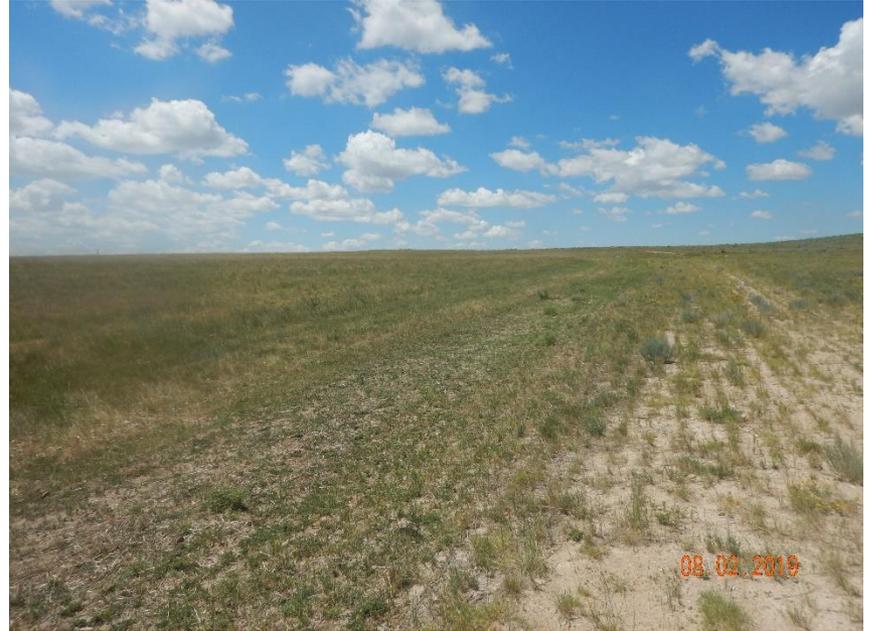
Photo 4: See comments under photo 1.

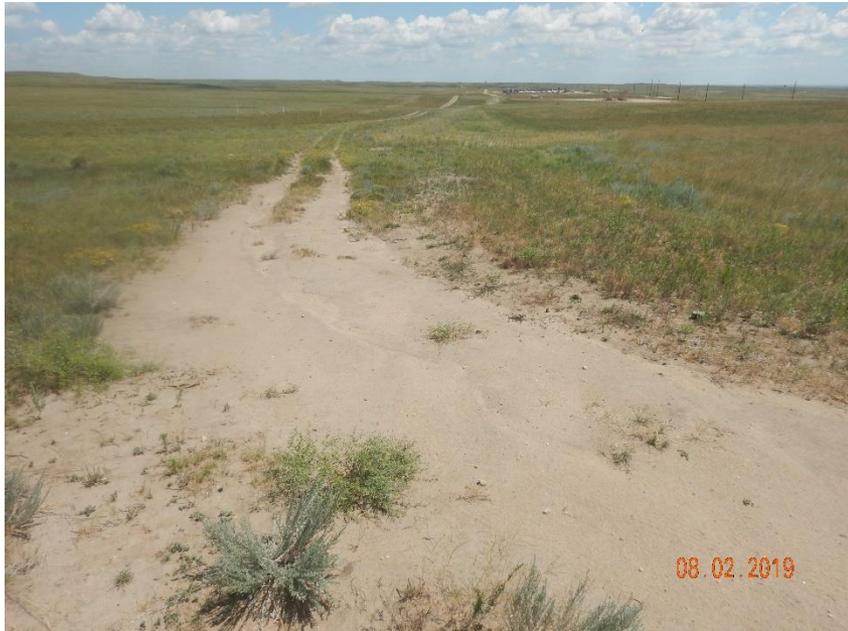
Photo 5: Photo taken from the northwestern end of the location, facing east. Photo shows additional road disturbances on the location that have not been reclaimed.

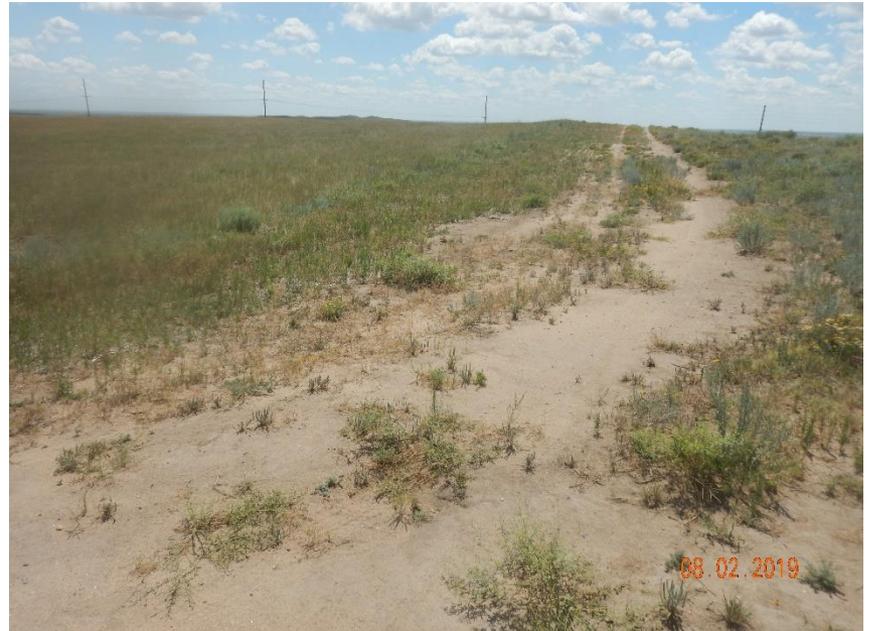
Photo 6: Photo taken from the northwestern end of the location, facing south. Photo shows additional road disturbances on the location that have not been reclaimed.

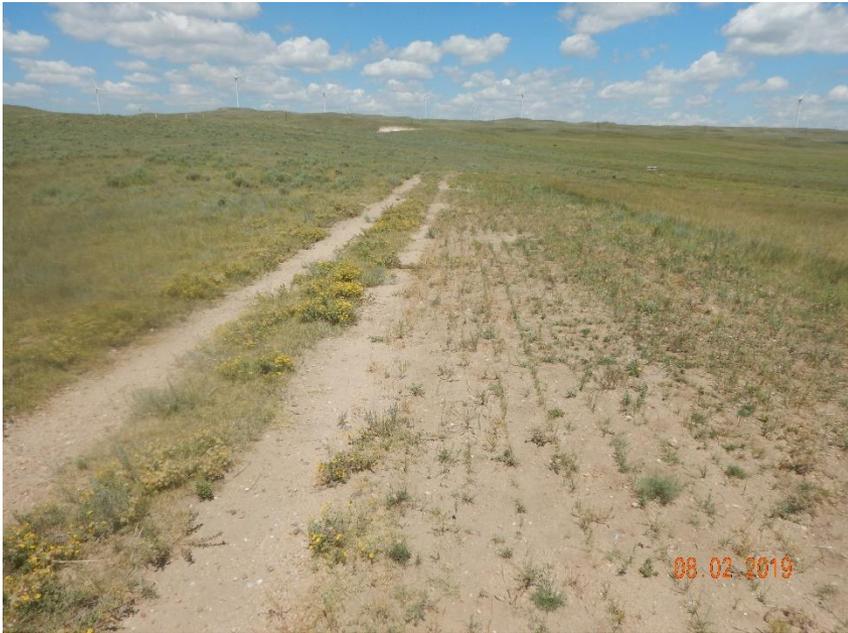
Photo 7: Photo taken from the west end of the location, facing north. Photo shows additional road disturbances on the location that have not been reclaimed.

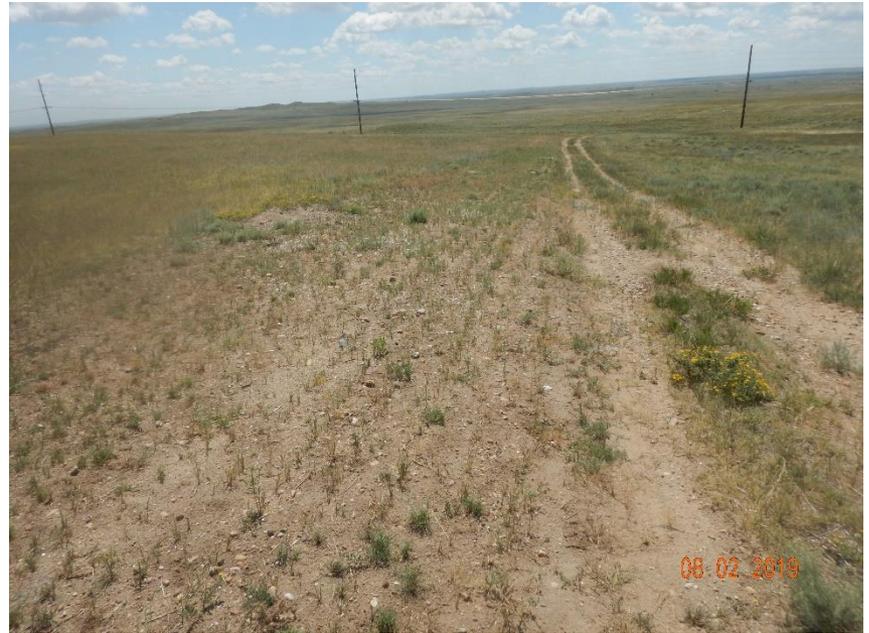
Photo 8: Photo taken from the west end of the location, facing south. Photo shows additional road disturbances on the location that have not been reclaimed.

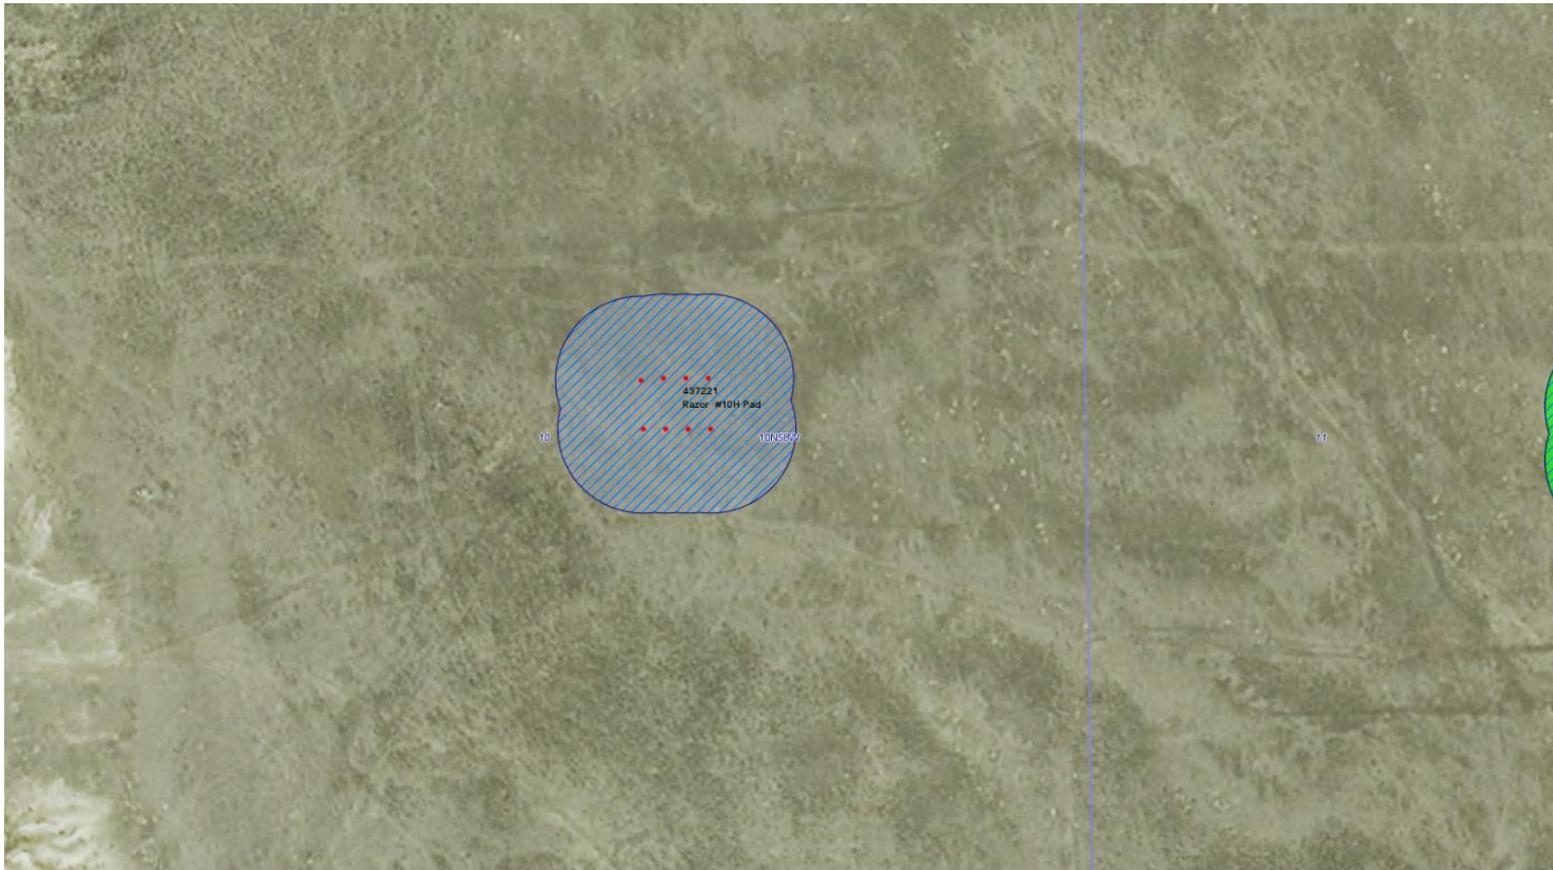
Photo 9: 2013 COGCC COGIS aerial image. Photo shows the Razor #10H pad prior to oil and gas activities/disturbances. Photo also shows access roads did not pre-exist oil and gas activities/disturbances

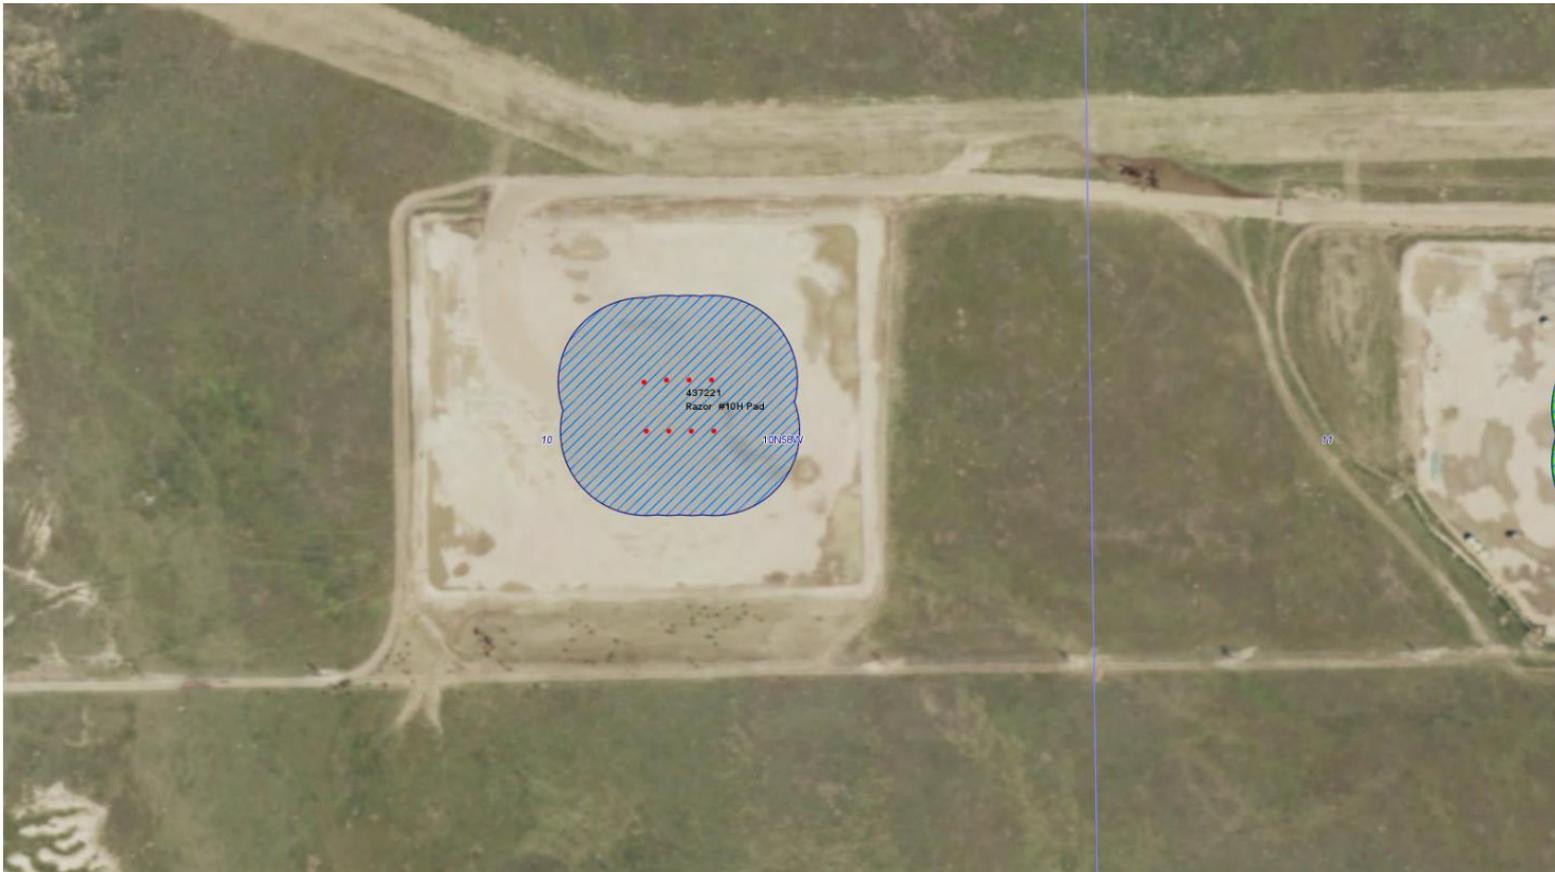
Photo 10: 2013 COGCC COGIS aerial image. Form 4 sundries for the wells (e.g. doc. # 402032274) state location has not been constructed. Photo shows location and access road(s) have been constructed. This is considered false reporting.

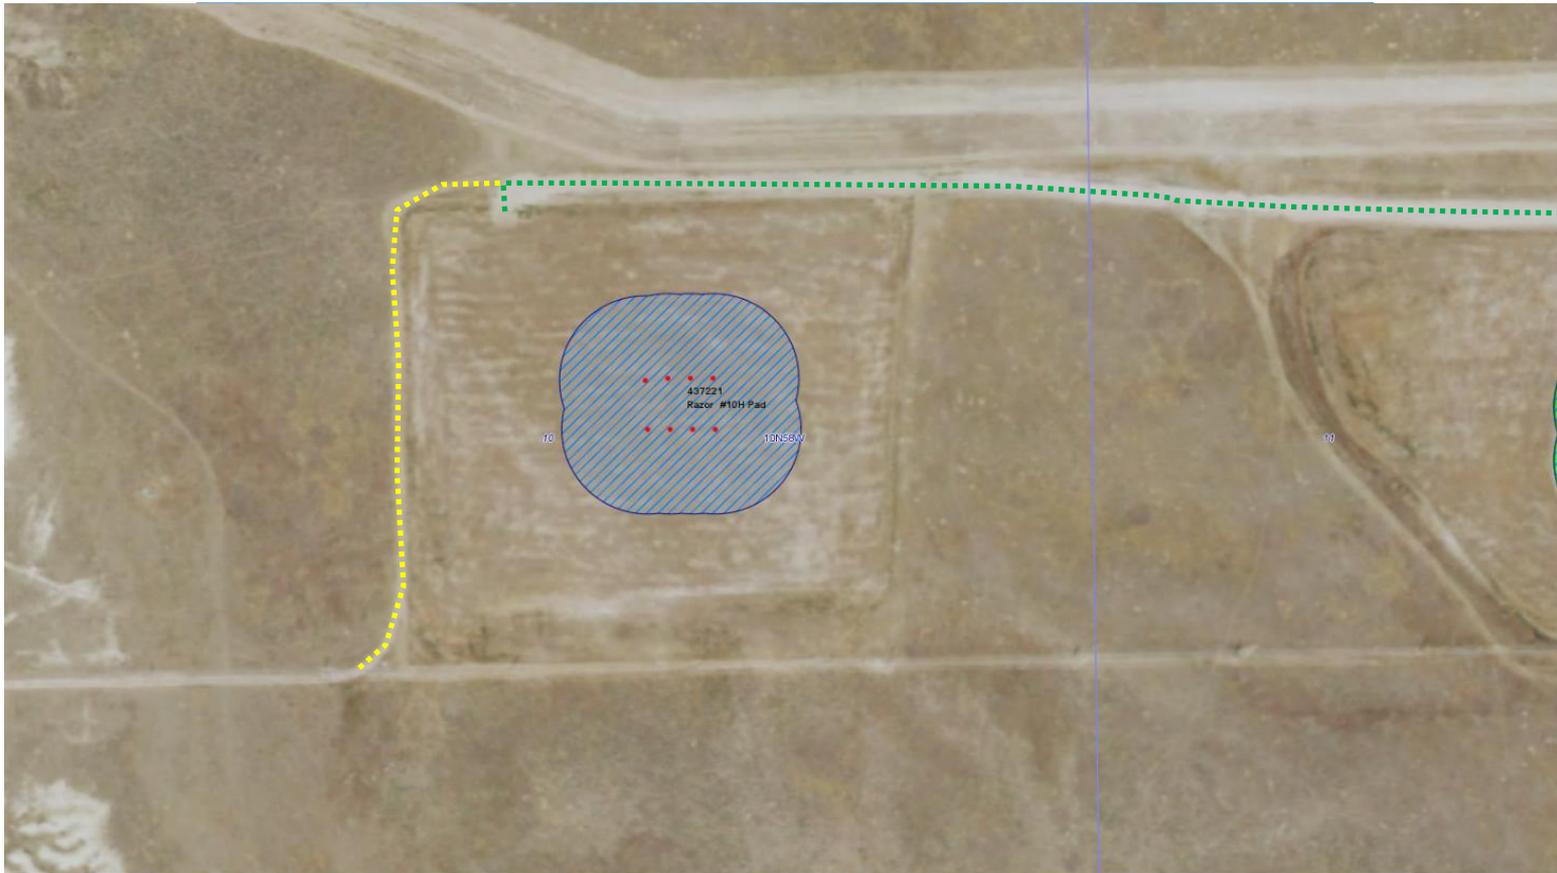
Photo 11: 2013 COGCC COGIS aerial image. Photo shows reclamation activities appear to have been conducted on the location. Reclamation activities appear to have been conducted on the access road on the north end of the location (green). Operator has failed to reclaim the additional road disturbance on the west end of the location (yellow).

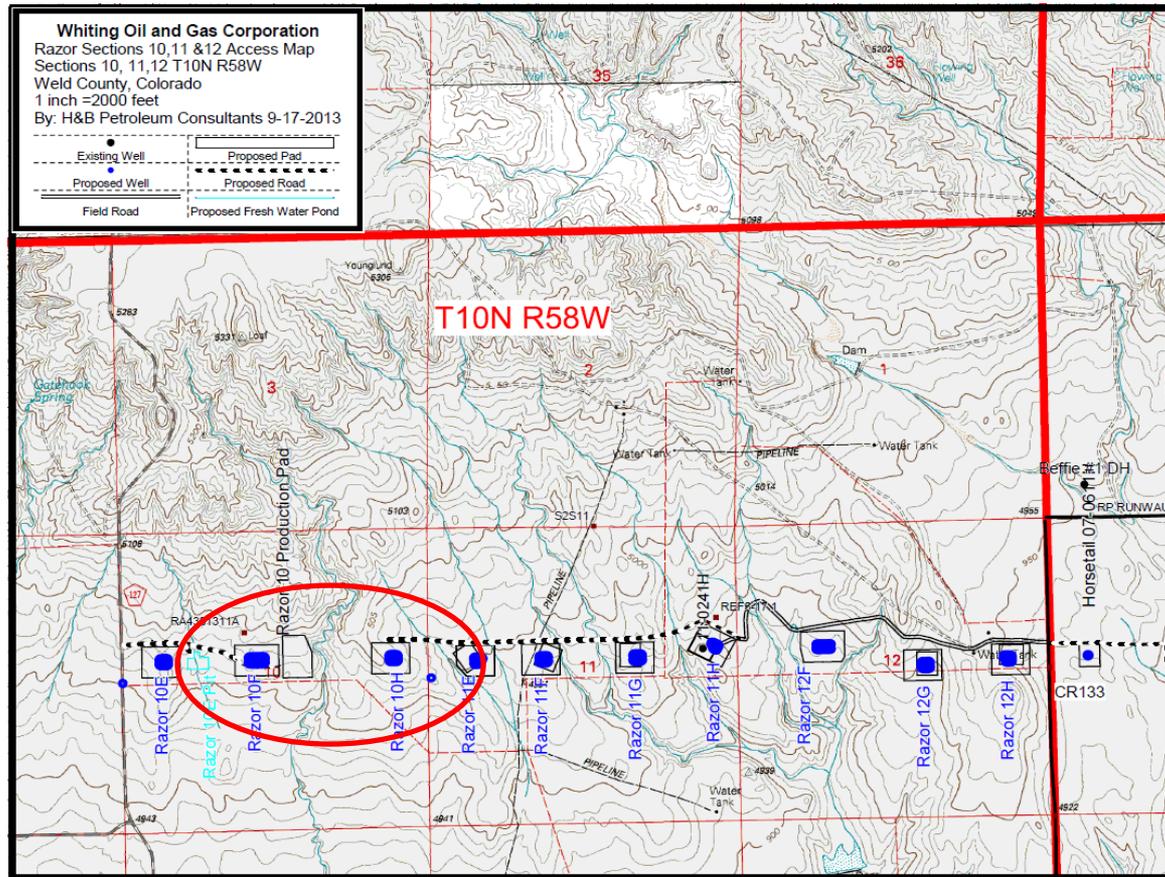
Photo 12: Access road map from doc. #400511535 submitted by Whiting with the Form 2A. Document shows no “Field Road” on the west end of the Razor 10H location existed, and that the additional road disturbance was not included with the “proposed road”.
