# Inspection Photos

08/02/2019

Operator: WHITING OIL & GAS CORPORATION  
- 96155

Location ID: 430127  
Weld County, CO

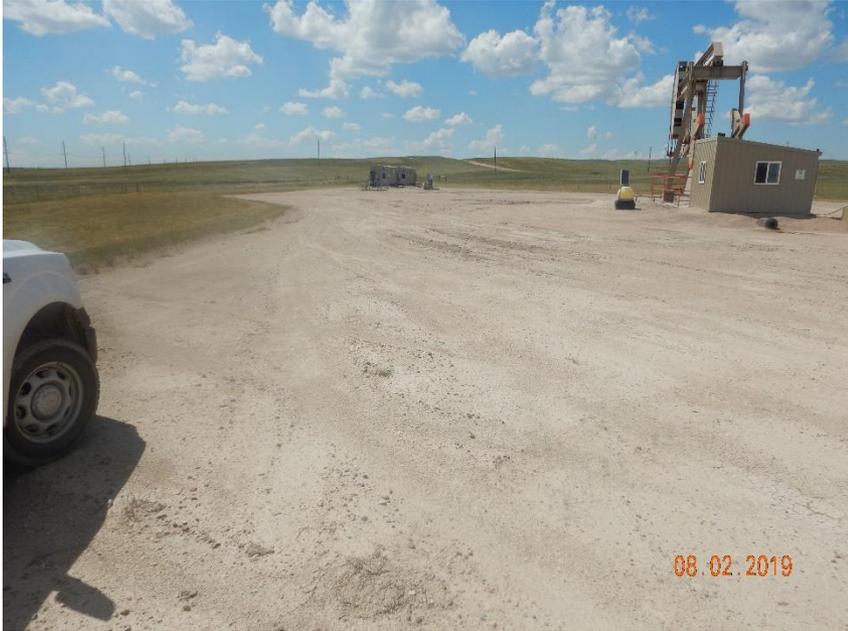
**Photo 1:** Photo taken from the south end of the location, facing west. Photos 1-3 provide an overview of the location from west, northwest, to northeast. Photos show active wells remaining on location. Photos also show that only the areas of the access road, and immediate areas surrounding the wells appear to have been stabilized. Photo shows large areas that remain unstabilized where stormwater ponding outside of the perimeter ditch is evident.

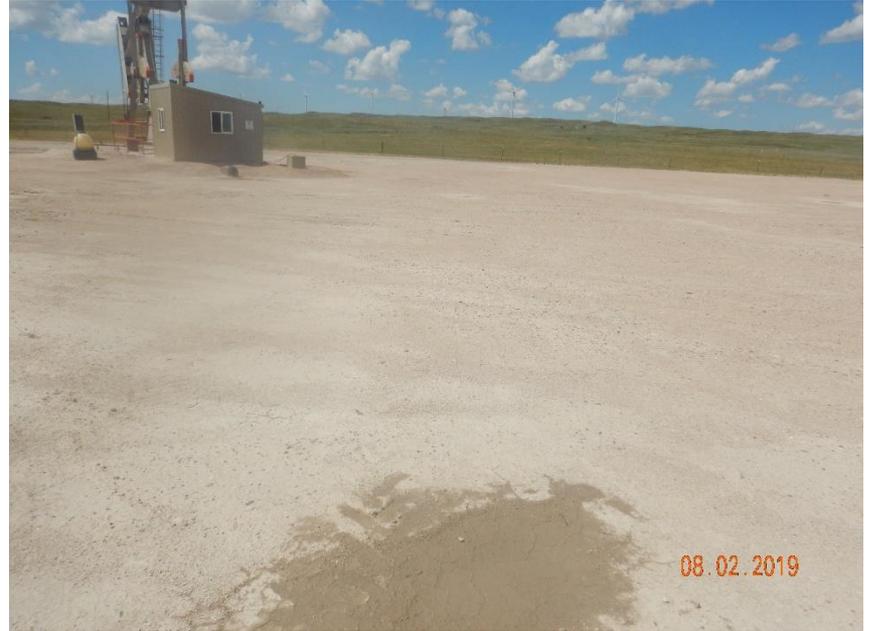
**Photo 2:** See comments under photo 1.

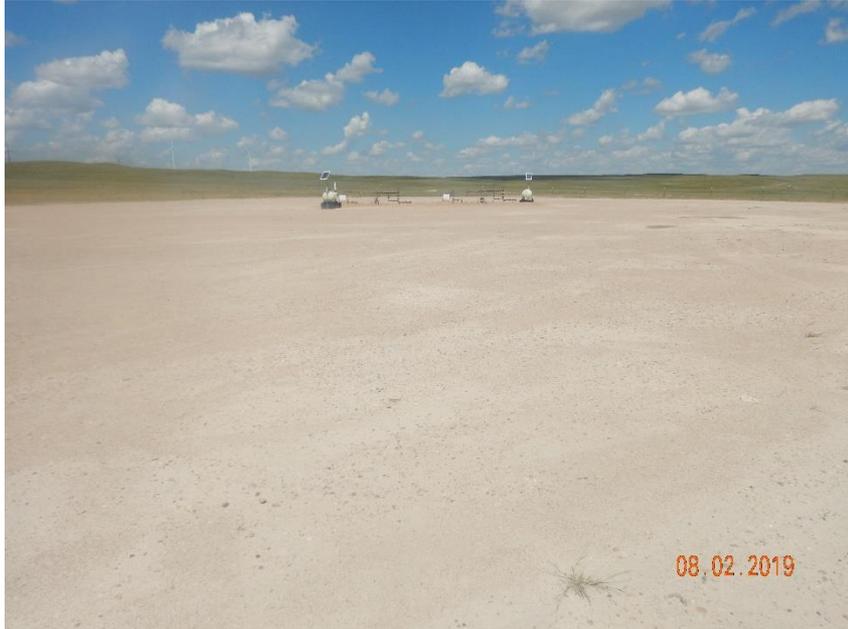
**Photo 3:** See comments under photo 1.

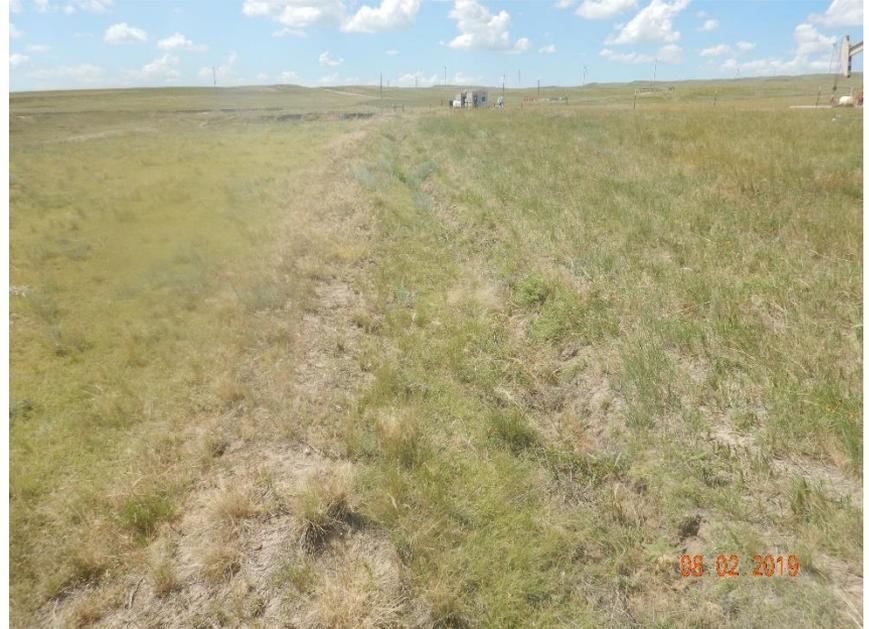
**Photo 4:** Photo taken from the south end of the location, facing west. Photo shows the perimeter stormwater ditch during initial construction activities remaining. Vegetation over interim areas appear to have sufficiently stabilized the soils; Original perimeter stormwater ditch, sediment traps, BMPs etc... no longer appear to be necessary and require reclamation.

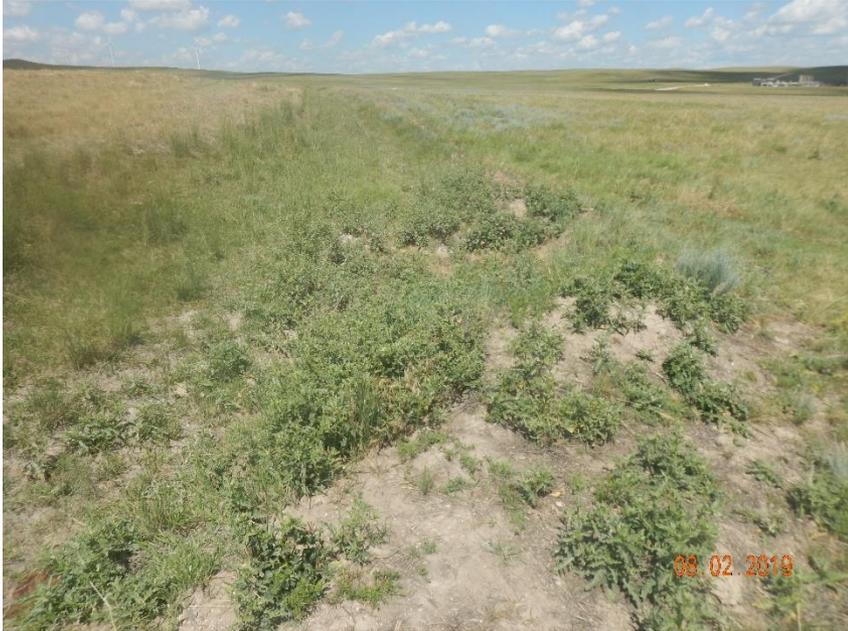
**Photo 5:** Photo taken from the south east end of the location, facing north. Photo shows the perimeter stormwater ditch and sediment trap during initial construction activities remaining. Vegetation over interim areas appear to have sufficiently stabilized the soils; Original perimeter stormwater ditch, sediment traps, BMPs etc... no longer appear to be necessary and require reclamation.

Photo also shows Canada thistle establishing on sediment trap/ditch. This is a Colorado State listed noxious weed and requires management.

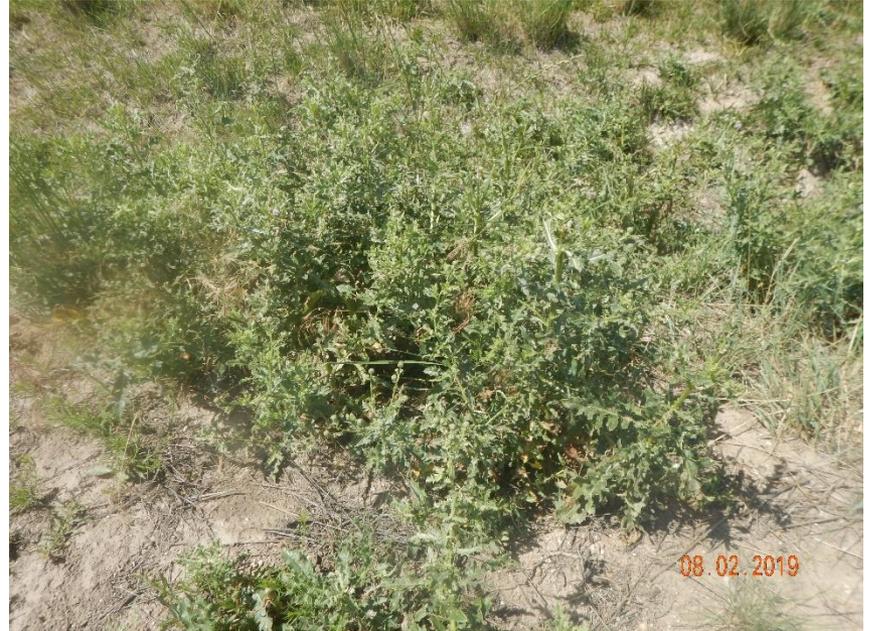
**Photo 6:** Photo shows Canada thistle establishing on sediment trap/ditch. This is a Colorado State listed noxious weed and requires management.

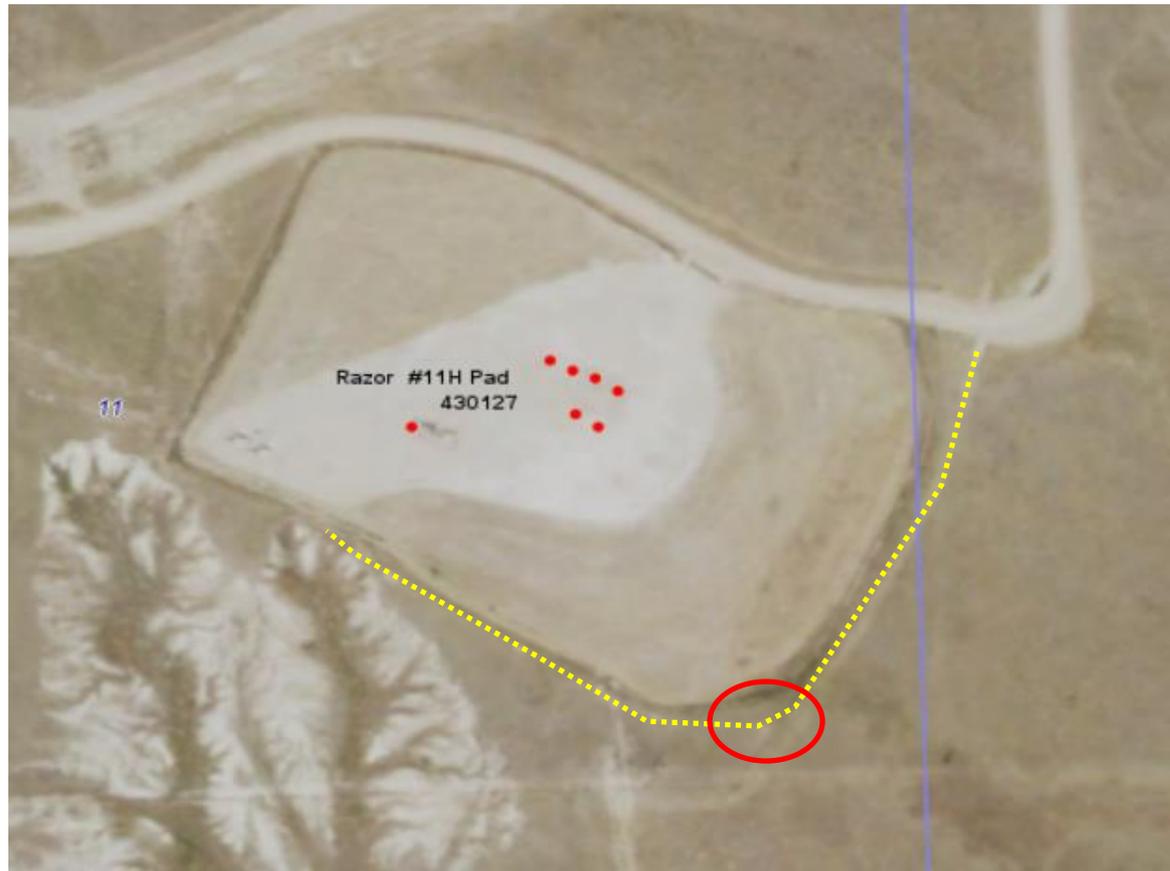
**Photo 7:** 2017 COGCC COGIS aerial image. Photo shows perimeter stormwater ditch (yellow dotted line) w/ sediment traps, BMPs, etc... that require reclamation. Red circle on the southeast corner of location represents areas where noxious weeds were observed.
