Inspection Photos

Operator: FOUNDATION ENERGY
MANAGEMENT LLC - 10112

Location ID: 455471
Weld County, CO

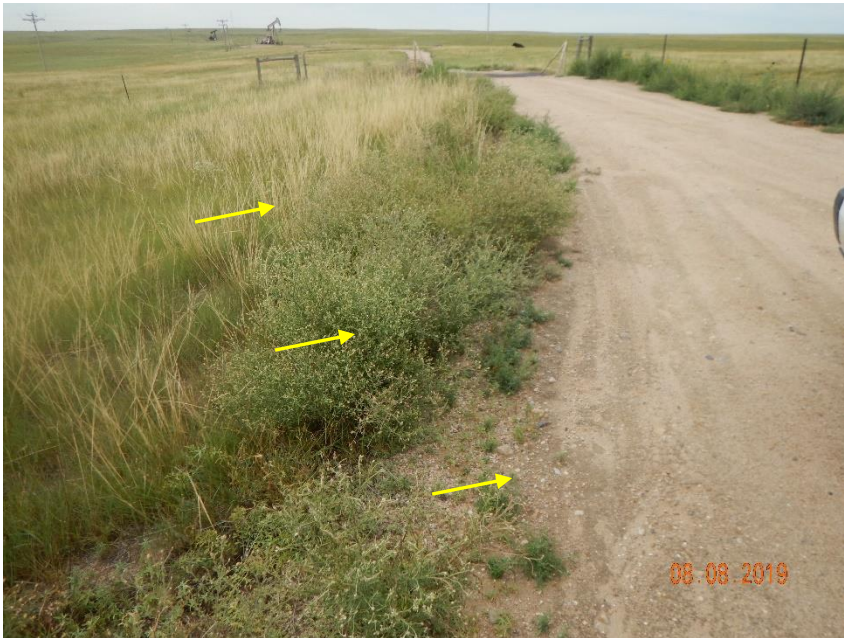
Photo 3: Photo taken from south end of the location, facing south. Photo shows Diffuse Knapweed (Plants with white flowers in photo) remains established on the location/access road. Operator has failed to conduct sufficient ongoing noxious weed management on the location.

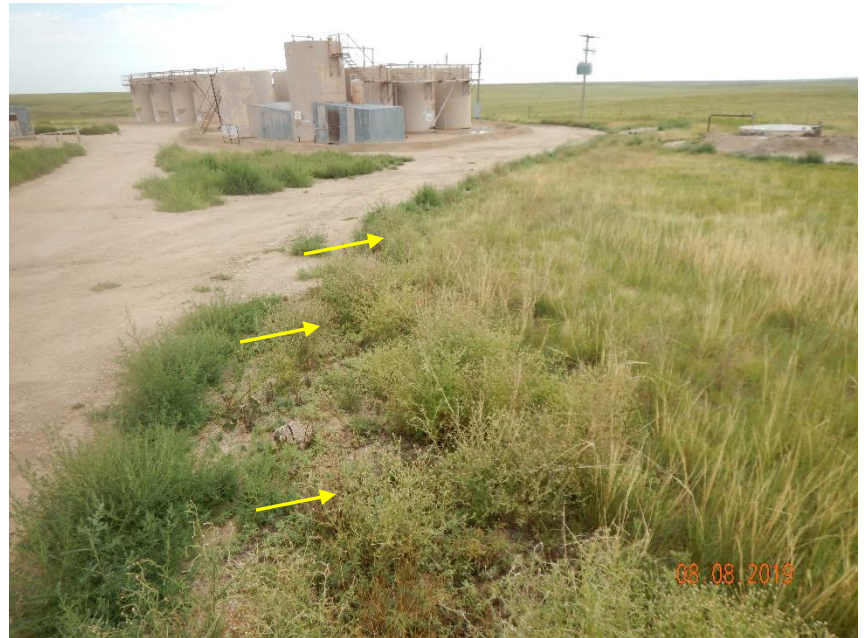
Photo 4: Photo taken from the southwest end of the location, facing northeast. See comments under photo 3

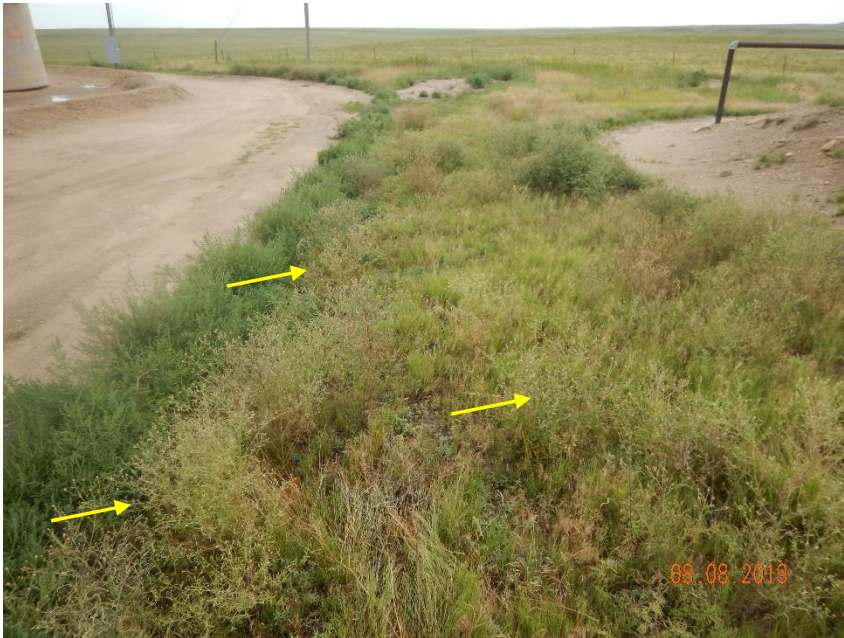
Photo 5: Photo taken from the south end of the location, facing northeast. See comments under photo 3

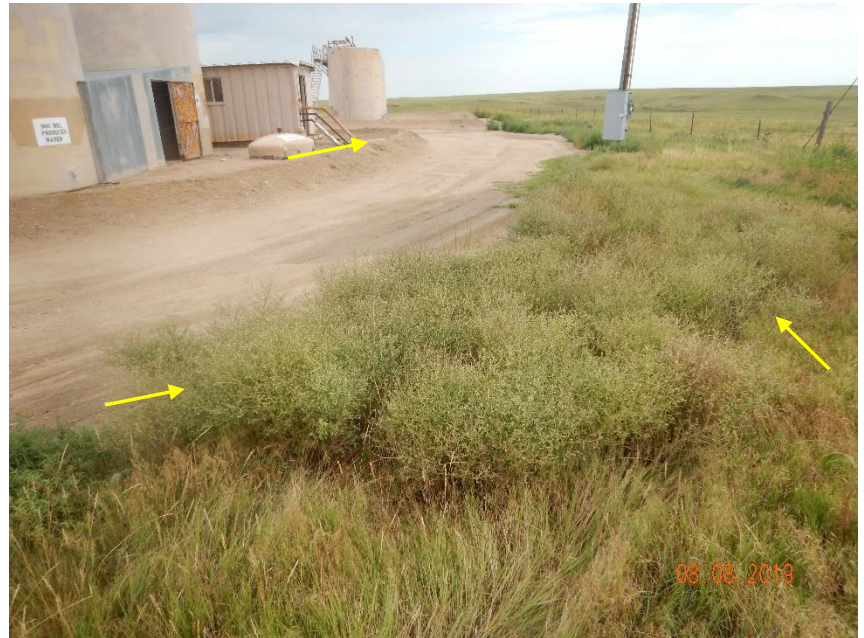
Photo 6: Photo taken from the southeast end of the location, facing northeast. See comments under photo 3. Photo also shows berm has been repaired per CAs
