Inspection Photos

Operator: MOUNTAIN PETROLEUM CORP #
60890

Location ID: 410482
Yuma County, CO

Aaron Trujillo
NE Reclamation Specialist
COGCC

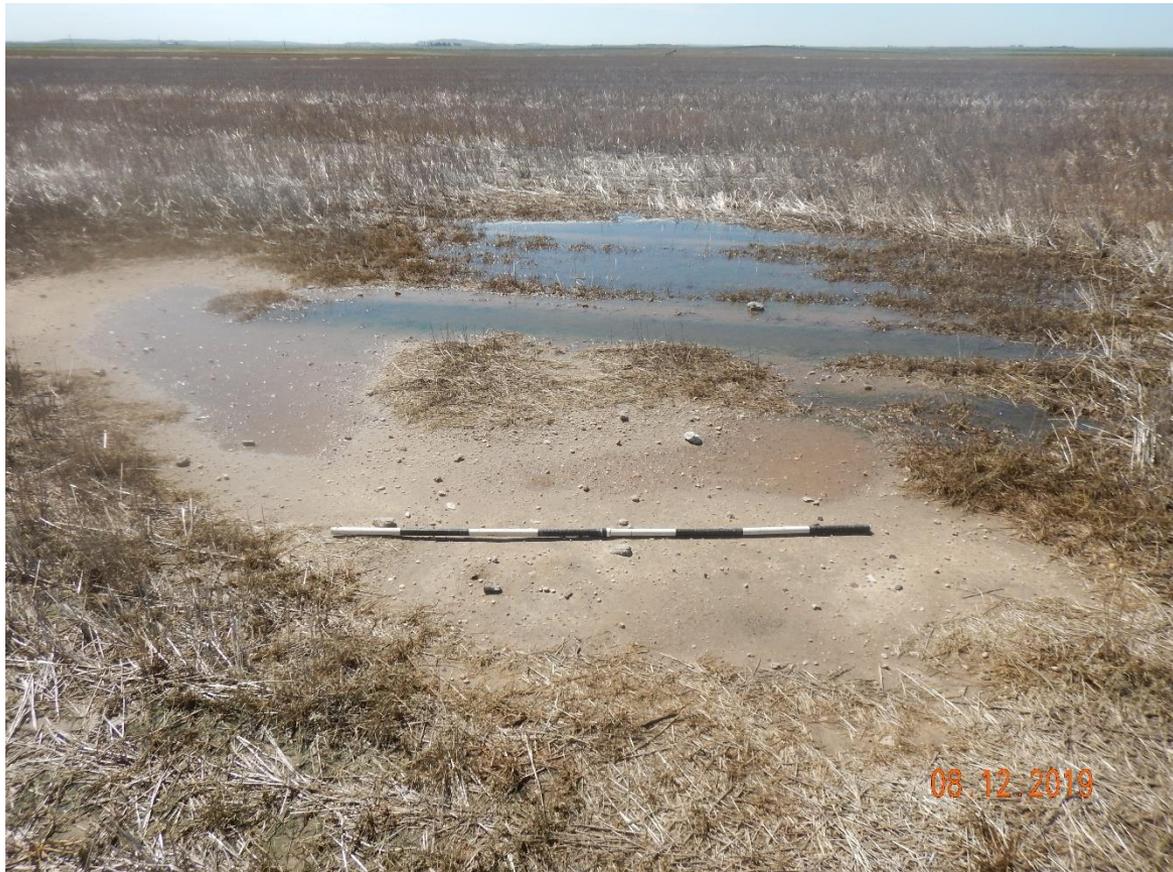
Photo 1: Photo taken from the north end of the well location, facing south. Location within cropland. Photo shows area of the well remains bare and exposed soils. Vegetation over the reclamation area is not uniform or reflective of the adjacent reference area. 2 meter robel pole for reference.

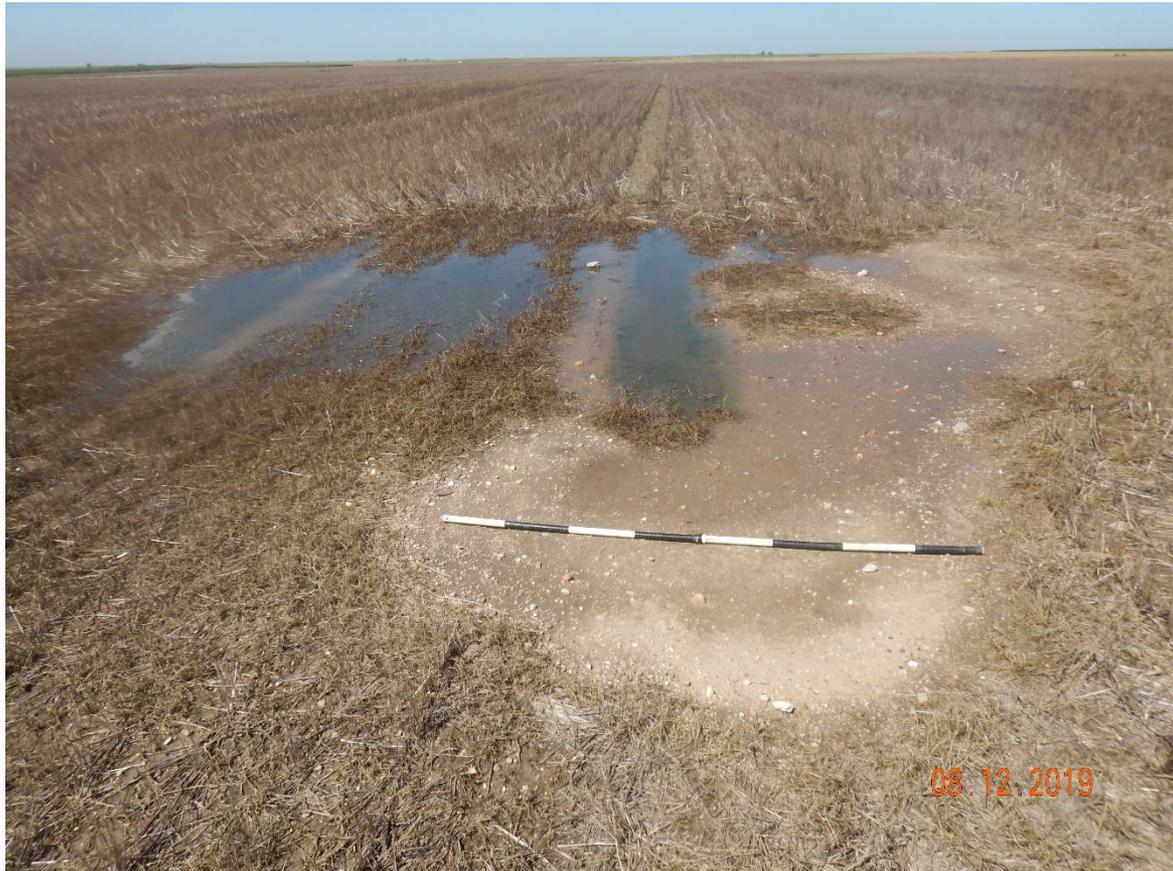
Photo 2: Photo taken from the east end of the well location, facing west. Location within cropland. Photo shows area of the well remains bare and exposed soils. Vegetation over the reclamation area is not uniform or reflective of the adjacent reference area. 2 meter robel pole for reference.

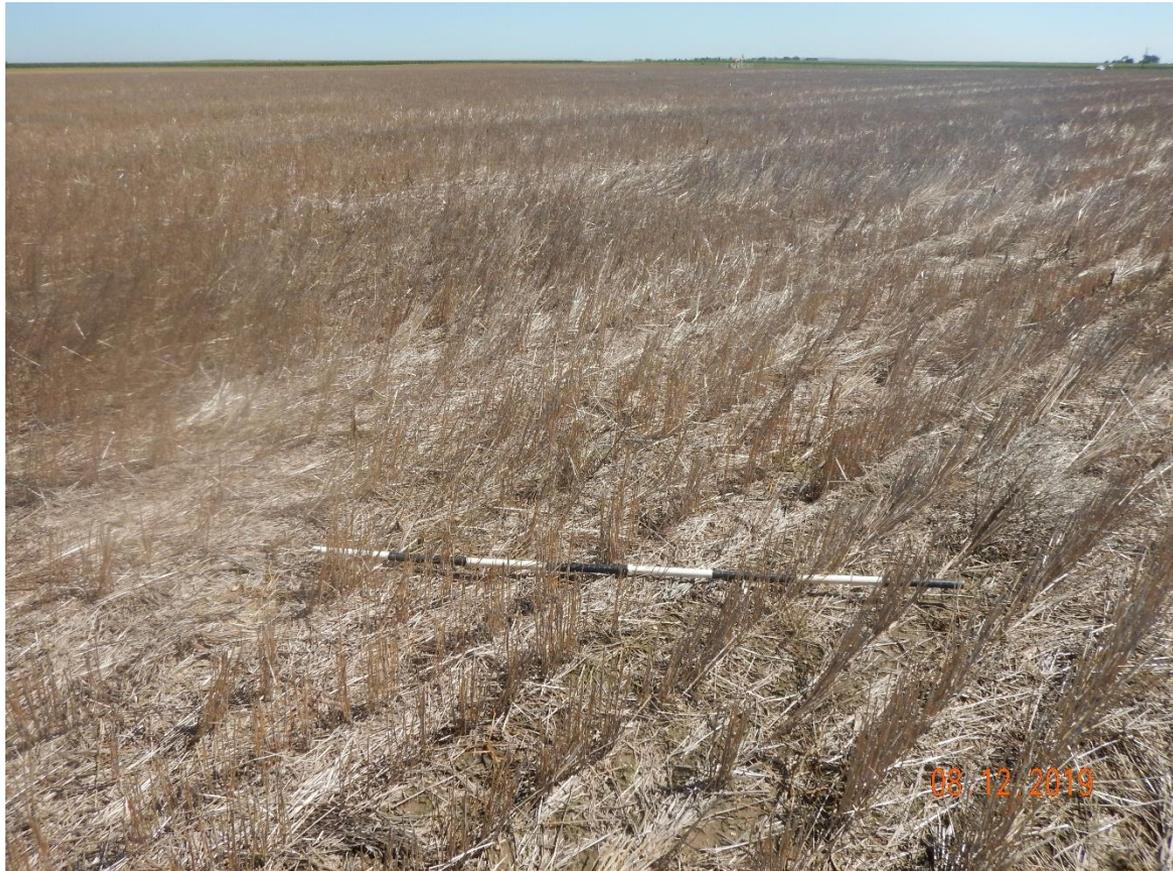
Photo 3: Photo taken from the adjacent reference area. Photo shows well location is not reflective of the reference areas.
