Interim Reclamation and Stormwater Inspection

Operator: VERDAD RESOURCES LLC - #10651

Location ID: 441092

Inspection Photos
Location Name: Rowe #01N-65W-26-8N
Location ID: 441092

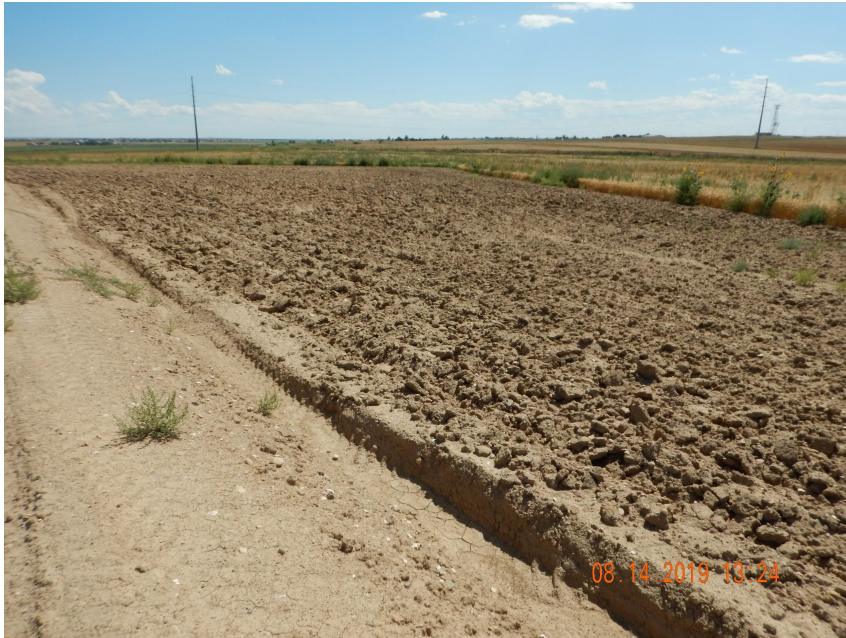
Photo 1. Photo taken from the entrance of the location, facing South. Photo illustrates the Operator has recently performed Interim Reclamation activities.

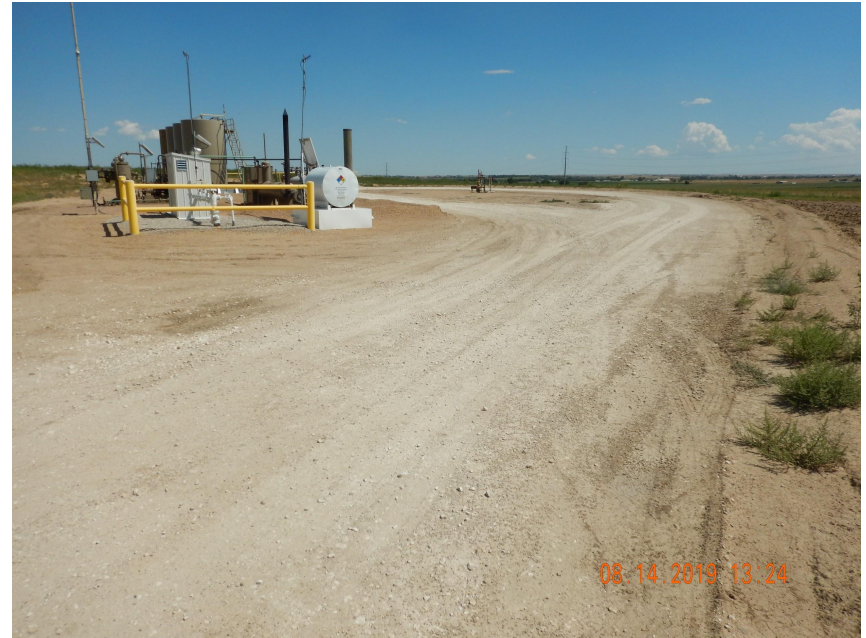
Photo 2. Photo taken from the entrance of the location, facing Southeast. Photo illustrates the Operator has reduced the size of the location only needed for production operations.

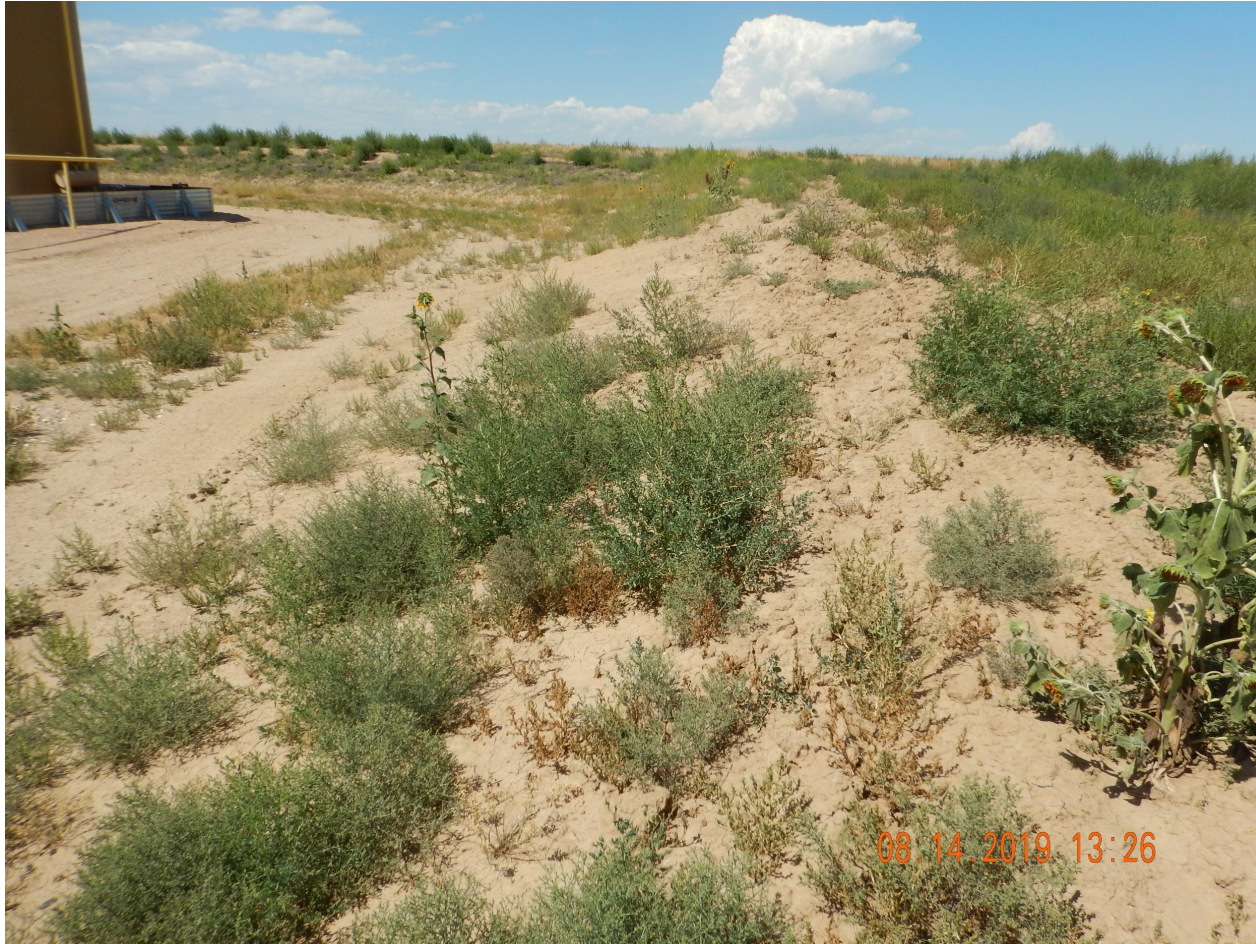
Photo 3. Photo taken from the eastern well pad, facing North. Photo illustrates unmanaged weeds throughout the cut slope areas.

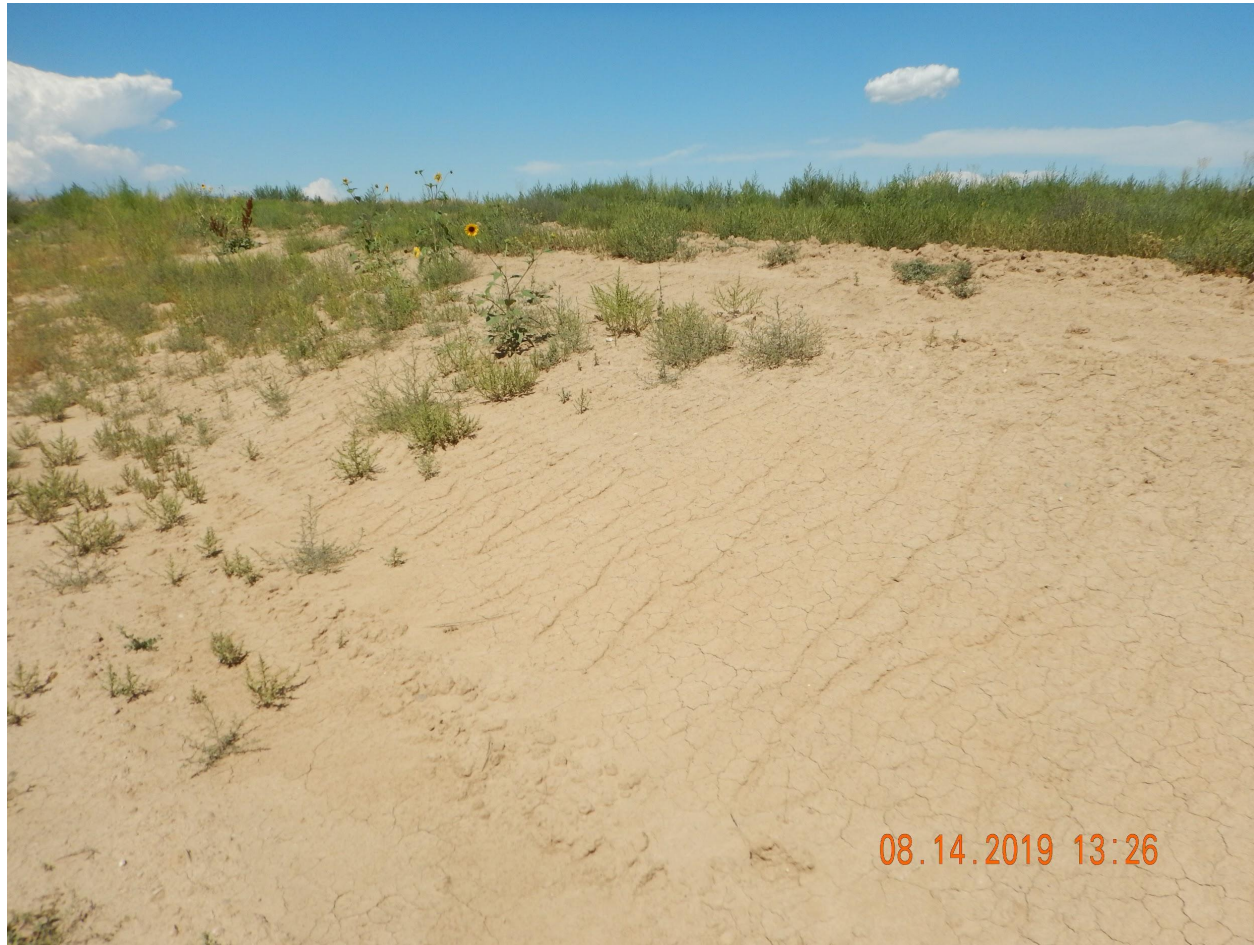
Photo 4. Photo taken from the eastern well pad, facing Northeast. Photo illustrates the cut slope areas have not been properly stabilized as rill erosion was observed.

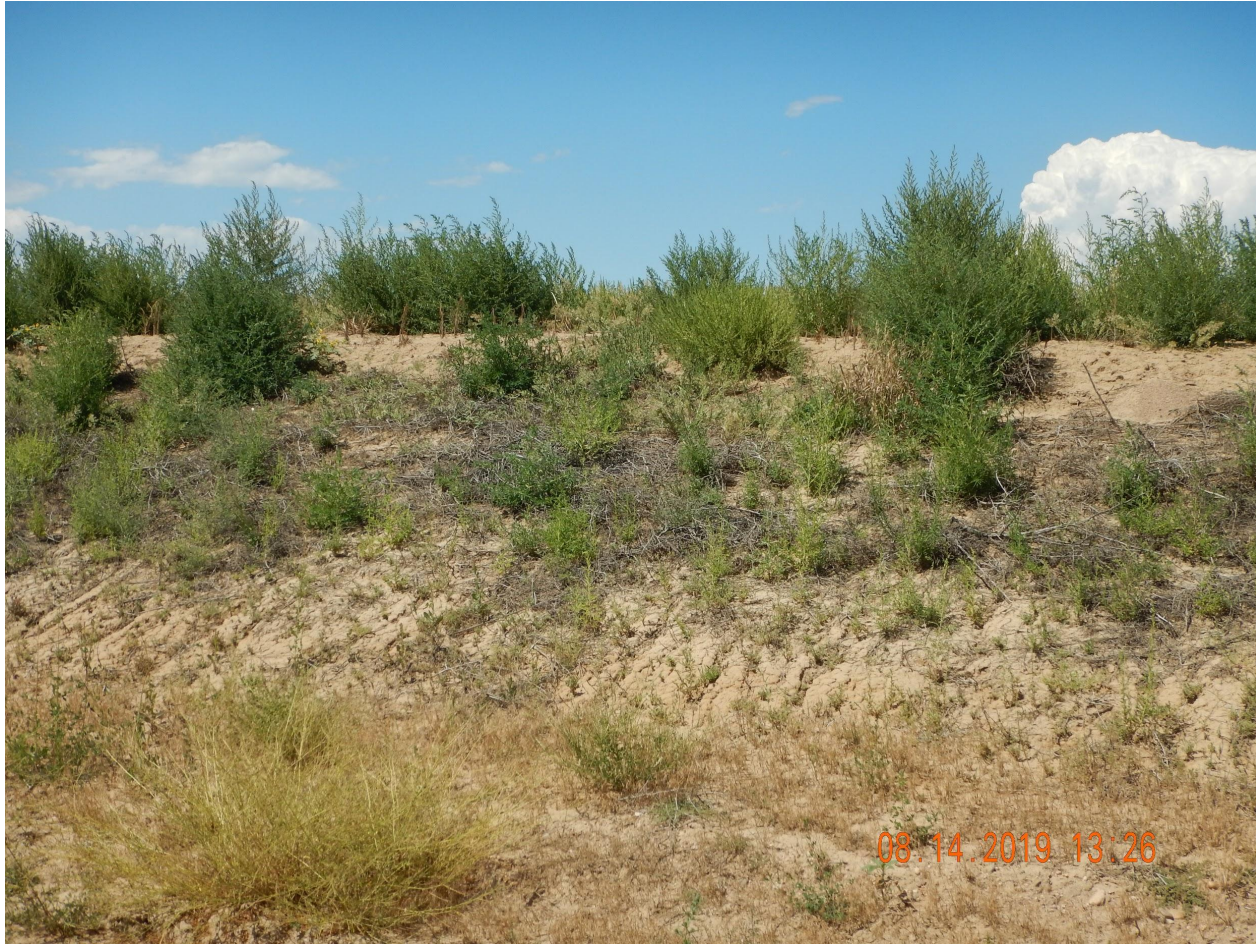
Photo 5. Photo taken from the northern well pad, facing North. See comments under Photos 3 & 4.
