Inspection Photos  
Location Name: ALBERT 13-15  
API#: 05-071-06441  
INSP. #: 695101222

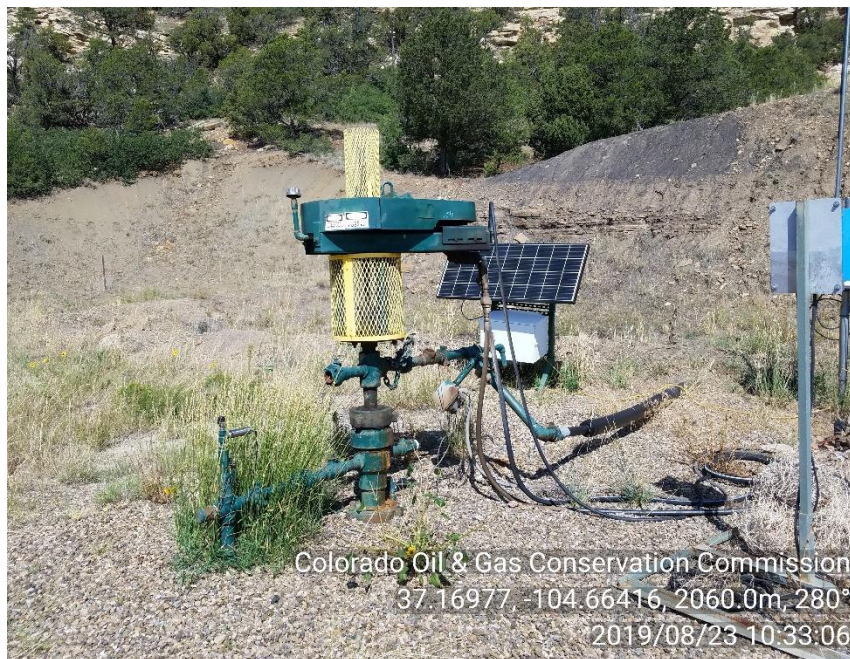
PHOTO 1: WELLHEAD

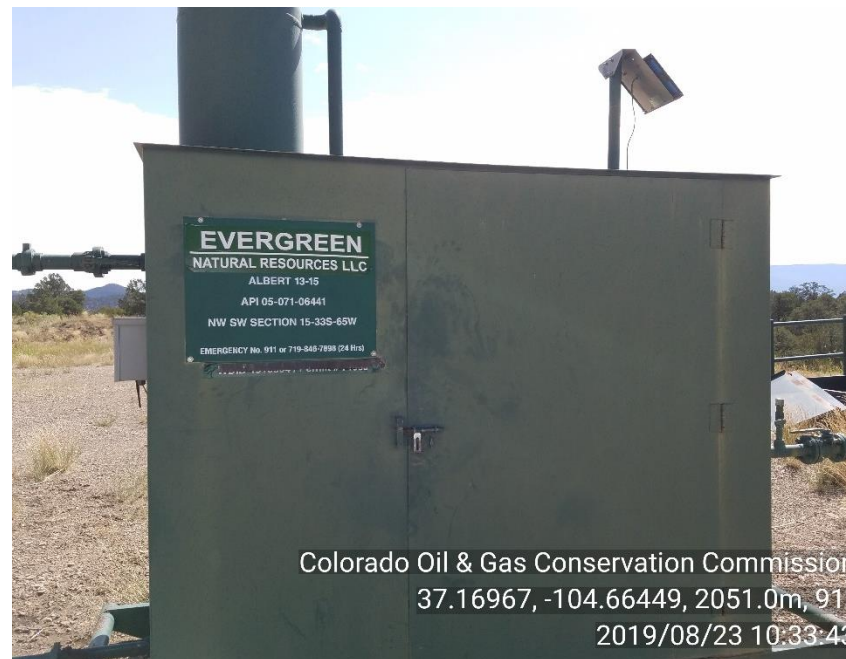
PHOTO 2: WELL SIGN

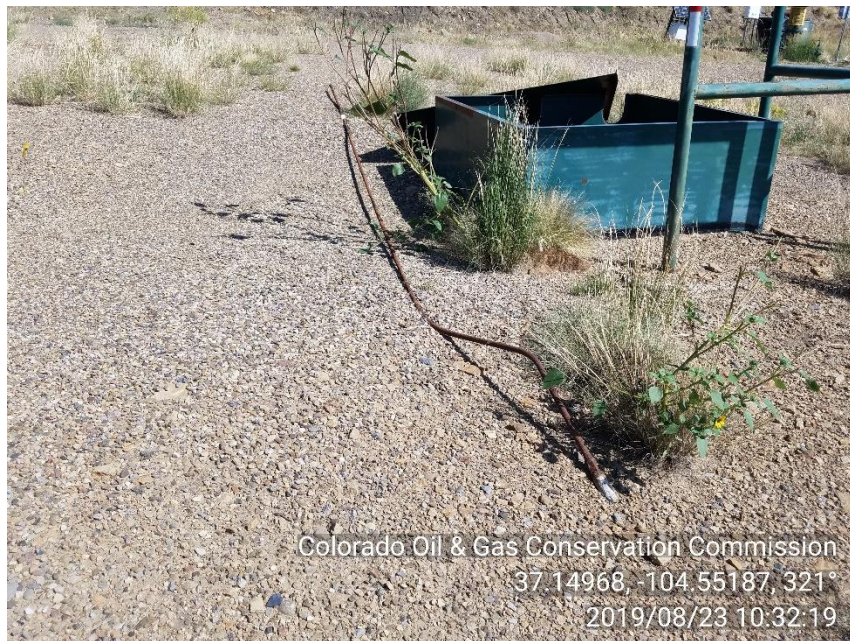
**PHOTO 3: UNUSED EQUIPMENT STORED ON LOCATION (SUCKER RODE). REMOVE UNUSED EQUIPEMNT, COMPLY WITH RULE 603.f. CA DATE 9-23-19.**

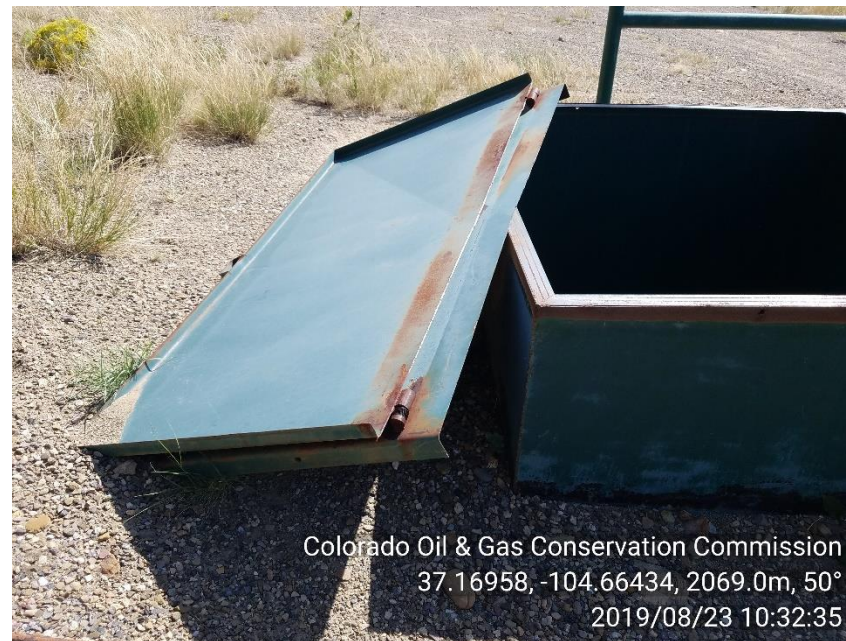
**PHOTO 4: UNUSED EQUIPMENT, LID TO UNDERGROUND VALVE BOX IS LEANED TO THE SIDE. REMOVE OR REINSTALL UNUSED EQUIPMENT, COMPLY WITH RULE 603.f. CA DATE 9-23-19**
