Inspection Photos

Location Name: STATE OF COLORADO AU 12-36 FOLLOWUP

API#: 05-071-06065

INSP. #: 695101236

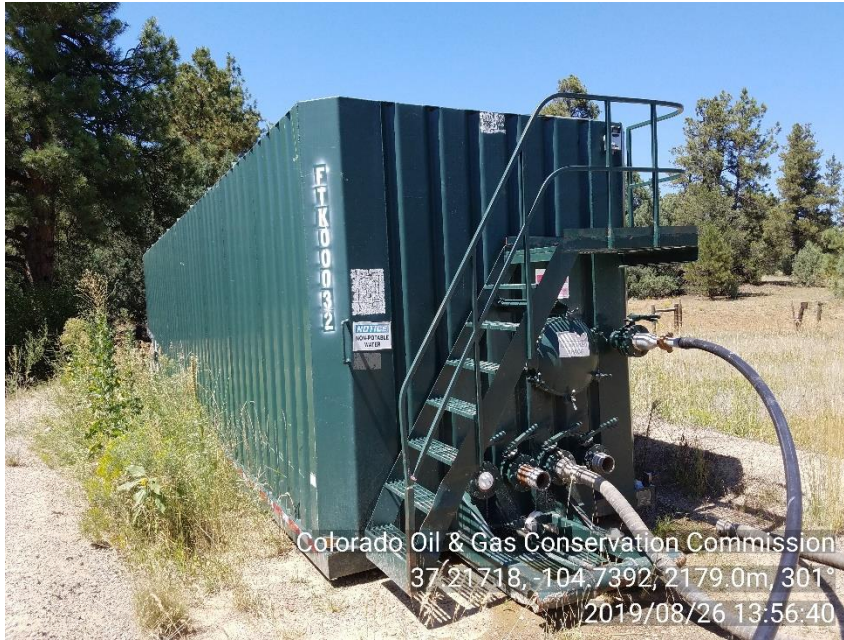
PHOTO 3: CORRECTIVE ACTIONS FROM PREVIOUS INSPECTION DOC# 697000036 HAVE NOT BEEN ADDRESSED. Sign or label not posted or information inaccurate on tanks or containers. Tank is missing volume and other labels required per rule. **Install sign to comply with Rule 210.d. CA DATE 9-26-19. IF CORRECTIVE ACTIONS ARE NOT ADDRESSED BY CA DATE ENFORCEMENT MAY BE CONSIDERED.**
